## Degradation in Fatigue Crack Propagation Resistance of a Gas Turbine Vane after Long Term Service.

Masakazu OKAZAKI<sup>1, a</sup>, Motoki SAKAGUCHI<sup>1</sup>, Yosuke SASAKI<sup>1</sup>  
and Koichi NAMBA<sup>2</sup>

**Abstract.** Degree of long term degradation damage of a retired gas turbine vane made of a Ni-based superalloy which had been operating for about 20000 hrs in a land-based gas turbine, was experimentally evaluated, through an assessment on the change in fatigue crack propagation resistance. For the purpose, a new testing apparatus has been developed to measure the local area fatigue crack propagation resistance, by extracting the miniature size compact tension specimens from the vane, where the specimens were extracted from the leading and the trailing edge, respectively. It was shown, the propagation rate of the crack that grew at the trailing edge part was significantly higher than that at the leading edge part. It was also shown that the crack propagation rates in the miniature specimen were generally higher than those in the standard size specimen. In order to explore an possibility to recover the degradation damage, the effect of a simple reheat treatment

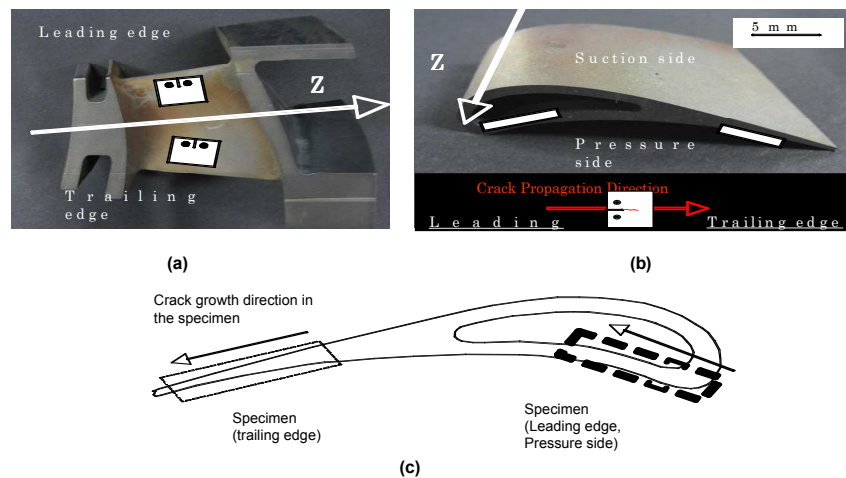
Fig.1 The post-service gas turbine vane and how to extract the specimens.  
 (a) Overview (b) Transverse cross section of the vane and the site for the specimens extracted  
 (c) How to extract the specimens

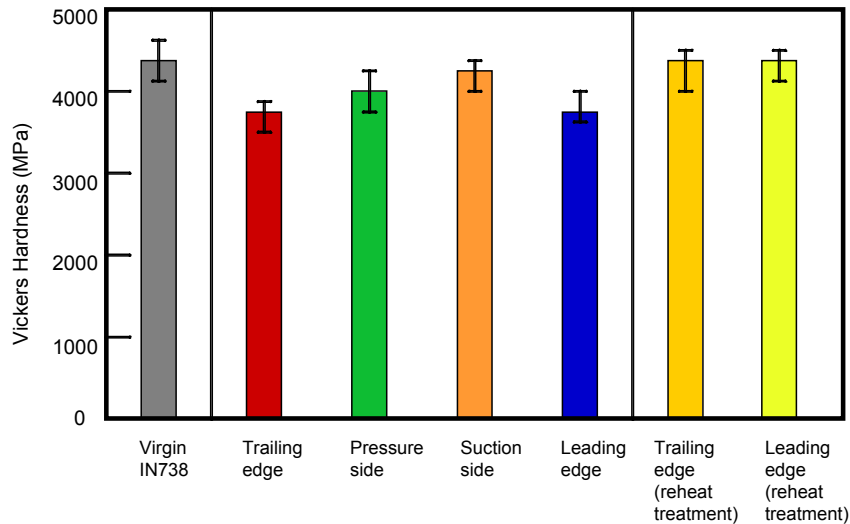
Fig. 2 Hardness distribution in the post-service vane.

The hardness was measured at the midsection of the vane: Fig. 2. It is found that the hardness of the trailing and leading edge were lower, compared with that of the other areas. This suggest that the more pronounced damage might be evolved at the former two areas than the others. Meanwhile, the hardness of the virgin IN738 was higher than those of all regions in the IN939 post-service vane.

The effect of a simple reheat treatment,  $1120^{\circ}\text{C} \times 2\text{h}$ , followed by an aging at  $845^{\circ}\text{C} \times 24\text{h}$  in air, on the hardness is given in Fig. 2, which shows the treatment was effective to recover the reduced hardness for the present post service IN939. Figure 4 reveals the effect of a simple reheat treatment ( $1120^{\circ}\text{C} \times 2\text{h}$ , followed by an aging at  $845^{\circ}\text{C} \times 24\text{h}$  in air) for the present post service IN939 on the FCPRs. Of particular importance in Fig. 4 is that the FCGRs at the trailing edge part were decreased by a half magnitude by the treatment, while the effect was not so pronounced at the leading edge. It is not necessary to say that these results show an effectiveness of reheat treatment to recover the fatigue crack growth resistance of the post service gas turbine vane. At the same time the difference in the effect of heat treatment on FCPR between the trailing and leading edges indicates that the difference seen in Fig. 3 should be attributed to a reduction of resistance itself to fatigue failure during the service period.

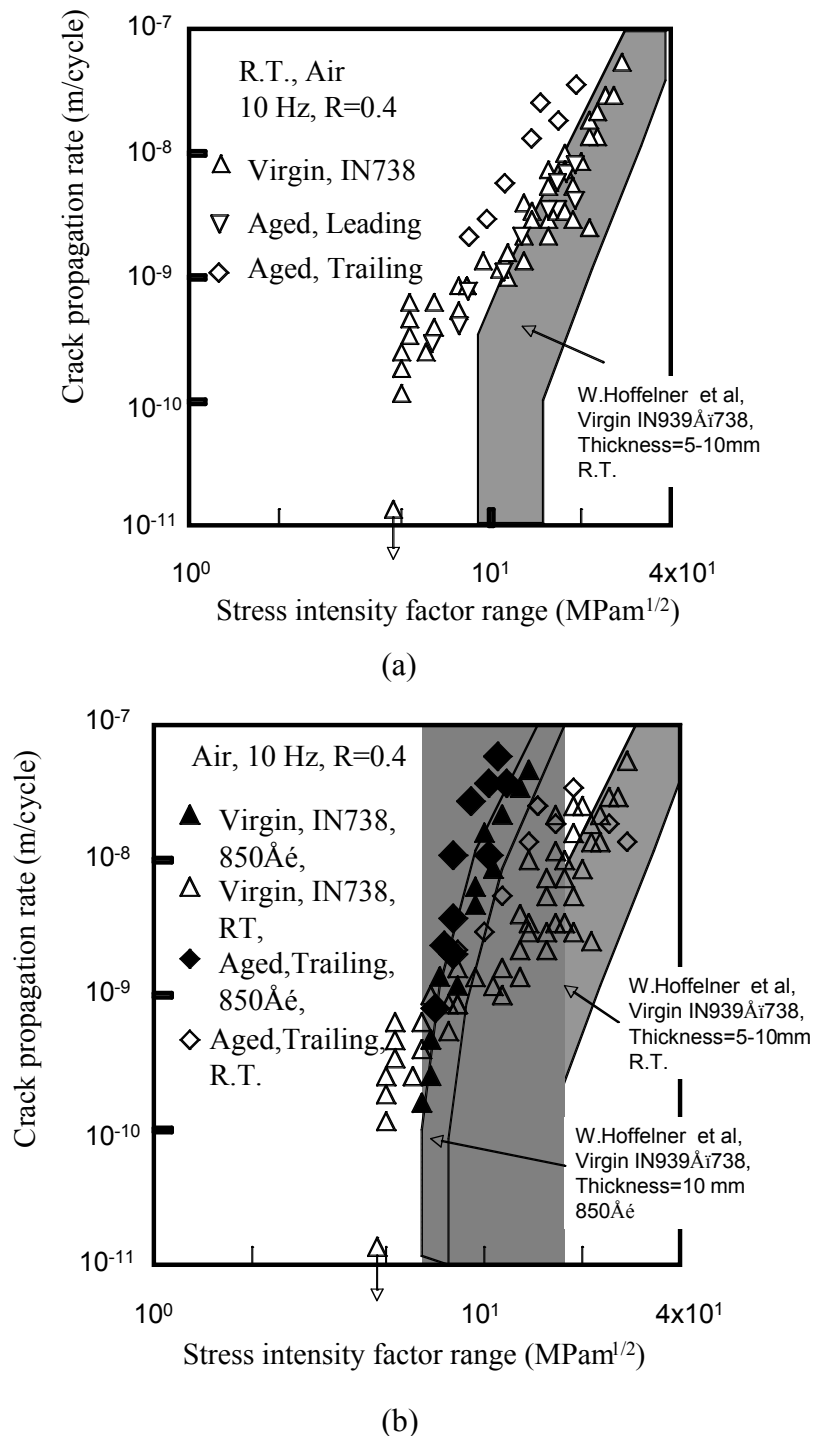
In Fig. 3 the fatigue crack propagation rates (FCPRs) in the post-service vane are correlated with the stress intensity factor range,  $\Delta K$ , and compared with some results by other researchers [8-10,12]. The crack propagating at the trailing edge reveals the higher rate by a magnitude of a few times than that propagating at the leading edge part, especially in the high  $\Delta K$  regime. In addition the rates at the former site are higher than those of the virgin IN738 specimen, whilst the rates at the latter site were almost comparable. Unfortunately the virgin IN 939 vane could not be prepared in this work, hence, it is difficult to explicitly confirm the reason for the higher FCPR at the trailing edge.

Fig. 3 The fatigue crack propagation rates those were significantly dependent on the crack propagating site in the post-service vane. (a) at room temperature, (b) at 850°C.

However, from the following two reasons it is reasonable to postulate that the difference between the trailing and leading edge parts would be taken place during the service period, and not from the difference in grain size in the both areas. The first is from such an experimental results that the FCPRs at the former part were significantly changed after applying the reheat treatment, which will be shown later (Fig. 4). The other is from such findings that the FCPRs are generally insensitive to the yield strength of materials, rather more sensitive to elastic modulus [10-13]: in the other words, the FCGR of the virgin IN939 must be comparable to that of the virgin IN738, because of comparable elastic modulus between the both materials. This postulation is not in conflict to the hardness measurement shown in Fig. 2.

Figure 3(b) shows the FCGRs at 850°C, indicating that the FCPRs at 850°C were higher than those

at room temperature. It is also found from Fig. 3(b) that the rates at the trailing edge part were still higher by about two times than those in the virgin IN738; an additional evidence suggesting a significant reduction of fatigue failure resistance there.

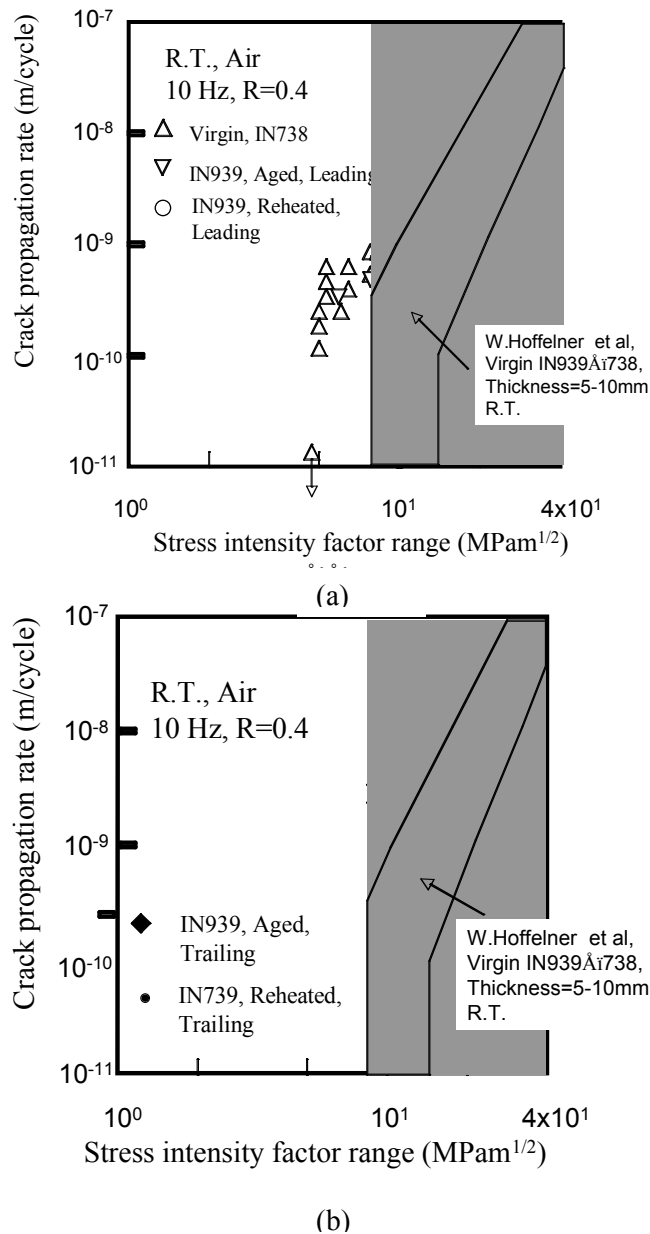
Fig.4 Effect of reheat treatment on FCPRs.  
(a) Trailing edge part, (b) Leading edge part.
