Failure Investigation & Analyses of AISI D3 Dies used in Tableting Machines for Pharmaceutical Application

¹STEER Engineering Pvt. Ltd, 4th Phase Peenya Industrial Estate, Bangalore, India

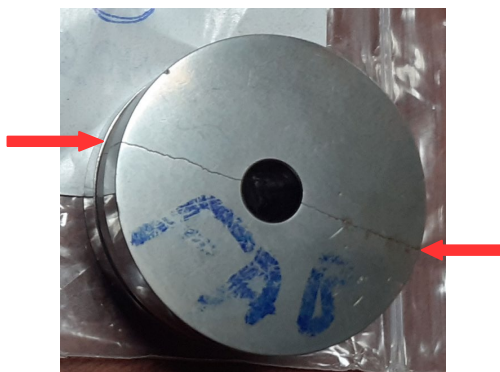
Fig. 3. Visual Examination -round Die

The results of chemical analysis & hardness survey (Table. 1) were found to conform to specification requirements. Visual examination of the round Die face showed a 180° crack across the top face (Fig. 3) but no such crack was found on the opposite bottom face. In the case of the elliptical Die the 180° crack was noticed on the top face along the major axis of the ellipse with minimum Die wall thickness (Fig. 4) but no such crack was noticed on the opposite bottom face.

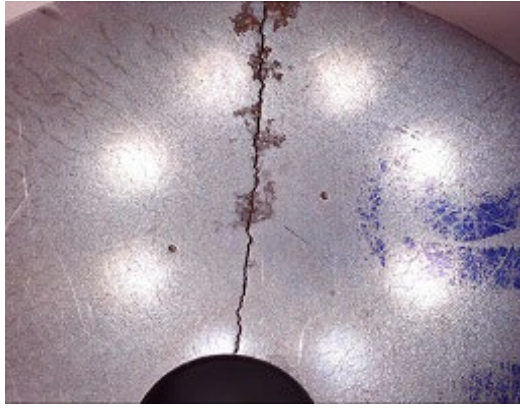
Fig.5. Macroexamination-round Die(rD) face

Macro-examination (3-5X) revealed cracks of jagged morphology with rust marks on both the round & elliptical top Die faces (Fig. 5 & Fig.6) but sharp hairline cracks of 20 mm length connected to the those on the top faces were noticed on the outer diameter (OD) surfaces (Fig. 7 & Fig. 8). The macro-examination of the cut section of the round Die revealed jagged crack of length 19.5 mm on the Internal Diameter (ID) surface from the top face (Fig. 9) and cluster pit marks of 4 mm length around mid-height of the Die. The macroscopic observations of the elliptical Die were similar to that of the round Die (Fig. 10).

While it is clear from the evidence stated and the above discussion that crack origination had occurred on the ID surface in the cluster pit mark zone (Fig. 18) of the round Die, the jagged appearance of the crack of about 20 mm along the ID surface (Fig.5) and on the Die face suggests progressive nature of crack propagation. In addition, the appearance of hairline crack on the OD surfaces (Fig. 7) indicate accelerated crack propagation resulting in abrupt failure. The three phases of a typical fatigue failure [4,7] namely crack initiation, crack propagation through steady state & unsteady state and final fracture have been clearly evidenced in the Tableting Die failure.

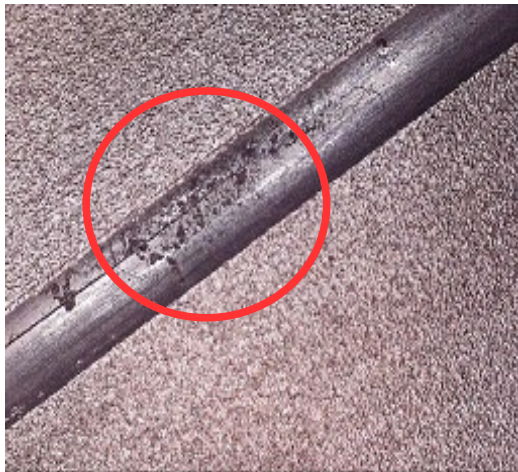
Fig. 9. Macroexamination - rD cluster pitmark

Owing to cyclic tensile hoop stresses generated in the Die cavity as mentioned above, the most prone region for the crack to initiate would be the zone of compaction on the ID surface for both the round & elliptical Dies. The cluster pit marks observed during macro-examination of the ID surface [Fig. 9] and the excessive bleeding noticed during Dye Penetrant examination of the ID surface [Fig. 11] at mid-height region of the Dies, confirm presence of multiple discontinuities in the said region and indicate the possibility of multiple crack initiation sites.

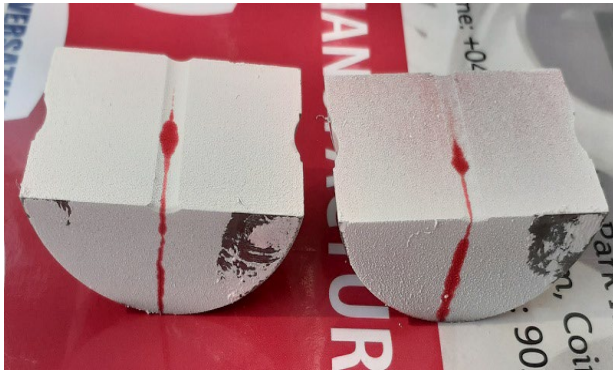
Fig. 11. Dye Penetrant Test – Round Die

Liquid Penetrant examination on the cut sections of both the round & elliptical Dies showed excessive bleeding around mid-height on the ID surface. Also, while it revealed linear indications from mid-height to the top face along the ID surface and on the top Die faces, no such indications were noticed near the bottom face (Fig. 11 & Fig. 12). Visual examination of the fractured surfaces of the round & elliptical Dies showed evidence of corrosion (Fig. 13 & Fig. 14) and clearly revealed the progression of corrosion into the material from the pitmarks observed on the ID surface.

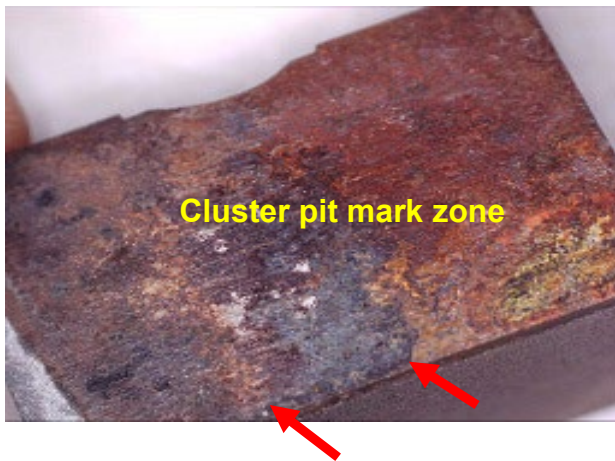
Fig. 13. Fractured surface – Round Die

either. However, the surfaces obtained by fracturing the Dies along the crack (Fig. 13 & Fig. 14) showed moderate to high corrosion suggesting contribution of environmental factors for the crack initiation on the ID surface.

While the presence of corrosion on the fractured surfaces (Fig. 13 & Fig. 14) indicate that some of the ingredients in the formulation had been corrosive to AISI D3 Dies, the SEM-EDX analysis (Table.3) showed low percentage of Cr₂O₃ (6.61%) on the fractured surfaces in the cluster pit mark zone, despite the AISI D3 material having close to 12% of Chromium. This clearly indicates depletion of available Chromium towards preferential formation of Chromium Carbides, thereby making the material susceptible to corrosion due to insufficient Cr₂O₃ content. It can be inferred that the pit marks have been formed due to the ingredients used in tablet formulation that have been corrosive to the AISI D3 Dies getting smeared onto the ID surface at high pressure similar to that of a high pressure jet during every downward movement of the top punch in the compression stage of the Tableting process.

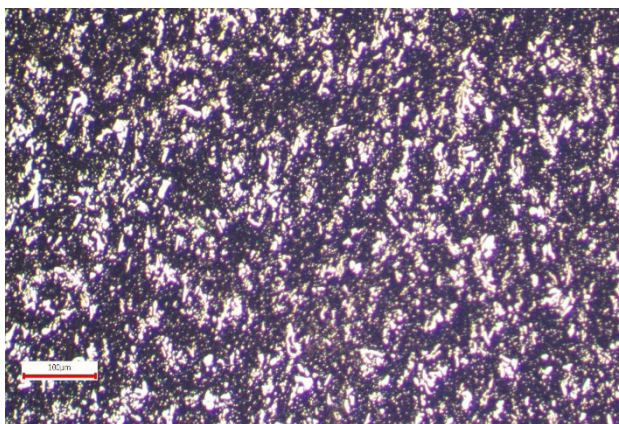
Fig. 15. Microstructure1 – Round Die face

Microstructural examination on samples taken on the top face of the round Die showed presence of 50% needle shaped carbides randomly distributed in tempered martensite matrix (Fig. 15). Also, several micro-cracks have been observed in the vicinity of the large crack on the top face of the round Die (Fig. 16). However, the microstructural examination on samples on the ID surface in the vicinity of the crack revealed severely banded carbides oriented along the axis of the Die (Fig. 17). The fractography of sample taken at the cluster pit mark zone of the round Die revealed several micro-cracks originating from the ID surface propagating into the cross section of the Die (Fig. 18).

Since the ID surfaces of both the round & elliptical Dies had smooth machined finish, geometrical factors such as sharp corners etc. had played no role in crack initiation. Also, as the inclusion contents were very low (Table 2) and no apparent grain boundary carbides were noticed (Fig. 15), these microstructural features do not seem to have contributed towards crack initiation

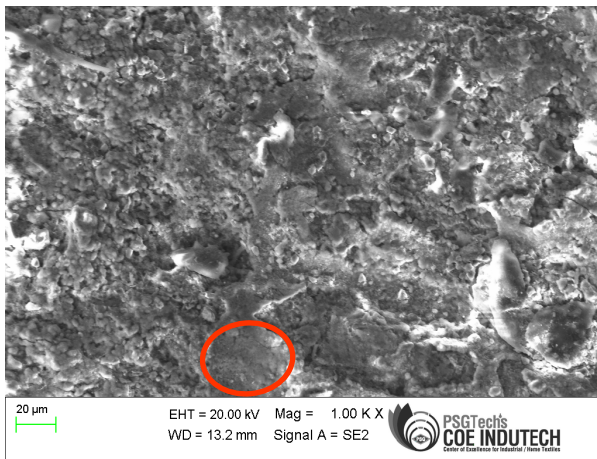
Fig. 19. SEM Analysis – Cluster pit mark zone

While Scanning Electron Microscopy in the cluster pit mark zone of the round Die (Fig. 19) revealed the presence of multiple micro-cracks, SEM – EDX Analysis (Fig. 20) in the marked location close to the ID surface confirmed high content of FeO (81.77%) and low content of Cr₂O₃ (6.61%).
