# Failure Investigation & Analyses of AISI D3 Dies used in Tableting Machines for Pharmaceutical Application

Vijay Shrinivas<sup>1,a\*</sup>, Rajesh Narasimhan<sup>1,b</sup> and Thillairajan Arumugam<sup>1,c</sup>

<sup>1</sup>STEER Engineering Pvt. Ltd, 4<sup>th</sup> Phase Peenya Industrial Estate, Bangalore, India

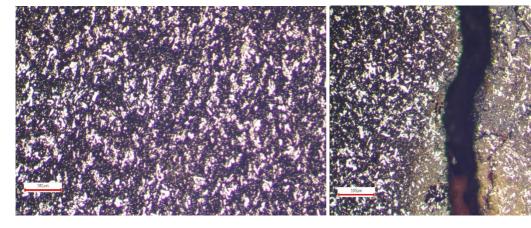
Fig. 15. Microstructure1 – Round Die face

Microstructural examination on samples taken on the top face of the round Die showed presence of 50% needle shaped carbides randomly distributed in tempered martensite matrix (Fig. 15). Also, several micro-cracks have been observed in the vicinity of the large crack on the top face of the round Die (Fig. 16). However, the microstructural examination on samples on the ID surface in the vicinity of the crack revealed severely banded carbides oriented along the axis of the Die (Fig. 17). The fractrography of sample taken at the cluster pit mark zone of the round Die revealed several micro-cracks originating from the ID surface propagating into the cross section of the Die (Fig. 18).

Since the ID surfaces of both the round & elliptical Dies had smooth machined finish, geometrical factors such as sharp corners etc. had played no role in crack initiation. Also, as the inclusion contents were very low (Table 2) and no apparent grain boundary carbides were noticed (Fig. 15), these microstructural features do not seem to have contributed towards crack initiation
