Strengthening of a Damaged Concrete Structure - Case Study of an Eleven Stories Building in Dar es Salaam

Dr John K. Makunza

University of Dar es Salaam, Department of Structural and Construction Engineering,
P.O. Box 35131, Dar es Salaam, Tanzania

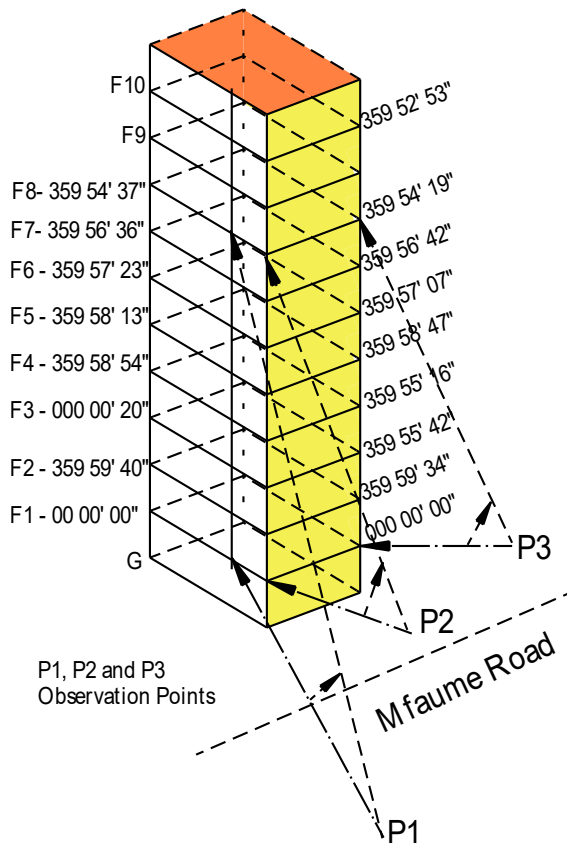
The observed angles were recorded and the deviation angles were computed in order to assess if the building exhibit a safe behaviour or if there is any significant tilt. From the data analysis, observations made from Column (CC) at point E3 showed that the highest deviation angle was 5' 23" while the lowest deviation angle was 20". Also, for the Column at point F3, observation made showed that the highest deviation angle was 7' 07" and the lowest deviation angle was 26". And, for the Column at point F8, observation made yielded the highest deviation angle of 6' 20" and the lowest deviation angle was 01". The control limit in tilting is normally $H*1/500$ to $H*1/1000$ [7]. Taking $H*1/500 = 33000/500 = 66$ mm. The obtained tilting of $0^{\circ}6'20''$ is equivalent to 60 mm for a 33.00 m height. Therefore, the tilting is within the allowable value. There is no any danger of toppling of the building.

Figure 3: Measurement of building verticality
