# Strengthening of a Damaged Concrete Structure - Case Study of an Eleven Stories Building in Dar es Salaam

Dr John K. Makunza

University of Dar es Salaam, Department of Structural and Construction Engineering,  
P.O. Box 35131, Dar es Salaam, Tanzania

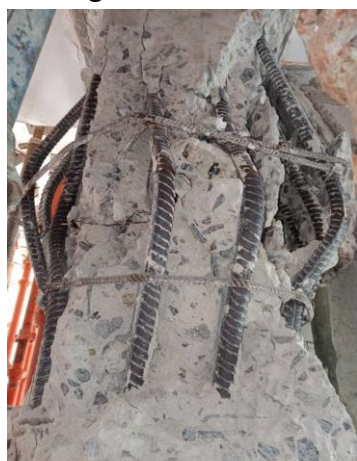
**Figure 1:** Crushed column

An eleven stories building located within the city of Dar es Salaam had one of its columns abruptly crushed at the head below 1<sup>st</sup> floor slab beams with a loud noise like a small bomb in the year 2018. The concrete column head failed by crushing and the main steel reinforcement bend by bowing outwardly as depicted in Figure 1. It was not clear on the reason of the failure knowing that the building has been in service for more than 10 years. Due to this problem, the government of Tanzania ordered the residents of the building plus those in the adjacent neighborhood to be evacuated as a safety measure in case of any progressive failure. Following this concern, the Office of the District Commissioner of Ilala requested the University of Dar es Salaam, to carry out a thorough investigation on the structural strength of the building, and provide recommendations on the strength status and appropriate corrective measures[6].

With regard to the tests done on the strength of concrete, it was found that all concrete elements of the structure had a strength of not less than 25 N/mm<sup>2</sup> except the crushed column where it was 19.0 N/mm<sup>2</sup> which is very low. It is therefore established that the column crushed because of concrete weakness at the top of the column at 1<sup>st</sup> floor level. The concrete at the point was observed to be rich in fines in comparison to others. Also the surveying measurements have shown that the building has not significantly tilted and that its vertical downward displacement is within the allowable values.

Due to the above results and concluding remarks, it was recommended that the columns be strengthened from foundation level to the first floor level by jacketing with 150 mm thick concrete of grade C30 (ratio 1:1.5:2 by volume) all around for those in grids C, E and F. Those in Grid A and B may remain without any treatment because of the masonry walls and Lift-shaft which helps the column system to be more stable. Reinforcement of 16 mm diameter 12 in number and links of 8 mm diameter spaced at 250 mm c/c were to be provided as shown in Figure 9.

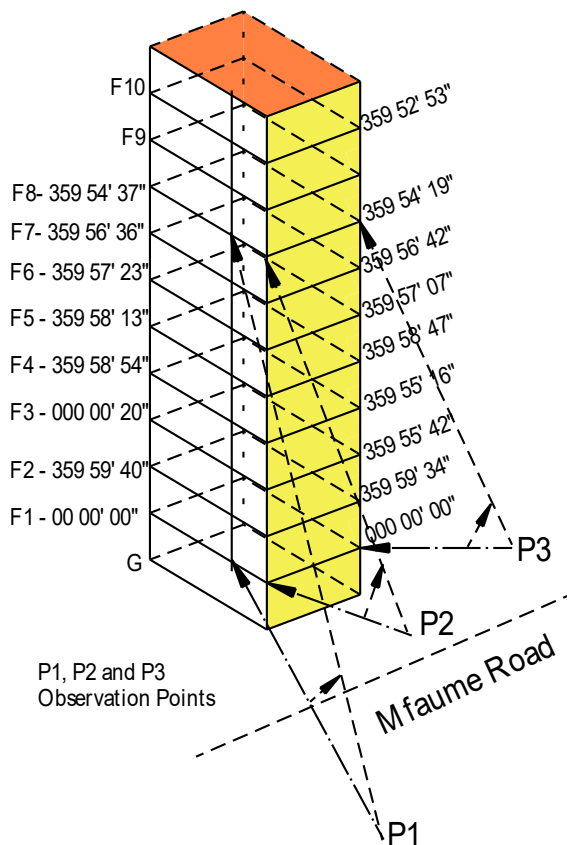
The observed angles were recorded and the deviation angles were computed in order to assess if the building exhibit a safe behaviour or if there is any significant tilt. From the data analysis, observations made from Column (CC) at point E3 showed that the highest deviation angle was 5' 23" while the lowest deviation angle was 20". Also, for the Column at point F3, observation made showed that the highest deviation angle was 7' 07" and the lowest deviation angle was 26". And, for the Column at point F8, observation made yielded the highest deviation angle of 6' 20" and the lowest deviation angle was 01". The control limit in tilting is normally  $H*1/500$  to  $H*1/1000$ [7]. Taking  $H*1/500 = 33000/500 = 66$  mm. The obtained tilting of  $0^{\circ}6'20''$  is equivalent to 60 mm for a 33.00 m height. Therefore, the tilting is within the allowable value. There is no any danger of toppling of the building.

**Figure 3:** Measurement of building verticality

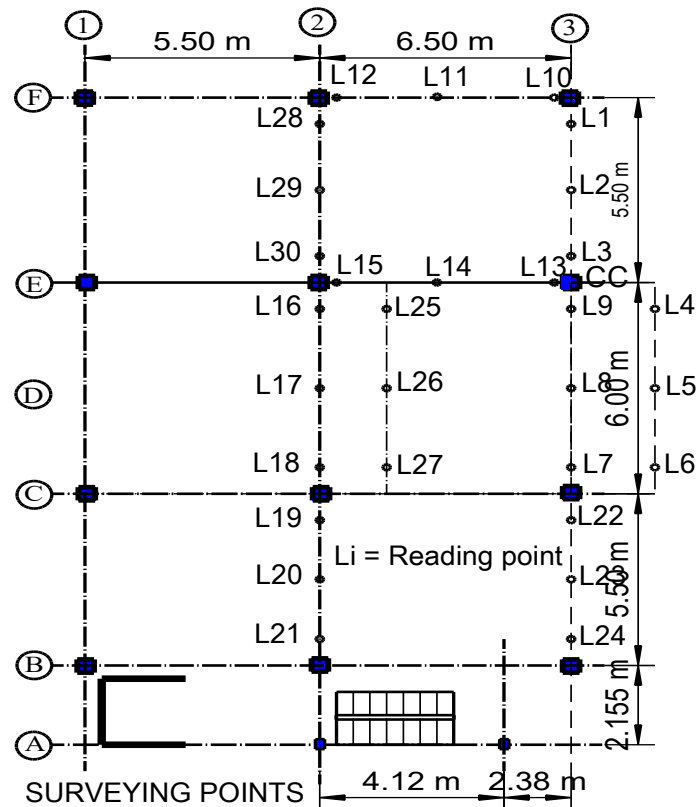
Levelling was done for the beams meeting at column E3 (ref. Figure 4) in order to check the settlement of the building. Beams levels were taken in reference to an established Temporary Benchmark at site with the help of an inverted staff. Referring to Figure 4 which shows the arrangement of beams at first floor, levels were taken for the beams along line numbers L1 and L3, L9 and L7 to L24. The results obtained indicate that the differences of the connected nodes of L1-L3 has a value of 0.012m, L9-L24 has a value of 0.024m and L7-L9 has a value of 0.042m. In this regard, the beam along grid 3 at the crushed column (E3) was shortened by 42 mm. This displacement is within the deflection limits of  $11500/250 = 46$  mm.

**Figure 4:** Surveying work layout

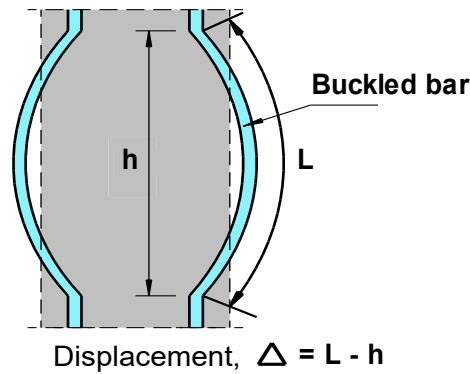
Measurement of buckled bars was carried out along the bend bars and also the actual vertical height between the end points as depicted in Figure 5. The results obtained were as given in Table 1, where it can be seen that the bend covered a depth of 40 mm, while from surveying measurement, the total downward movement was observed to be 42 mm. These results together, show that there was a settlement of  $42 - 40 = 2$  mm for column E3.

Based on the survey tests done to determine the tilting of the building, and downward displacement at the crushed column, the analysed data shows that the plumb of the building is within the allowable values, and the levelling data shows that the beams deflected down by 42 mm, while measurements along the bent bars gave an average of 40 mm downward displacement. This implies that the foundation moved downward by 2 mm only. In general, the downward displacement is still within the allowable values of not more than 20 mm.

**Figure 5:** Configuration of measurement of depth due to crushing

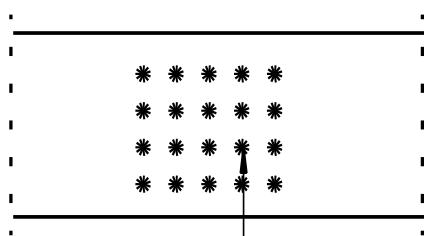
**Figure 6:** Rebound Hammer Test on Columns and Beams

The Rebound Hammer test is a non- destructive test, and it was undertaken in order to assess the strength of the existing concrete in the building. This test was performed on selected columns, beams and slabs at locations as shown in Figure 6. The Rebound Hammer test was done at positions in structural elements as shown in Figure 6. The average rebounds numbers were 15 per location or point. For the columns, from ground floor level to the eleventh floor, the obtained average concrete compressive strength was as summarized in Table 3.

At ground floor storey, it can be seen that the concrete compressive strength for the defective column was  $19 \text{ N/mm}^2$  being lower than concrete grade **C20** which is the minimum grade for structural concrete. The other columns had strengths of not less than  $25 \text{ N/mm}^2$ . It is most probable that column **CC** at point **E3** (ref. Figure 2) crushed because it had less compressive strength of concrete up to bottom of 1<sup>st</sup> floor beams. The compressive strength obtained from Rebound Hammer Test is in agreement with the results obtained from concrete cores.

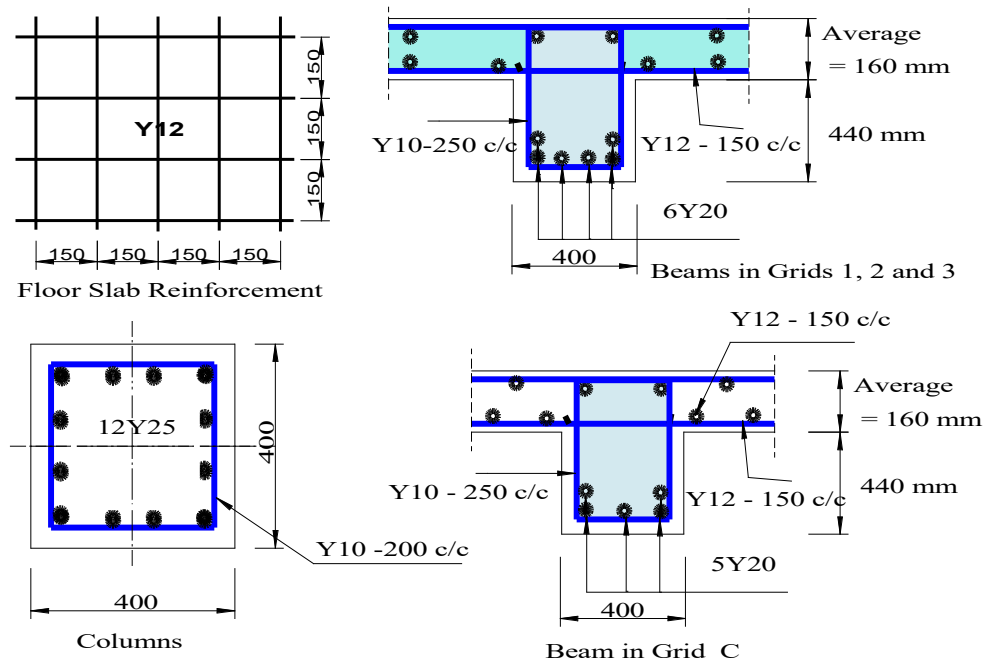
Steel detection was done using a Profometer steel detector equipment. The test was performed in order to find out the sizes and quantity of reinforcement in various structural elements. For beams, slabs and columns, the observed amount of steel was found to be sufficient even from analysis as shown in Figure 7.

**Figure 7:** Steel detection in slabs, beams and columns

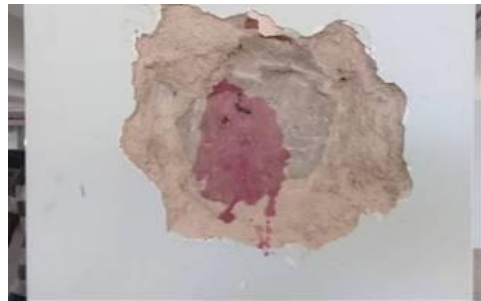
Phenolphthalein chemical solution was applied to the concrete in columns in order to assess as to whether the concrete has been affected by carbonation attack. As seen in **Figure 8**, the test results showed that the concrete wasn't attacked by chemicals and therefore the reinforcement in it can't corrode easily, and that the concrete is still safe without any agent of diminishing the strength thereof.

**Figure 8:** Carbonation test results  
- No carbonation attack

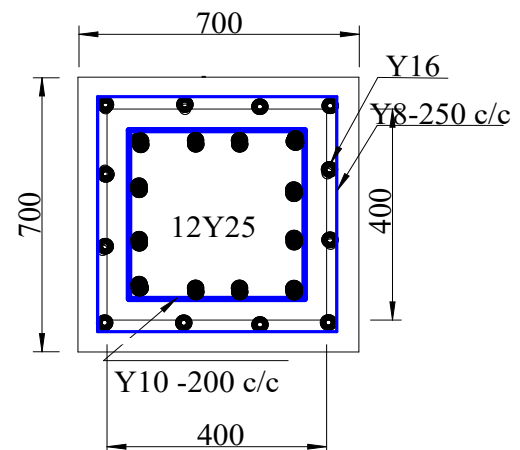
**Figure 9:** Columns strengthening

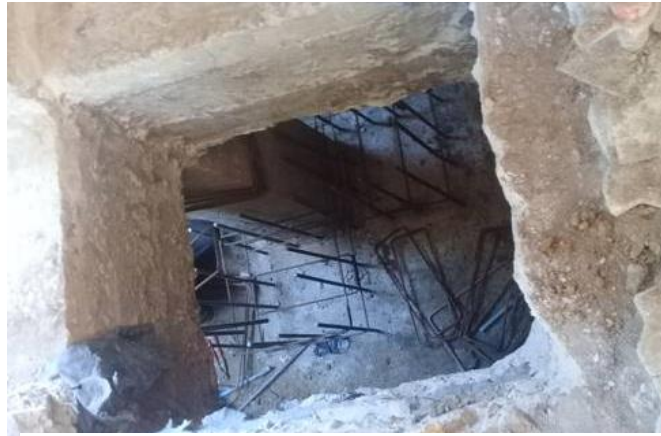
**Figure 10:** Excavation to expose the footing and fixing of starter bars

Each column footing was excavated from ground floor level by removing the paving bricks and breaking the oversite concrete of varying thickness from 100 to 150 mm. The excavated soil materials was heaped around the trench, then the top of the footing was cleaned and scarified to form key for bonding with the new concrete. Locations for the holes were marked, then holes of 16 mm diameter and 200 mm deep were drilled and cleaned again.

From calculations in BICO report[9], the required amount of steel was 10Y16, but 12Y16 bars were provided to increase the safety margin. The starter bars of around 1000 mm long and 16 mm diameter were fixed in the epoxy filled holes as shown in Figure 10 above. The defective column as shown in Figure 11(a) was replaced by 3 columns bundled and attached to the old column in the directions of the three beams meeting at the said column. The concrete was tested to see that it conformed to grade C30.

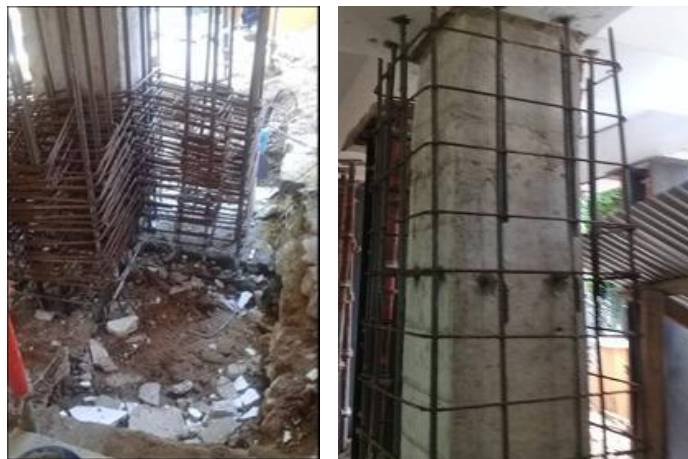
**Figure 11:** (a) Column E3 (b) Columns along grid D reinforcement

In Figure 11(b), shown are the main reinforcement bars and links for jacketing of columns along grid D. Thereafter, the formwork from marine wood was fixed and then concrete was cast and properly vibrated.

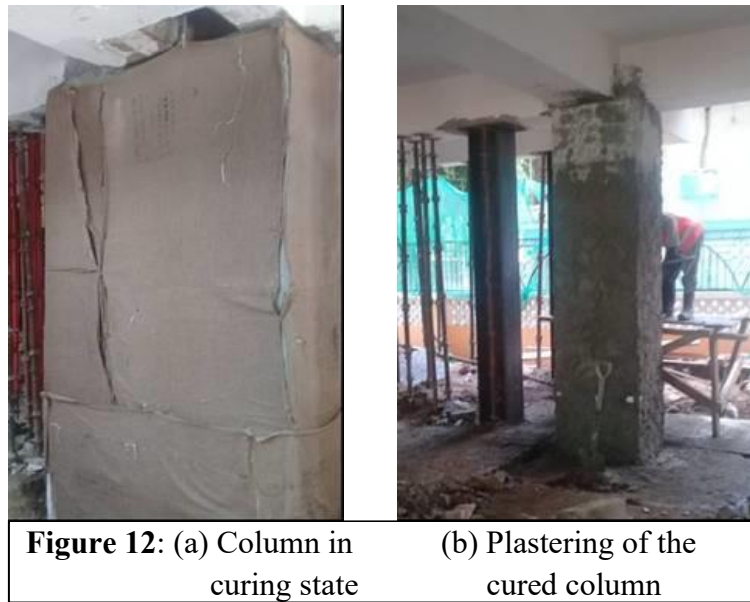
**Figure 12:** (a) Column in curing state (b) Plastering of the cured column

With respect to Figure 12(a), after casting the jacketing concrete, after 7 days, the formwork was removed, then the columns were clothed with sacks sheets and continuously cured for 21 days. On finishing the curing, plastering was done to each of the columns as illustrated in Figure 12(b), and then cured for 7 days.

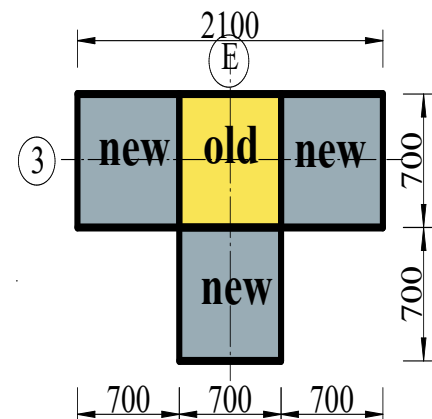
The observed original size of columns was 400 x 400 mm, with 12Y25 bars. However, after jacketing with 150 mm thick all round, the size changed to 700 x 700 mm. Column CC at point E3, (ref. Figure 13) the crushed one, but now replaced by 3 columns and itself jacketed as well, was analyzed and redesigned to ascertain its adequacy. Reduction of live loads in each floor was done as per Table 2 of BS 6399 Part 1 (1996)[10]. From calculations[6], the imposed load constituted 33% of the total design load. Hence, the total axial design load was calculated in kN/floor. Bending moment in column E3 was also established in kNm. The slenderness ratio was found to be 4.5, implying that it is a short column, and so no presence of an additional moment. Thus, the load acting at the bottom of column CC (the crushed one) was analyzed and established in kilo Newton.

**Figure 13:** Column E3 layout

Since the compressive strength of concrete in the crushed column was 19.0 N/mm<sup>2</sup>, and the compressive strength for the new jacketing[11] concrete was not less than 25 N/mm<sup>2</sup>, an average of 20.0 N/mm<sup>2</sup> was taken into account, specific for the defective column. The design results, revealed that, for the new column size, the required amount of steel would be 10Y16. The added steel during jacketing was 12Y16, being higher than the required amount of steel.

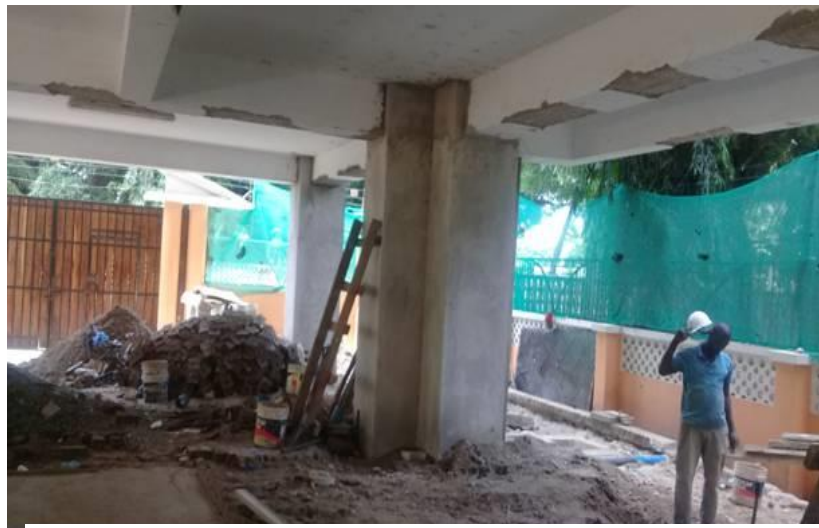
**Figure 14:** Revived column E3 (in skimming process)

After all concrete works have reached 28 days age, the supports to the structural system, namely steel H-sections and other steel props were taken carefully as was indicated in Instructions No. 9 quoted as follows

*“When removing the supports, start with the steel H-Sections and at the end remove the steel props by unthreading slowly. This action will ensure smooth transfer of loads from the supports to the concrete columns safely”*[9]. Figure 14 portrays the ground floor columns after removing all the temporary supports which were instituted when Column E3 crushed in March 2018.
