Investigation of Hot Section (Nozzle Guiding Vane) Distress due to Interaction of Thermal Barrier Coatings with CMAS

Institute of Industrial Control System, Rawalpindi, Pakistan

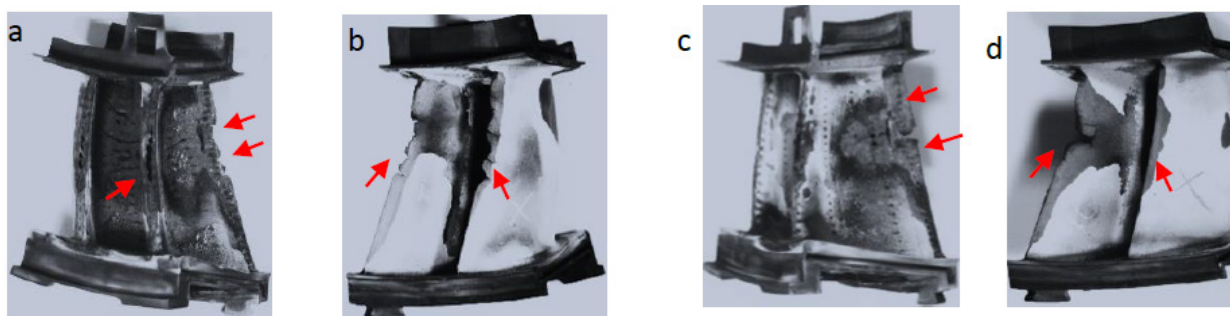
Visual Observation. 2nd stage nozzles guiding vanes (NGV's) were inspected. NGV's were severely damaged from both pressure and suction side. Vanes were coated with YSZ and damage phenomenon like delamination, degradation and foreign material deposition were evident on surface. Cracks due to merging of cooling holes were present on pressure side of the NGV's (Fig. 1).

Fig. 1. Photograph of NGVs (a & c) Pressure side, delamination of coating, erosion, cracks and loss of metal and crack at the leading edge (b & d) suction side, showing coating delamination of pressure side.

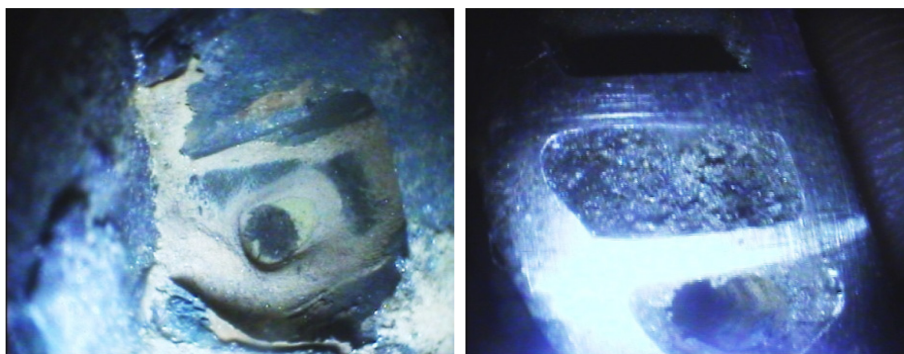
Boroscopy. Internal surface inspection through boroscopy showed evidences of foreign deposits. Deposits were present all around the internal surface (Fig. 2). These were introduced usually, either with low quality fuel or ingested air from atmosphere.

Fig. 2. Photographs of NGVs, (a) foreign deposits on internal surface, (b) Blockage of internal cooling path with foreign material.

Deposits of foreign material (CMAS) were identified on NGVs. Analysis found that CMAS infiltrated the TBC columnar structure. Such infiltration at high temperature is called hot corrosion by molten CMAS [6, 12]. The infiltration of CMAS was either due to dirty fuel or dust ingested through the air intake (Fig.2). The origin of this failure was high temperature interaction of YSZ (TBC) with molten (CMAS) deposits. This caused allotropic change in TBC. Allotropic change began with depletion of yttria in YSZ, which converted the tetragonal stable structure into monoclinic structure which was not stable to service temperature [1, 6]. Consequently destabilization of the YSZ occurred. XRD analysis confirmed the presence of iron oxide at the surface (Fig. 4); Fe_2O_3 worked as flux and decreased the melting temperature of CMAS [6]. After melting CMAS infiltrated into the TBC. Upon cooling infiltrated CMAS solidified. Solidified CMAS in between columns destroyed its capability to withstand volumetric changes [6]. Which extinct the TBC strain tolerance. Reduction in strain tolerance of TBC reduced its capacity to withstand thermo-mechanical stresses. Delamination and cracks were subsequent results of these thermo-mechanical stresses (Fig.6 a, b) [8-11].

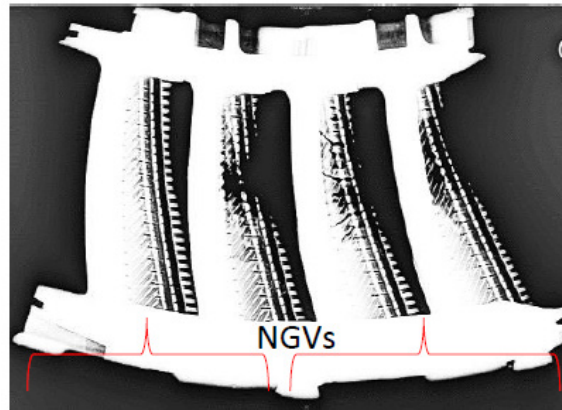
X-ray Radiography. Radiograph of NGV's was taken to reveal the any hidden cracks underneath coating. Radiography revealed cracks on pressure side and thinning of substrate material. This indicated prolonged time high temperature exposure (Fig. 3)

Fig. 3. Radiograph of turbine nozzle guide vanes internal structure.

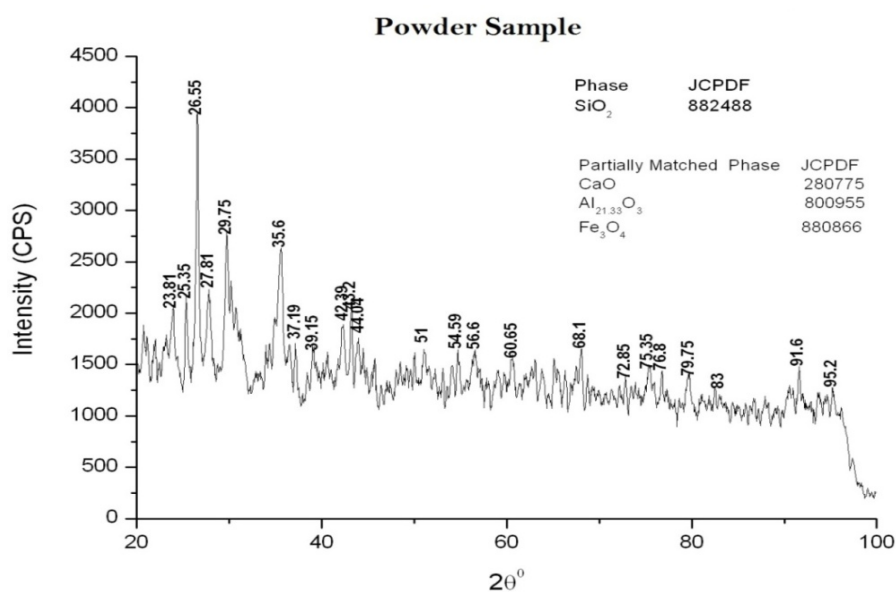
X-ray Diffraction. Foreign deposits were extracted from internal surface and XRD analysis was performed. Analysis reported that deposits consist of four different constituents, calcium oxide, magnesium oxide, aluminum oxide and silicon oxide ($\text{CaO-MgO-Al}_2\text{O}_3\text{-SiO}_2$). Combination of oxides of Ca, Mg, Al and silicon is collectively known as CMAS [3]. These are fundamental constituents of the dust (Fig. 4).

Fig. 4. XRD Spectrums of CMAS Powder, showing existence of SiO₂ phase and partial existence of CaO, Al₂O₃ and Fe₂O₃.

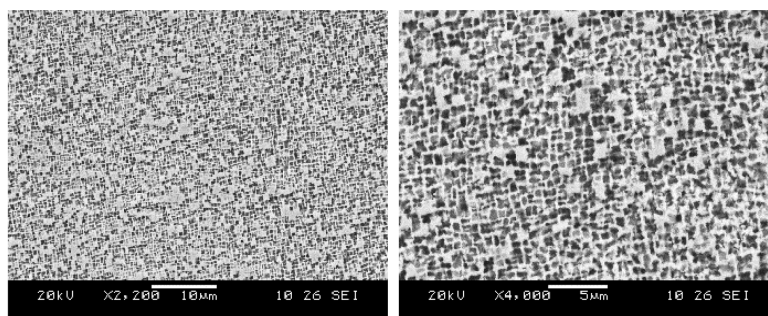
Optical Microscopy. EDS analysis confirmed substrate material as PWA 1484/1487, see Table 1 Metallographic Samples were prepared using conventional techniques grinding, polishing and etching respectively. Super alloys etchant 200g FeCl₃, 200 mL HCl, to 1000mL for 90min 212°F is used to reveal the microstructure. Typical super alloy structure consisting of γ and γ' was observed. (Fig. 5)

Fig. 5. Micrographs of NGV's base material typical super-alloy structure having gamma prime (γ') in gamma (γ) matrix.

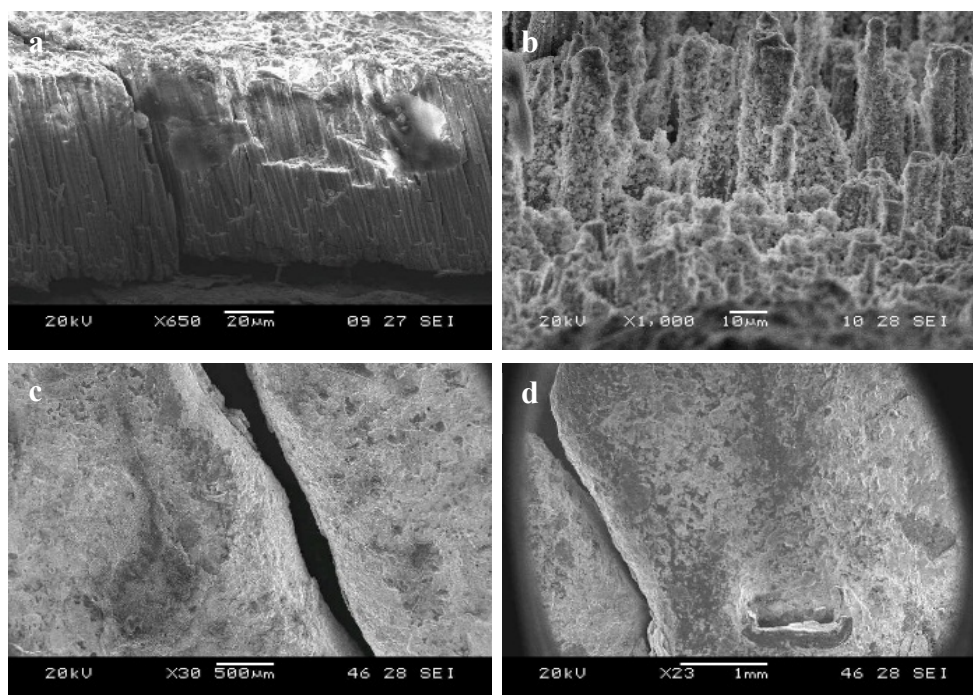
SEM-EDS. Characteristic columnar morphology of electron beam physical vapor coating was observed under SEM. EDS analysis reported that coating is yttria stabilized zirconia (YSZ) known as thermal barrier coating TBC. Surface assessment under SEM-EDS revealed that CMAS ($\text{CaO-MgO-Al}_2\text{O}_3\text{-SiO}_2$) was present on entire surface of the NGVs. Moreover oxide of iron was also observed at often points. CMAS was infiltrated through the columnar structure of PVD coating. At many sites PVD coating was absent due to interaction of CMAS and yttria stabilized zirconia at high temperature (hot corrosion). Electron microscopy revealed delamination of TBC coating and burn through of substrate material caused by high temperature exposure. Cracks formation owing to merging of cooling holes was also apprehended. (Fig. 6)

Fig. 6. Micrographs of NGVs surface expressing (a) columnar TBC, crack in TBC, (b) infiltration of CMAS in EB-PVD TBC, (c) crack formed due to merging of cooling holes, (d) choking of cooling hole.

Evidence of higher temperature exposure of substrate material was observed during investigation (Fig. 6c, d). This may be due to delamination of thermal barrier coating because of hot corrosion and CMAS deposition at internal surface of engine components. CMAS deposits (internal surface) worked as an insulator and decrease heat conduction from blade surface to cooling air. Both delamination of Thermal barrier coating from external surface and decrease in heat conduction from internal surface raised the temperature of component up to distressing level.
