Twisting of the Tail Rotor Shaft – A Case Study

Abstract. Presented results report the findings of a case study carried out to determine the possible factors that lead to the twisting of tail rotor shaft. The structural material of the shaft was evaluated in terms of microstructural analysis and mechanical properties to rule out any material fault. The SEM images showed that the localized fractures at twist ends occurred without any significant plastic deformation. Moreover, there was no evidence of fatigue. Such behavior suggests that twist occurred under impact / high strain rate loading. Such loading conditions are not possible during the event to ground hitting. The Ansys simulation confirmed that the observed twisting can increase the stress at localized point in excess of UTS and cause fracture.

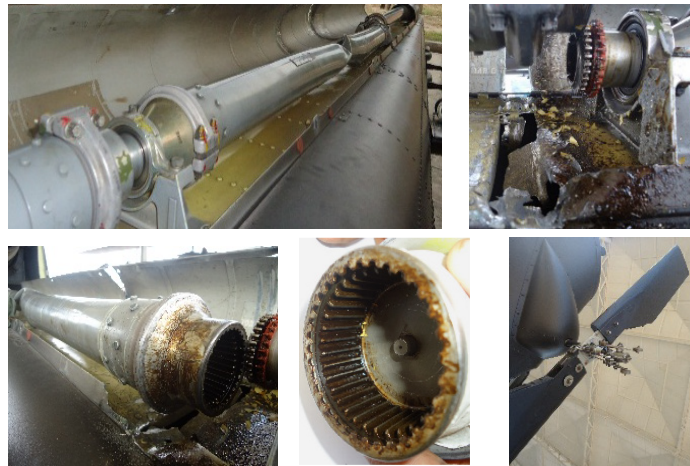
One of the observation made during the detailed visual inspection was that the tail rotor shaft of the helicopter was twisted and has become loose probably due to the consequent shortening of the twisted shaft (Fig. 2a). The loose rotating shaft caused some damage to the outer casing at several places (Fig. 2b).

Fig. 2. Twisting of the tail rotor shaft and the damage done by the loose rotating shaft.

The length of the twisted part 14 inches is about 25% of the total length (about 57 inch). The location of the twist is near center of the shaft. The twist caused length shortening of 0.7 inch which was enough to detach the shaft from the drive train connector at the farther end. The amount of damage shown in Fig. 2 clearly indicates that the shaft remained rotating after becoming free for quite some time.

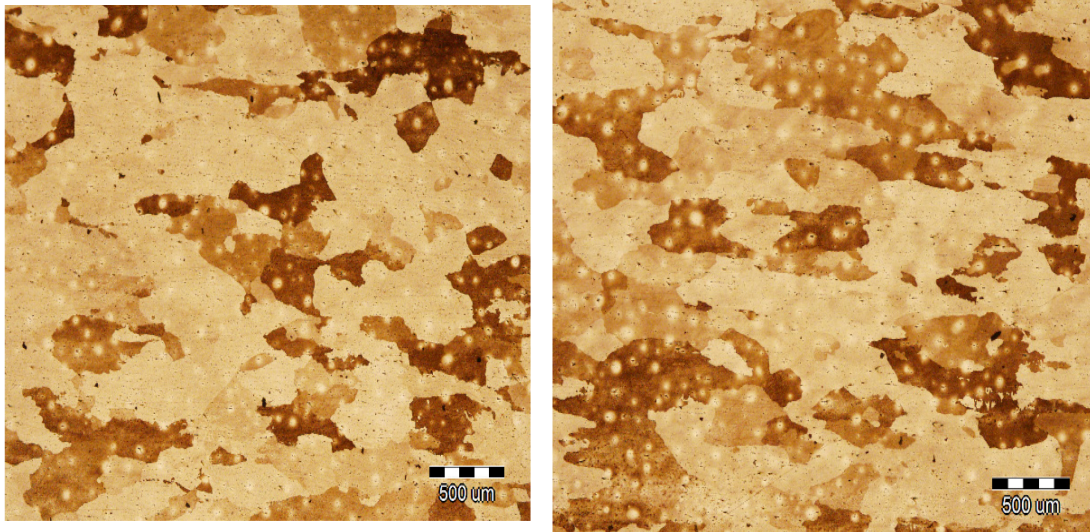
The results of chemical analysis given in Table 1 matches with the aluminum alloy 2024 which is a common materials for the aerospace applications. The mechanical properties of the alloys (Table 2) show quite high yield stress and ultimate tensile stress values of 350 MPa and 475 MPa, respectively with good elongation before fracture. Such values are common for any of the heat treated /tempered conditions i.e. T3, T4, T6 of the 2024 Al alloy. The observed hardness and tensile strength values are almost similar which indicate the absence of any strain hardening which can happen after plastic deformation. The optical micrographs (Fig. 3) also show no evidence of any recrystallization which can happen during significant strain hardening. Thus the mechanical stress by large did not exceed the yield stress in the twisted regions, except of course at the cones of twisted ends where the material has fractured.

Fig. 3. Optical micrographs of (L) twisted and (R) sound sections of the shaft.

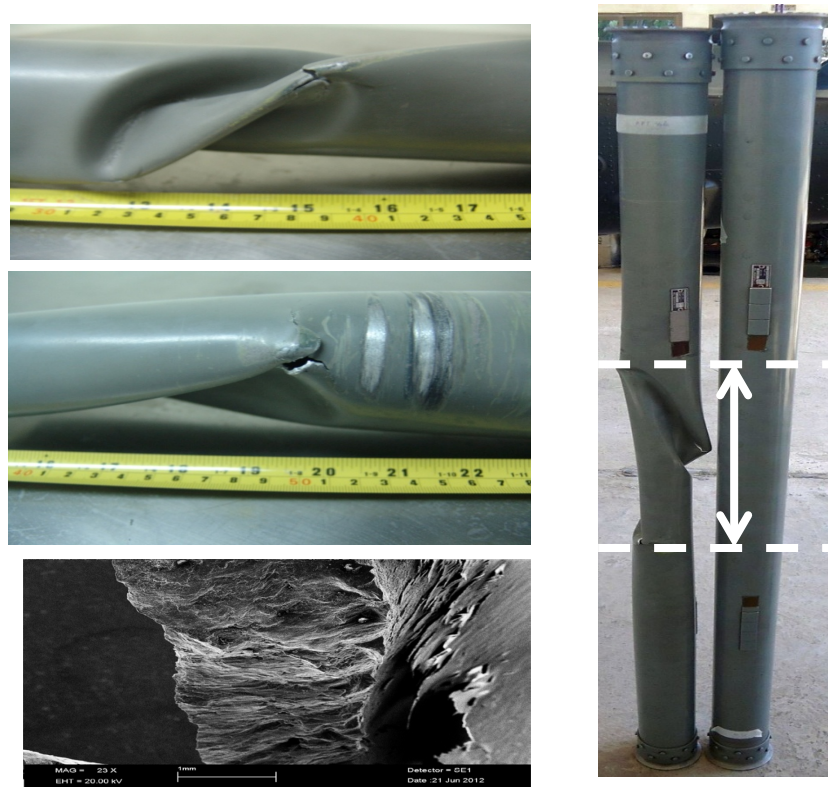
Fig. 4. Length shortening due to twisting in 14-inches section and shear fractures at twist ends.

There are fractures at three locations, i.e. at two twist ends and in the middle of twisted region. The camera images of the fractured regions show no evidence of plastic deformation before fracture (Fig. 4). The SEM fractographs also show no evidence of plastic deformation and show brittle fracture features. Moreover, no fatigue striations are present which rule out fatigue failure.

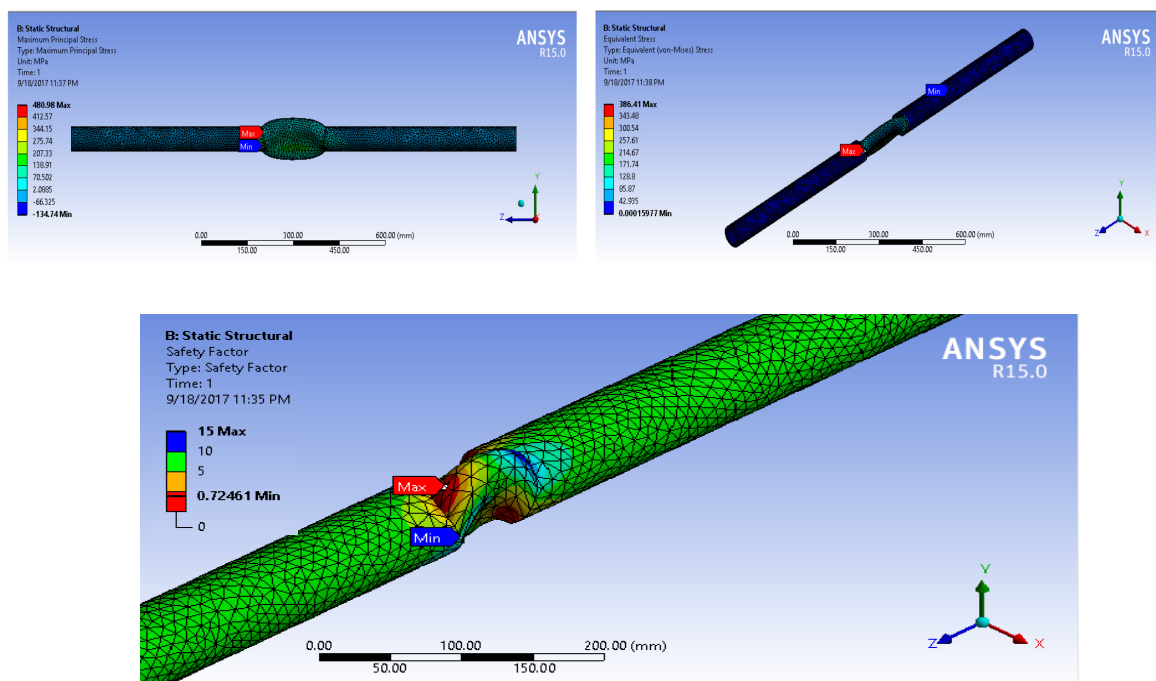
Fig. 5. ANSYS simulation showing stress concentration sites where the stress exceeds the UTS value.

The FEM based analysis was carried out using commercial software ANSYS R15.0 to simulate the twist phenomenon by fixing one end of the shaft while applying torque at the other end. Several configurations were tried to simulate the observed twist that involves flattening of radial shaft with stress concentration sites at the twist ends. The closest results were obtained by restricting the z-axis movement and applying twist at selected y-z planes rather than at the shaft ends.

The ANSYS result proved two points. One, that twist cannot happen unless there is one end fixed. Thus, if shaft would have become free after ground hitting, the observed twist cannot occur. Second, that the twist can cause stress concentration in excess of the UTS at locations of shaft-twist intersection, while the stress at other location is below the yield stress, or even compressive at some locations.
