Procedures and Techniques Used to Increase the Durability of Weak Masonries with Clay Mortars

The joint strengthening procedure

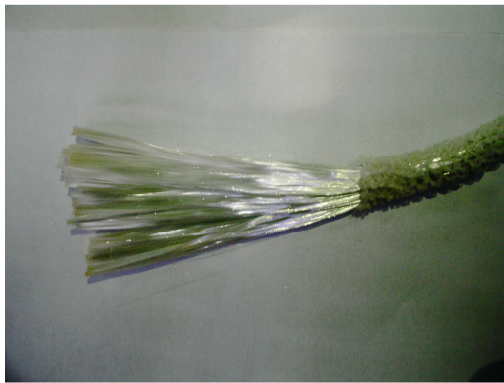
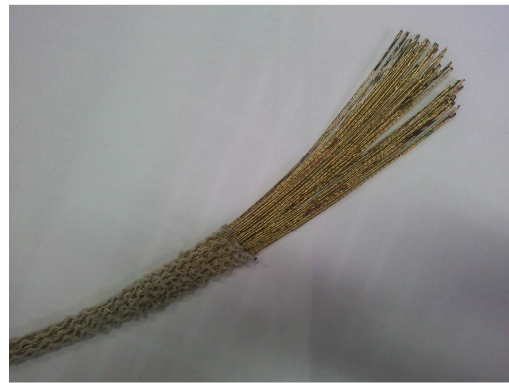
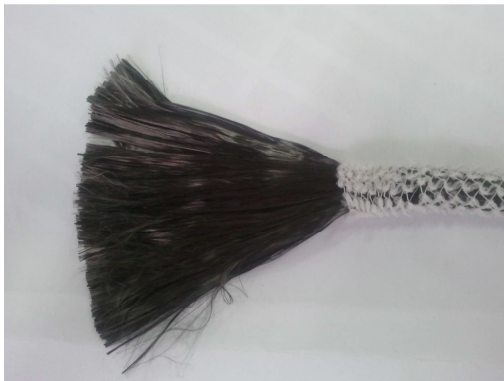
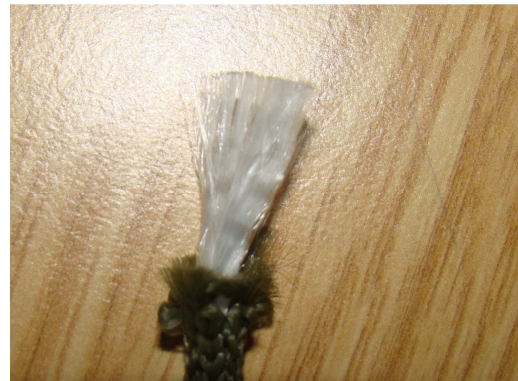
Fig.1 The fibres utilized for the flexible reinforcing of the joints
a. glass fibres, b. steel fibres, c. carbon fibres, d. polypropylene textile fibres

Several panel type specimens have been conceived and manufactured to perform the tests. The reinforcing of the masonry joints has been achieved using the following coated fibre products: glass fibres (MapeWrap G Fiocco, fig. 1a), carbon fibres (MapeWrap C Fiocco, fig. 1c), steel fibres (MapeWrap Steel, fig. 1b) and regular polypropylene yarns (fig. 1d). The external chord diameter including the protective mesh is 10 mm for the first three fibrous products and 4 mm for the textile yarns (requiring the of three twisted strings within the joints). The main characteristics of these materials are given in Table 1.

For each of the fibre chords (Fig. 1) groups of 3 samples were prepared by joint priming with M10Z mortar and insertion of the corresponding ropes.

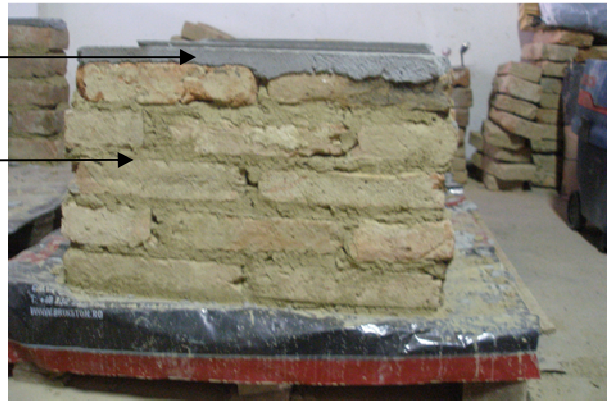
A plain leveling layer of cement mortar has been applied on the top of panel type specimen to ensure the flatness during testing, fig.2.

Leveling layer with
cement mortar

Masonry joint
with clay mortar

Fig.2 The witness/control specimen for compression testing

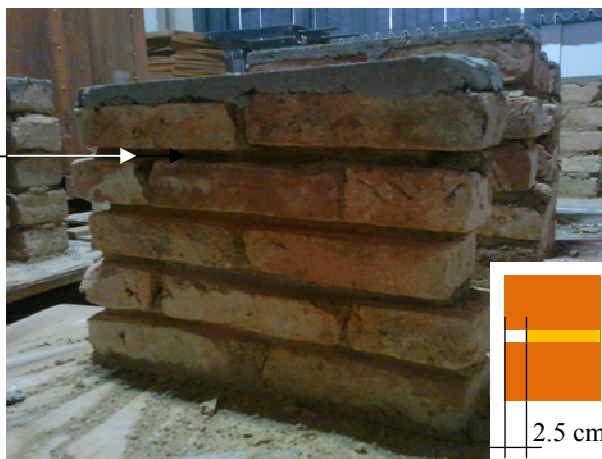
Capped
masonry joint

Fig.3 The specimen with 25 mm joint capping

The test specimens were kept under laboratory conditions while three specimens have been assigned as control samples. The other 12 panels were prepared for the joint re-pointing procedure. The joints, on both sides (fig.3), have been capped to a depth of 25 mm, cleaned of dust and primed with mortar; after this, the chord type fibre reinforcement has been inserted and covered with M10Z mortar (fig. 4).

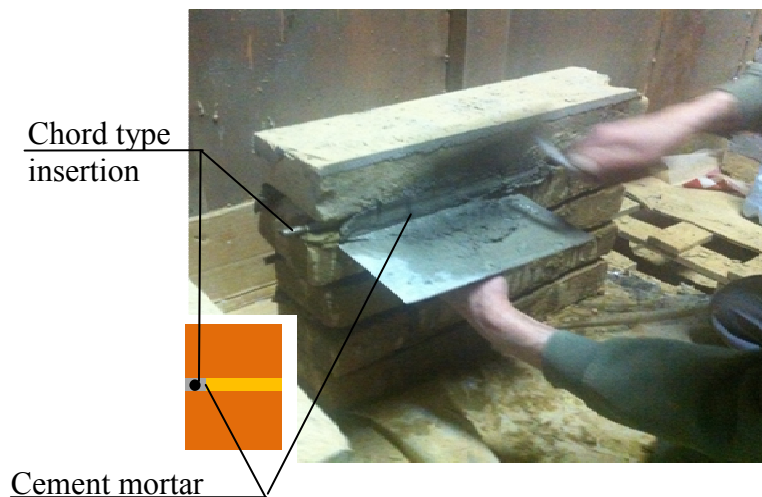
Fig.4 Disposal of the chords and mortar within the specimen joints

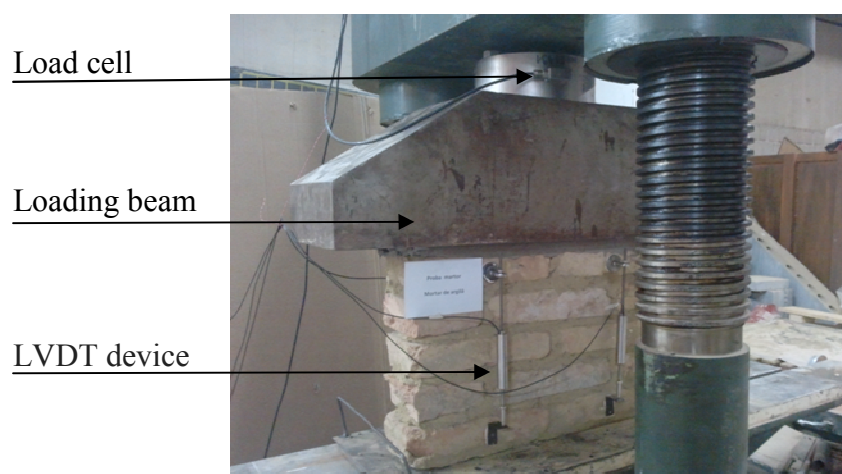
The experimental program consisted of testing all 15 specimens loaded in compression utilizing a universal testing machine of 3000kN load capacity. A special load cell (Fig. 5) equipped with electrical strain gauges has been utilized to ensure precise reading needed during the experimental program.

The deformations undergone by the compressed specimens have been recorded using 4 Linear Voltage Displacement Transducers (LVDTs) placed symmetrically on each side (Fig. 5). Their positions have been assigned on the central portions of the masonry panels. The instalment of the transducers has been specially chosen to enable the loading up to the specimen failure. The distance between the measuring points corresponds to the interval between four layers of mortar. Each test has been performed until the specimen failure.

Fig.5 The instrumentation of the specimen

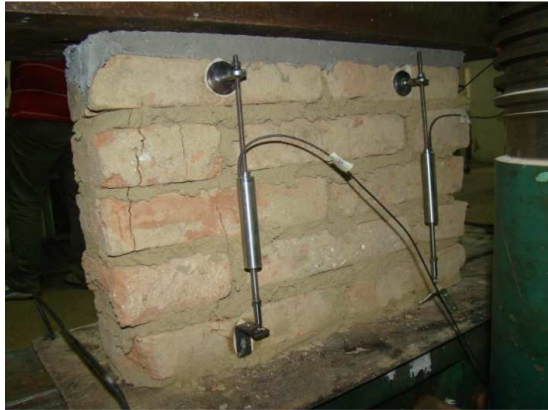
Fig.6 The failure mode of the witness/control specimen

The failure of all masonry control specimens is characterized by large cracks penetrating the whole structure.

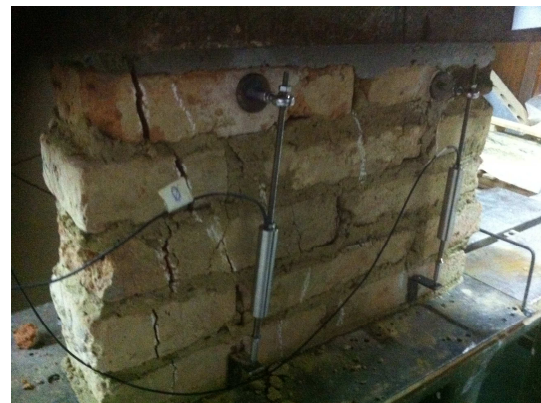
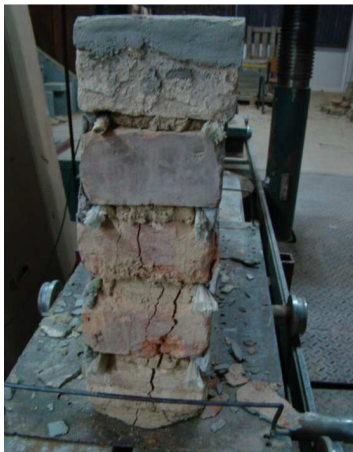
Fig.7 The failure mode of the specimen with joints reinforced with glass fibres chord

The failure modes of the reinforced joint masonry differs from those observed on the control specimens, namely with vertically developed cracks near the joint reinforced area, with a less affected central area.

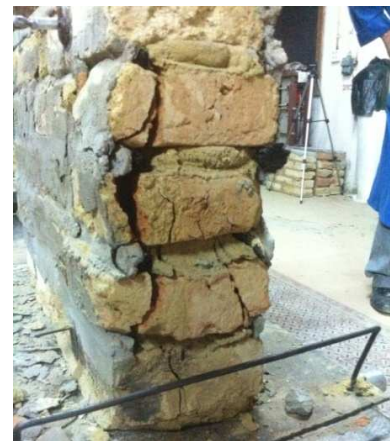
Fig.8 The failure mode of the specimen with joints reinforced with carbon fibres chord

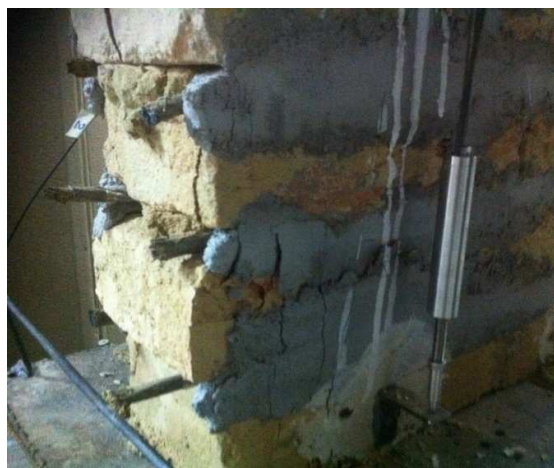
Fig.9 The failure mode of the specimen with joints reinforced with steel fibres chord

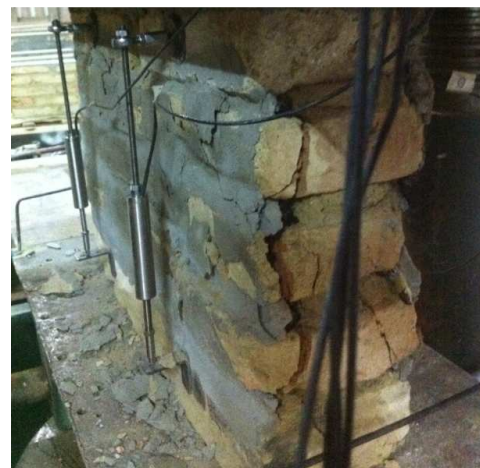
Fig.10 The failure mode of the specimen with joints reinforced with 3 polypropylene strings

The polypropylene fibre insertion resulted in higher resistance and less increase in stiffness, but a more convenient cost-effective solution.
