## Damage Occurrence in Welded Structures of the Bucket-Wheel Boom

**Abstract.** Causes of damage occurrence in vital components of welded structures of the bucket-wheel excavator boom (DU1) at the coal landfill of the thermal power plant 'Nikola Tesla A' in Obrenovac (Serbia) are investigated. Bucket-wheel excavator was produced by French company 'Ameco' and it moves along the circular track. Taking into account lack of technical documentation, all tests and were carried out under the assumption that welded structures were made of structural steels S355 and S235. Investigation of causes of damage occurrence are based on results of non-destructive tests (NDT) and tensometric measurements.

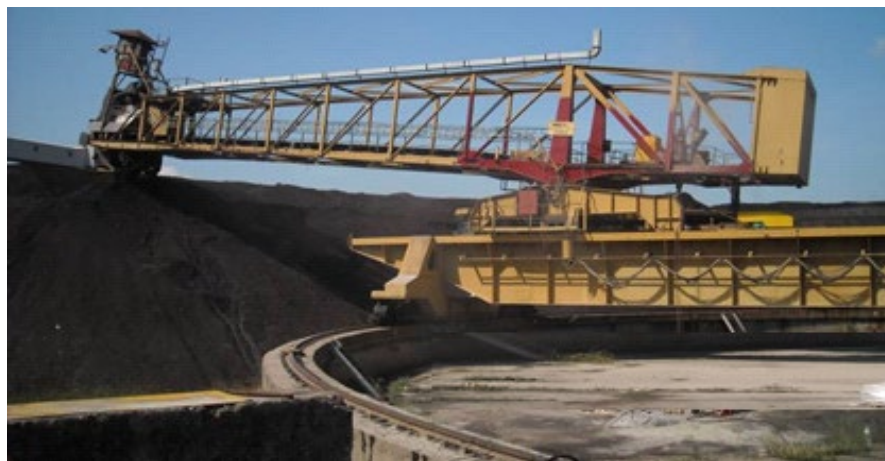
Bucket-wheel excavator with designation DU1 is presented in figure 1. Considering the fact that there was no technical documentation, all tests and researches presented in this paper were carried out under the assumption that welded structures were made of structural steels S355 and S235 [13].

Figure 1. Bucket-wheel excavator DU1 at the coal landfill of the thermal power plant 'Nikola Tesla A'

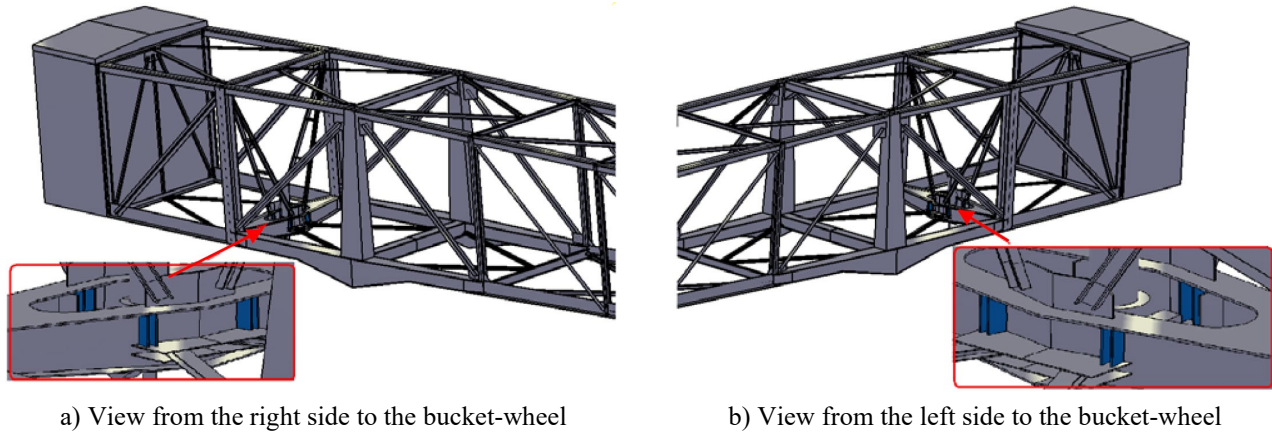
Damage was detected mainly through visual testing (VT) of parent material and welded joints. No defects were detected with other non-destructive testing methods, as well as no deviations from expected results during hardness testing. In figure 2 the reinforcements in the damaged support structure of the cylinder, which role is to enable the moving of the bucket-wheel boom, are shown, while in figure 3 the reinforcements that were embedded in the damaged section of one of the vital girders of the structure are shown. Sections of the vital structure in the upper zone of the bucket-wheel boom with damage in the area of welded joints are shown in figure 4.

Figure 2. Reinforcements (blue) embedded in the damaged structure of the cylinder

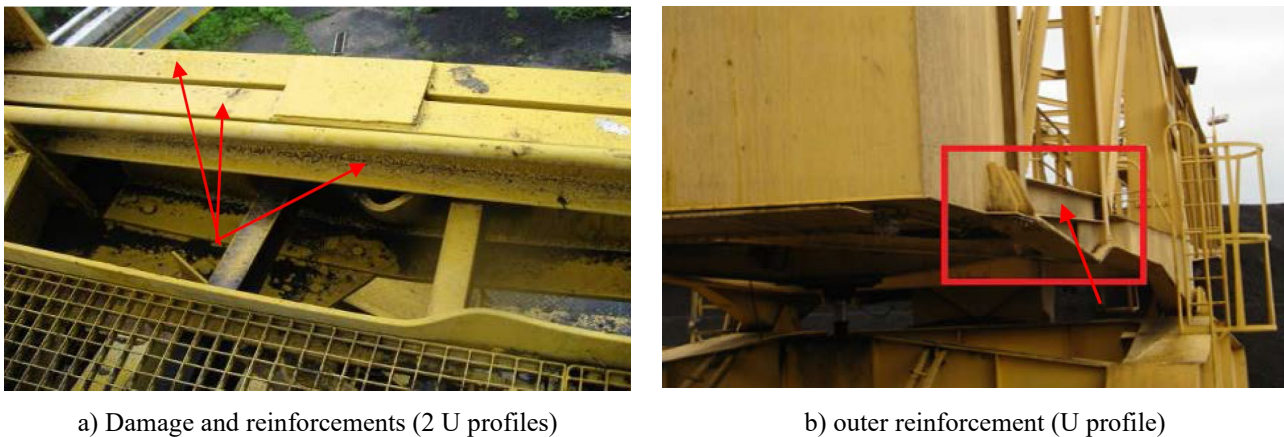
Figure 3. Reinforcements embedded in the damaged section of a vital girder at the boom structure

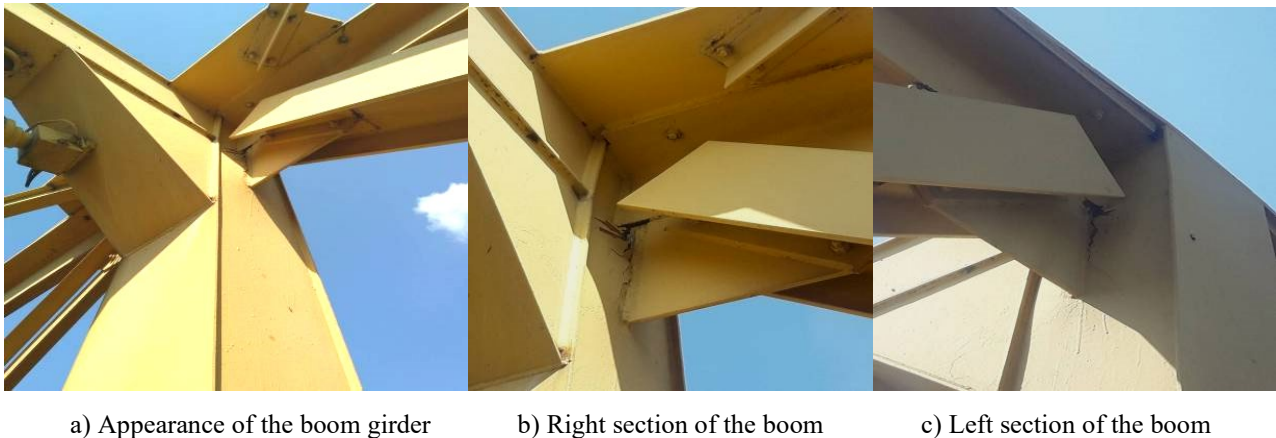
Figure 4. Sections at the vital structure of the upper zone of the bucket-wheel boom of the excavator DU1

Based on the analysis of results of non-destructive tests executed at vital structures of the bucket-wheel boom, it can be concluded that initial cracks within welded joints can propagate until they reach the critical length, which confirms the assumption that damages at vital structures occurred due to inadequate welding technologies during the manufacture of the bucket-wheel excavator and/or during previous repairs performed on parent material and welded joints, figures 2-4. Significant presence of defects in the area of welded joints, figure 4, is caused by complex geometry, figure 11.

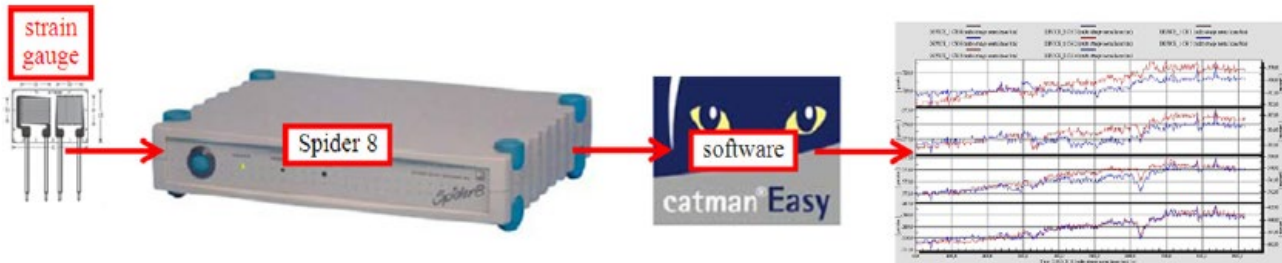
Stresses were determined on the basis of tensometric measurements of local strains in the areas of parent material and welded joints at the lattice structure of the bucket-wheel boom of the excavator with designation DU1. Measurements were executed through the use of electro-resistant extensometers – measurement gauges TML PL-10 and TML PL-20. Measurement equipment for detection and processing of signals from measurement gauges to readable strain values is shown in figure 5.

Figure 5. Measurement equipment for registration and processing of electric signals

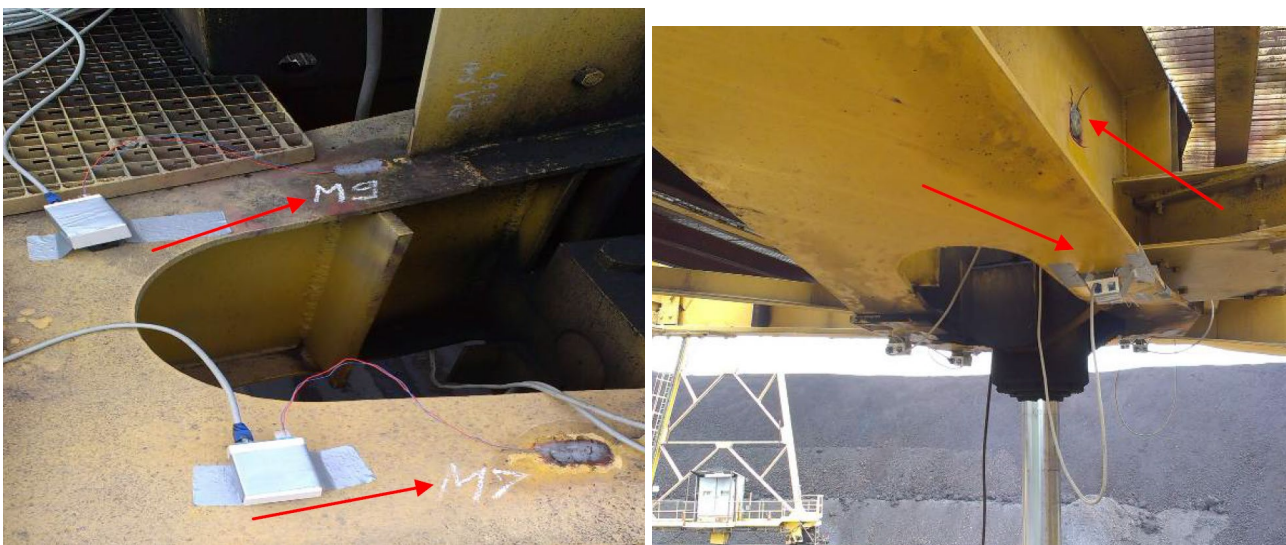
Stresses were calculated on the basis of tensometric measurements of local strains in different positions of the bucket-wheel boom during the operation of the bucket-wheel excavator DU1 (figure 1), in order to check if there is a possibility of appearance of initial cracks due to fatigue that occurs at vital structures of the cylinder, which enables the movement of the bucket-wheel boom. Measurements were carried out through the use of a large number of measurement gauges TML PL-20. Certain number of measurement locations at damaged vital structure in the area of the cylinder and at the support structure of the cylinder itself are presented in figures 6 and 7. On the basis of results of measured local strains and calculated stresses it was determined that the above-mentioned structures are subjected to the highest variable stresses, when bucket-wheel excavator DU1 is in the lowest position of exploitation. Allowable tensile stresses for structural steels S235 and S355 for safety level  $S=1.5$  are  $TS_{all} = 157$  [MPa] and  $TS_{all} = 237$  [MPa] respectively, with note that compressive stresses do not have the same effect on the propagation of the initial crack and structural integrity.

Figure 6. Measurement locations at the vital structure in the area of the cylinder which enables the movement of the bucket-wheel boom

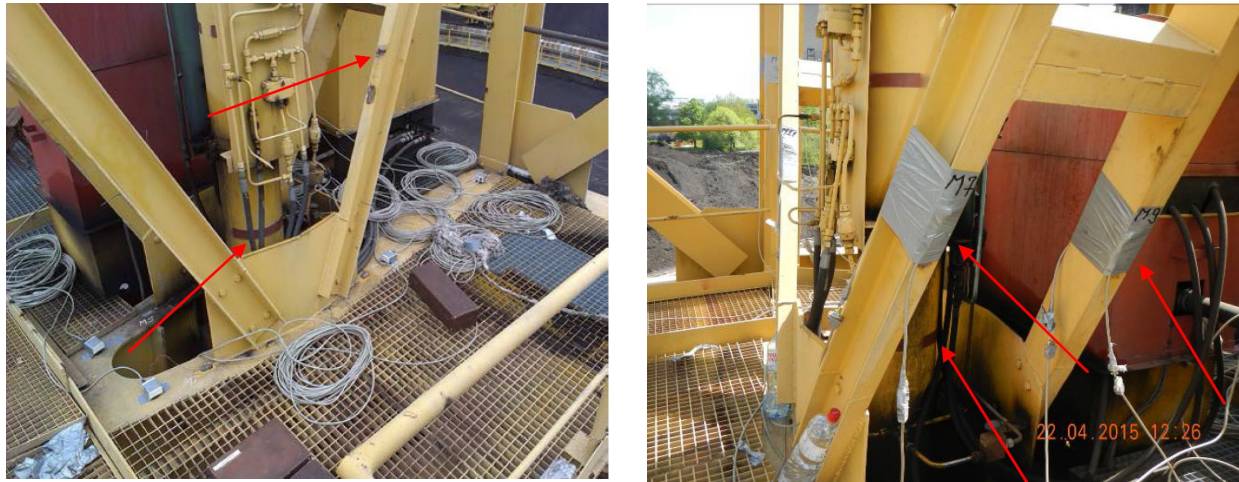
a) Measurement locations right of the support structure

b) Measurement locations left of support structure

Figure 7. Measurement locations at the support structure of the cylinder

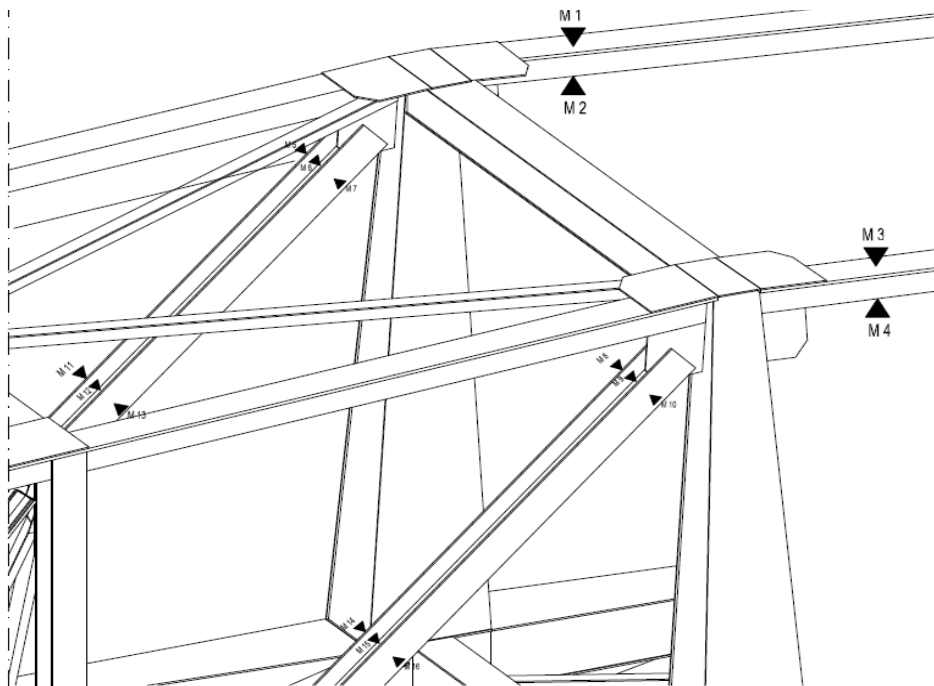
Stresses have been calculated in order to check if there is a possibility of occurrence of initial cracks due to fatigue at the vital structures of the cylinder, which enables the movement of the bucket-wheel boom, on the basis of tensometric measurements of strains at the vital section of the structure for two positions of the boom ( $0^\circ$  and  $12.5^\circ$ ) during the operation of the bucket-wheel excavator DU1. Measurements have been carried out through the use of a large number of measurement gauges TML PL-10. Measurement areas and measurement locations at the vital lattice structure of the bucket-wheel boom, which is an integral part of excavator DU1 are presented in figures 8-10. Results of stresses calculated on the basis of measured strains are presented in tables 1–3, where maximum values are marked in red and bold.

Figure 8. Measurement locations at the vital structures of the bucket-wheel boom

Table 1. Stresses at the vital structure of bucket-wheel boom (cross-section 0, Fig. 8), maximum values marked in bold

Loads at the bucket-wheel excavator DU1	Measurement locations							
	M <sub>1</sub>	M <sub>2</sub>	M <sub>3</sub>	M <sub>4</sub>	M <sub>5</sub>	M <sub>6</sub>	M <sub>7</sub>	M <sub>8</sub>
$\sigma_D$ - Measured stress for boom position at 0°, MPa	-	-	15.2	16.0	<b>32.8</b>	32.4	31.2	31.2
$\sigma_D$ - Measured stress for boom position at 12°30', MPa	-	-	<b>28</b>	19.0	21.2	22	19.2	17.2

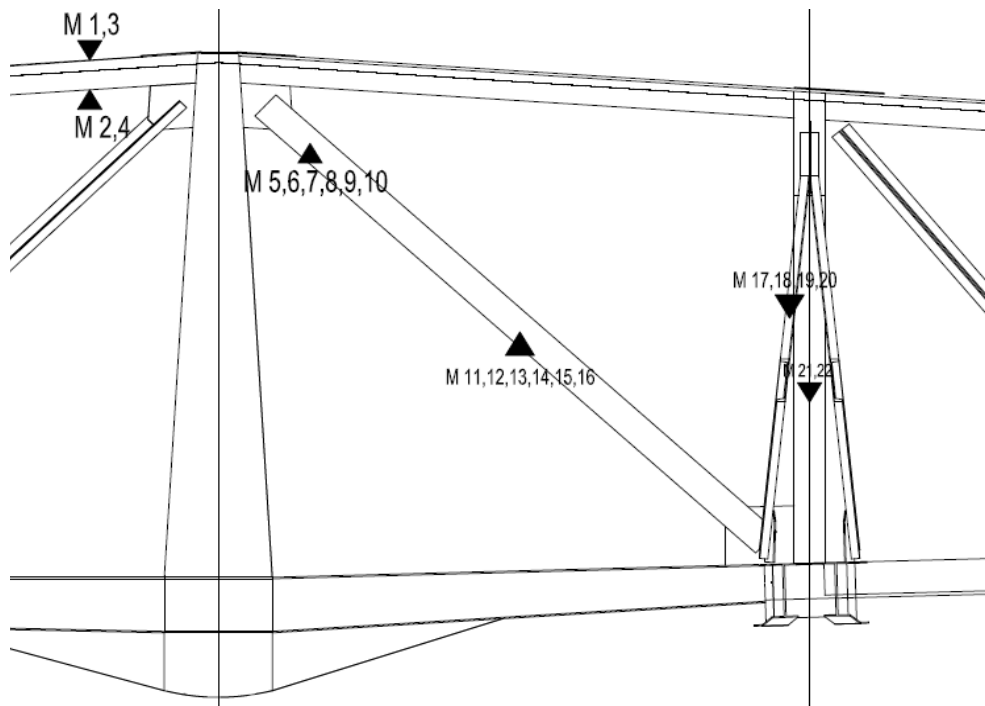
Cross-section 0 (position 11, figure 6)

Cross-section 11 (position 11, figure 6)

Figure 9. Measurement locations at the vital structures of the bucket-wheel boom

Table 2. Stresses at the vital structure of bucket-wheel boom (cross-section 0, Fig. 9), maximum values marked in bold

Loads at the bucket-wheel excavator DU1	Measurement locations							
	M <sub>9</sub>	M <sub>10</sub>	M <sub>11</sub>	M <sub>12</sub>	M <sub>13</sub>	M <sub>14</sub>	M <sub>15</sub>	M <sub>16</sub>
$\sigma_D$ - Measured stress for boom position at 0°, MPa	<b>32.8</b>	27.6	31.2	30.8	28.4	27.2	30.0	29.6
$\sigma_D$ - Measured stress for boom position at 12°30', MPa	<b>20.4</b>	18.0	20.0	19.2	18.0	19.2	16.8	16.4

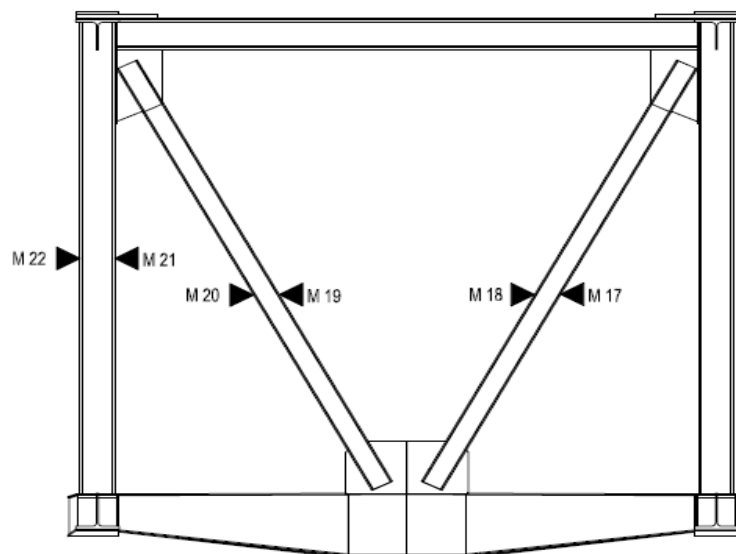
Figure 10. Measurement locations at the vital structures of the bucket-wheel boom (cross-section 11)

Table 3. Stresses at the vital structure of bucket-wheel boom (cross-section 11, Fig. 10), maximum values marked in bold

Loads at the bucket-wheel excavator DU1	Measurement locations					
	M <sub>17</sub>	M <sub>18</sub>	M <sub>19</sub>	M <sub>20</sub>	M <sub>21</sub>	M <sub>22</sub>
$\sigma_D$ - Measured stress for boom position at 0°, MPa	41.2	<b>44.4</b>	<b>44.4</b>	41.2	20.4	20.4
$\sigma_D$ - Measured stress for boom position at 12°30', MPa	<b>31.2</b>	31.2	30.0	30.4	12.0	12.4

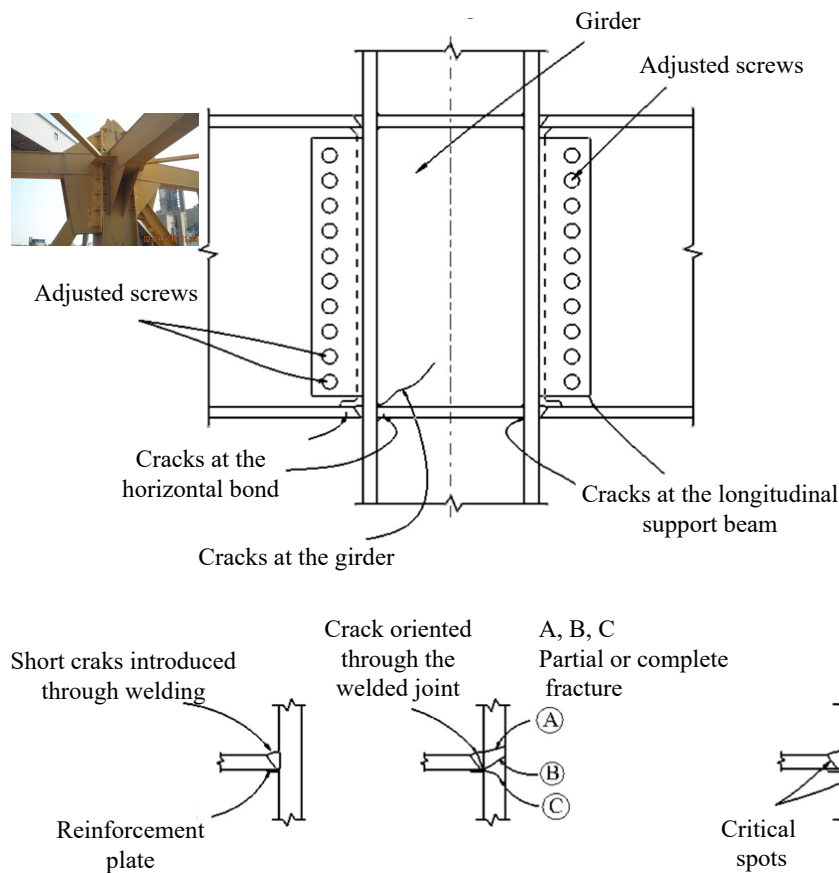
Figure 11. Node at the welded structure and locations at which fatigue cracks mainly occur

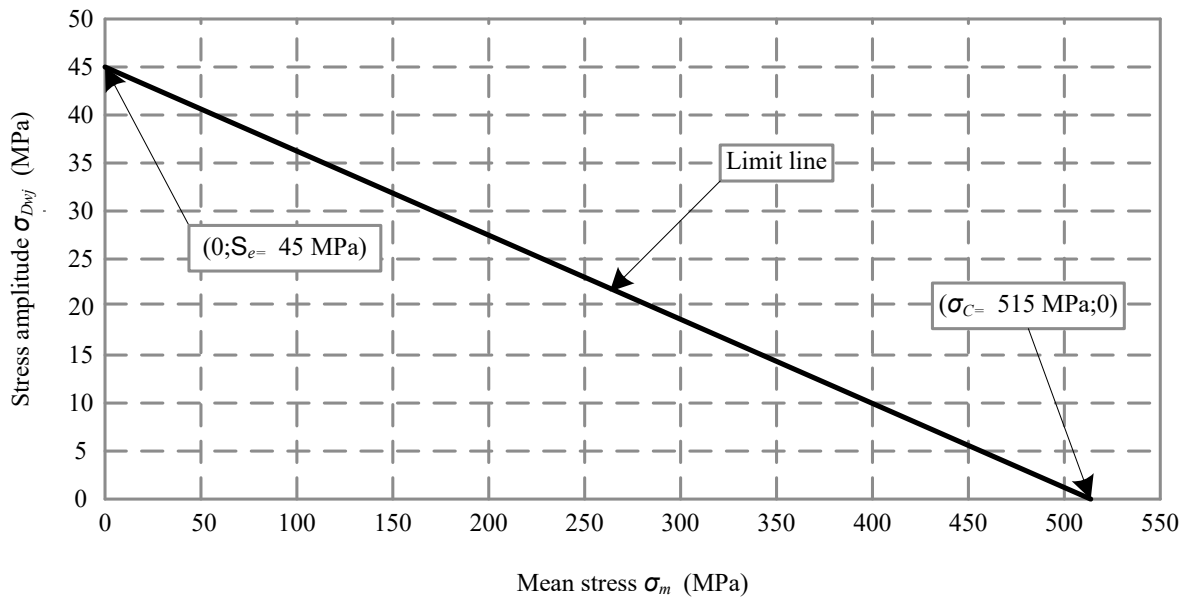
It is obvious that in both representative combinations of static stresses (figure 12), measured stresses in critical areas of vital components of the bucket-wheel (tables 1-3) lie beneath the limit line which connects fatigue strength  $\sigma_{Dwj}$  and tensile strength  $\sigma_{UTSmin}$  of weld metal, which proves that damages at vital components of welded lattice structure of the bucket-wheel boom occurred due to the application of inadequate welding technologies during the manufacture of the bucket-wheel excavator and/or during the previous repairs.

Fig. 12. Modified Goodman diagram

In accordance with recommendations [14], it was adopted that critical value of fatigue safety is  $\sigma_{Dwj} = 45$  MPa. Tensile strength of the weld metal is determined by the following expressions [15]:
