Residual life assessment of electricity pylons – a case study

Abstract. This case study describes a structural integrity assessment of a 220 kV overhead power line. The line comprises 70 pylons over a distance of approximately 30 km, predominantly in a valley location. The pylons are spaced at intervals of approximately 400 m and each pylon is approximately 32 m in height. The line was originally constructed in the 1950's, approximately 50 years prior to the requested structural integrity assessment. This paper describes the independent assessment that was carried out. The review established site-specific safety factors at the time of original design and construction; at the time of the review (2007), accounting for the possible presence of the "Thomasstahl" steel; and in the future, at the anticipated end of pylon life (in 2012).

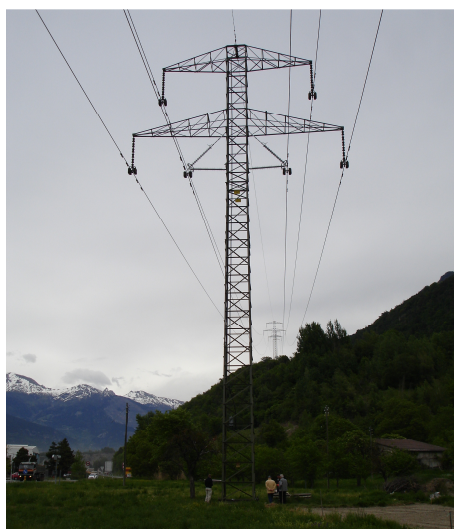
A significant reason behind requesting this particular assessment was the failure of part of a power line in an adjacent country which was considered to exhibit certain similarities with the subject line. Both lines had been partially constructed with steel components which had used the "Thomasstahl process" during steel making, resulting in a steel which has been found to become more brittle than usual with age. Following a high-level risk assessment, a set of visual inspections, materials tests and chemical analyses of the 70 pylons were conducted, which suggested that all 70 were possibly at risk from Thomasstahl-affected steel. It was therefore decided that a more detailed structural integrity assessment (SIA) should be carried out on 12 specific pylons (that had to be structurally modified for other reasons), and that such an assessment be carried out by an independent body – Lloyd's Register EMEA, Technical Investigations. A photograph of a typical pylon is shown in Fig.1. The reasoning behind the structural modifications was excessive sagging of some of the power cables (conductors), due to long term cable creep, which had necessitated the raising up of the lower conductors onto new hangers during 2007, as shown in Fig.1 below.

Fig.1. General view of typical pylon
