Impact of Dislocation on Warpage of Thinned 4H-SiC Wafers

Brunella Cafra^{1a,*}, Ruggero Anzalone^{1,b}, Andrea Severino^{1,c}

¹ST Microelectronics, stradale primosole, 50 95121 Catania, Italy

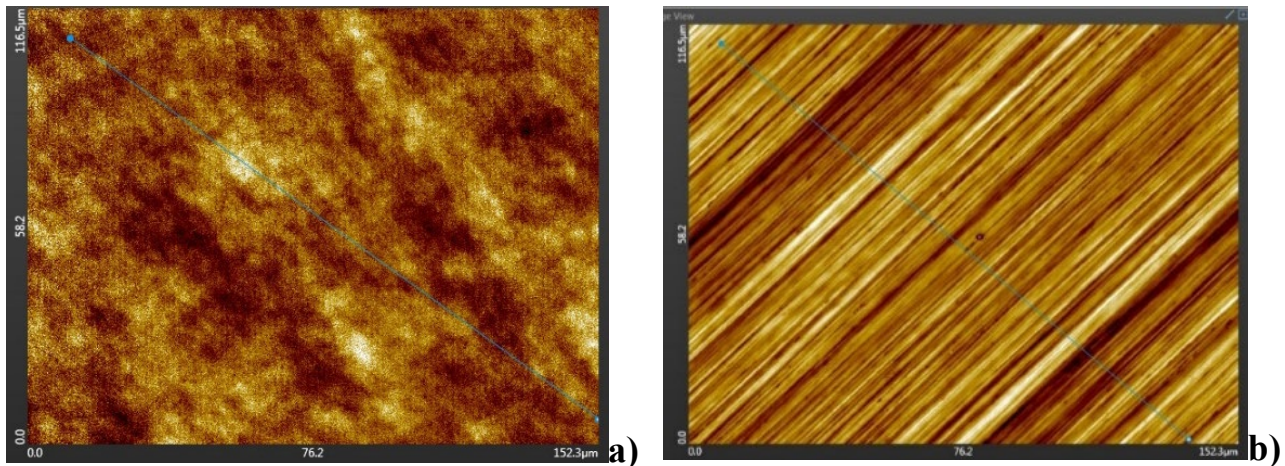
Figure 1 shows large area (152 x 116 μm) optical profilometer analyses performed on SiC C-face before and after grinding process. As received wafers show a quite flat face with a surface roughness (S_q) of about 0.6 nm and a peak to valley height (R_t) of about 3 nm (fig. 1 a)). As a consequence of the thinning process the shape of the surface remarkably changes showing grinding wheel marks, a surface roughness (S_q) of about 4.6 nm and a maximum height of the profile (R_t) of about 29 nm (fig. 1b)). The corresponding morphology in section, investigated by TEM analysis (images not shown), reveals a damaged region with lateral and median cracks extending for a depth of about 600 nm. This damaged region is an area with high density dislocations and large strain [8,9].

Figure 1. Optical profilometer images of the as received SiC C- face surface a) and grinded surface b)

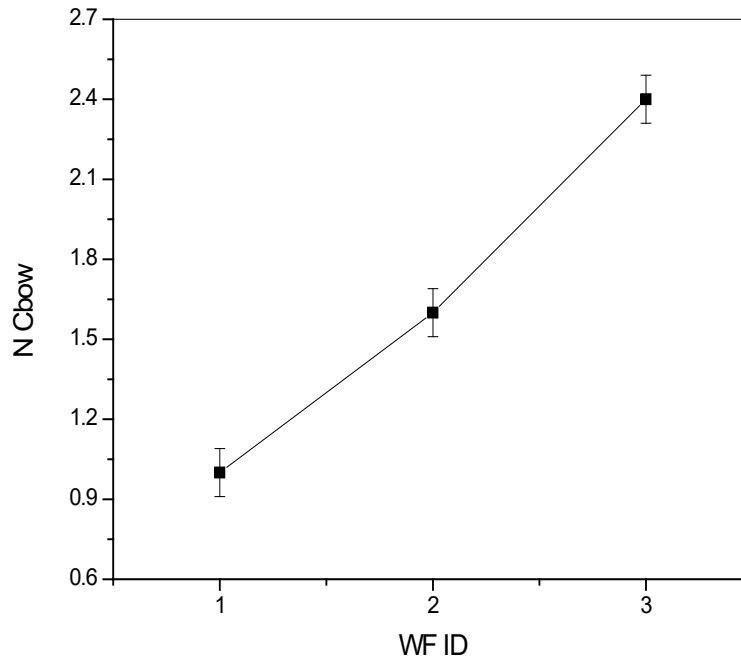
Despite the same grinding process has been performed on all SiC wafers under investigation, different Cbow values have been measured as it is possible to see from data collected in fig. 2 where Cbow values normalized (N Cbow) to the lowest one, obtained for wafer 1, have been collected. It is to note an increasing by a factor of about 1.6 and 2.4 in Cbow values respectively for wafer 2 and wafer 3. The differences found cannot be accounted for in terms of grinding process variation since the same grinding process has been performed on all wafers and we wonder if a correlation exists among variations in wafer Cbow and wafer defect density (mainly dislocation).

Figure 2. Normalized Cbow (N Cbow) values for wafers under investigation. The Cbow value increase by a factor of 1.6 and 2.4 on wafer 2 and 3 respectively.

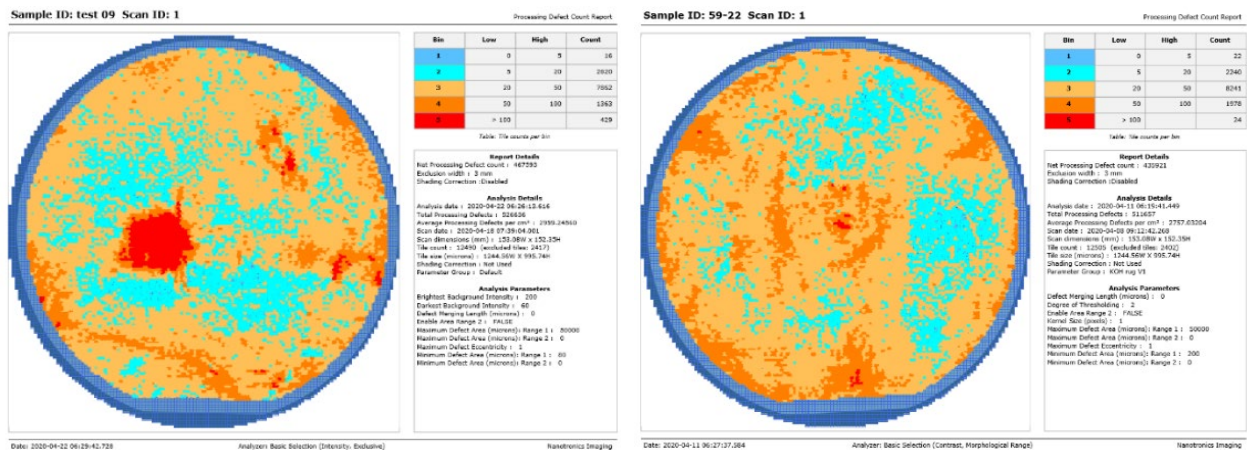
Fig. 3 shows the whole defect count maps of wafers 1 and wafer 3 having respectively the lower and higher value of Cbow. With the nspec tool, the high-resolution map (about 14.000 tiles) allows observing with high level of detail the entire wafer, counting the whole Etch Pits Density (EPD) with the possibility to distinguish within all the pits the different type of dislocations (BPD, TSD and TED).

Figure 3. High resolution whole wafer map of the 6 inch. samples with the higher value of dislocation density (left) and lower valuer (right). The EPD density is 3500 ± 200 pits/cm² for sample 1 (left) and 2900 ± 100 pits/cm² for sample 3 (right). The edge exclusion is 2 mm for both maps.

The EPD density is 3500 ± 200 pits/cm² for sample 1 and 2900 ± 100 pits/cm² for sample 3. A deep analysis allowed a better classification of dislocation type and the same trend was observed for the basal plane dislocation (BPD) that are between 1900 and 2000 pits/cm² for sample 1 and less than 200 pits/cm² for sample 3. This means that in sample 1 over than 60% the pits are made by BPD.

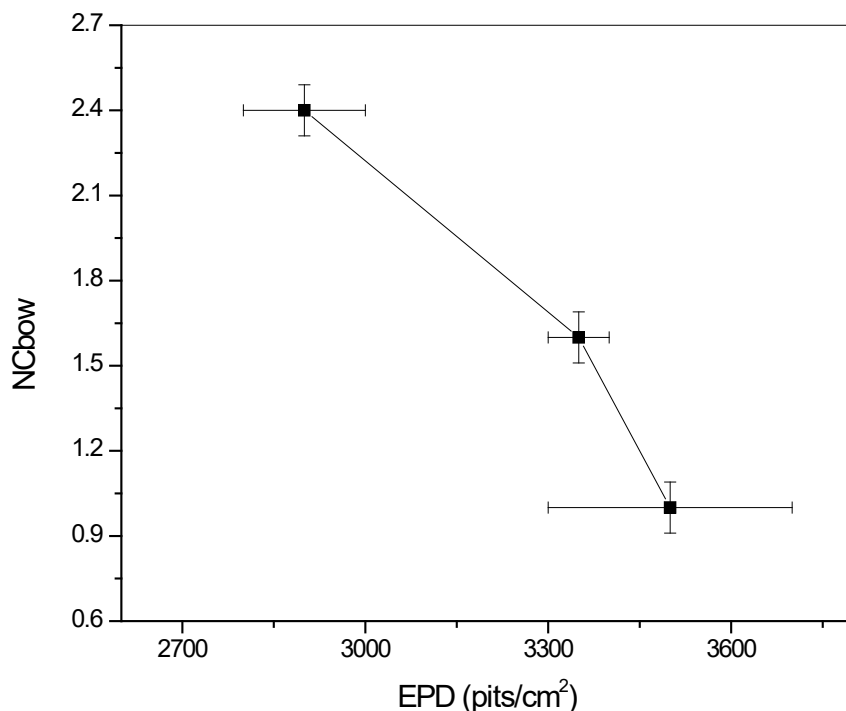
In figure 4 the relationship between the Cbow and the etch pits density (EPD) has been reported. From the figure the correspondence between the high value of Cbow and the lower value of dislocation density is clearly observable. The wafer that exhibits the highest wafer bowing (wafer 3) shows also the lowest EPD count.

Figure 4. Center bow (Cbow) as a function of Etch pit density (EPD). All the three wafers have been measured after the same thinning process.

For energetic reason the defect (mainly dislocation in SiC substrate was observed) is a preferential way to release the internal stress of the wafer after the growth. For this reason the highly defect sample correspond to the lower bended samples and vice versa.
