Decoration and Density Increase of Dislocations in PVT-Grown SiC Boules with Post-Growth Thermal Processing

Keywords: 4H-SiC, bulk crystal growth, post-growth thermal processing, dislocation density, X-ray topography, dislocation decoration, surface inspection tools

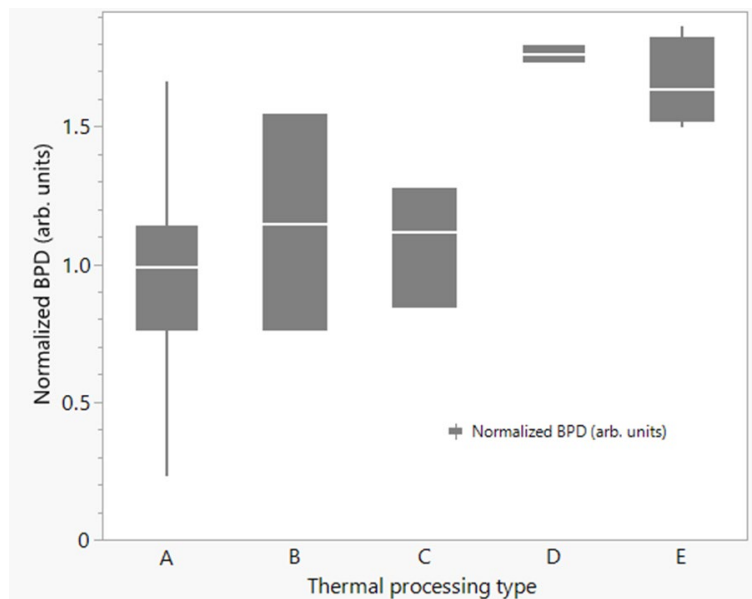
Figure 1. Normalized mean BPD values measured for different post growth thermal processing. Thermal temperatures are increasing from A to E. Processing duration time and cooling rate were fixed. The quantile box plot shows median, 25th and 75th pecentiles. Wafers in this plots include multiple crystals grown from different seeds. BPD values are counted by XRT imaging and counting method.

It is found that higher post-growth thermal processing temperatures generated more BPDs in wafers as shown in Fig. 1, but the correlation is not strong due to different sampling sizes at different processing temperatures. The driving force for BPD multiplication is the shear stresses in 1) the primary slip direction, that is, the $a/3 \langle 11\bar{2}0 \rangle$ and 2) in prismatic slip caused by thermal gradients during the boule growth [5, 6]. The Frank-Read source could be also responsible for multiplication. Higher post-growth thermal processing temperature causes more dislocation gliding and multiplication to result in higher BPD values.

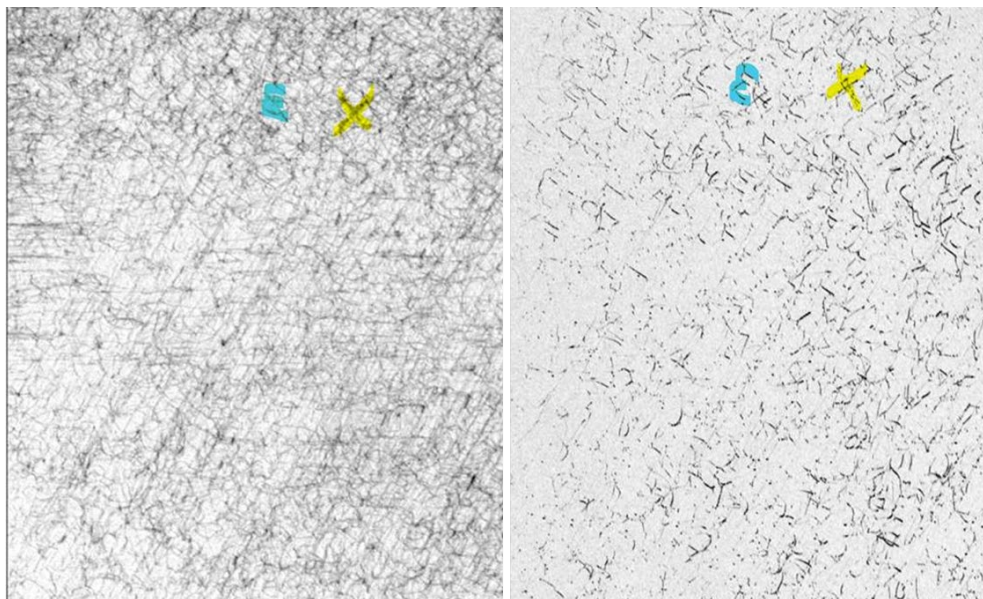
Figure 2. XRT (left) and CS8520 ScN (right) images from the same area. Marks in blue and yellow are only for visual guidance.

Features in the CS8520 ScN image (scattering channel images from the normal laser) match well with BPD lines in XRT images from $(11\bar{2}8)$ as shown in Fig. 2. Wafers processed at different thermal processing temperatures, however, show different CS8520 feature densities as shown in Fig. 3 even at very comparable dislocation densities. It was also learned later that those features in CS8520 images could be eliminated or made invisible by further thermal processing. Dislocation decoration by point defects or dopants has been proposed to explain dislocation visibility in CS8520 images. Interaction between strain fields associated with dislocation lines and point defects/dopants could be a thermal process and depend on energy and entropy of the process. This decoration process seems sensitive to post-thermal processing temperatures and is more aggressive in middle temperature ranges like process C and D as compared to the lowest and highest temperatures (process A and E) in fig. 1.

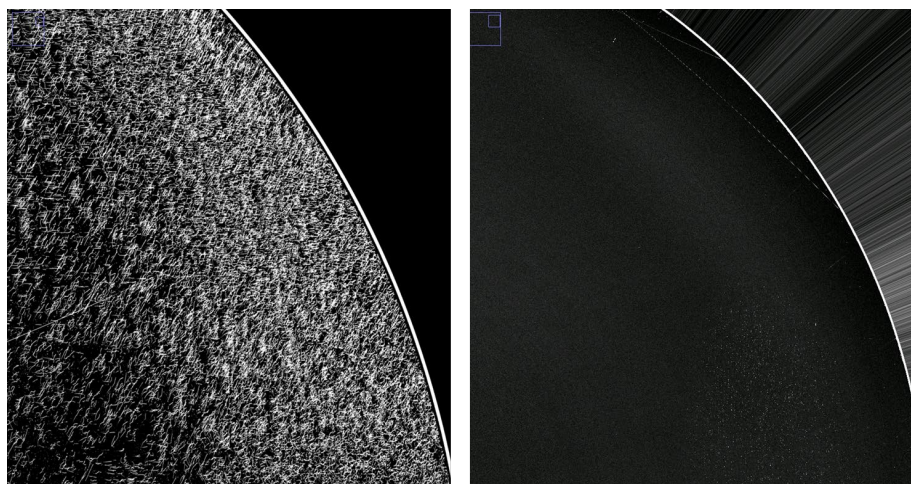
Figure 3. CS8520 ScN images from wafers processed at different post-growth thermal processing temperatures. 36-08 (left) and 71-10 (right) were processed at process D and A, respectively. Bright lines in the images might be decorated dislocation lines. These two wafers show very comparable wafer resistivities and BPD densities.

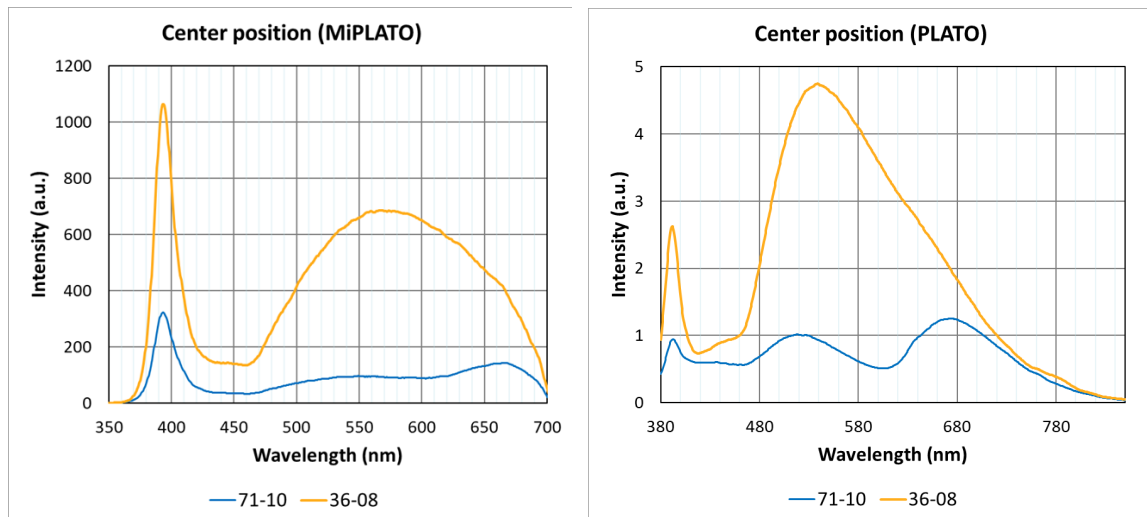
Figure 4. PL Spectra from two spectrometer tools. Laser Power/Diameter: 200mW/1200 μ m (PLATO), 15mW/2.5 μ m (MiPLATO), Spectrometer: Andor SR303i/idus Du-420A-BU2, 150G gratings/500 μ m entrance slit, exposure time: 500msec(PLATO) and 50msec (MiPLATO), MiPLATO use a mirror for laser beam reflection and PL transmission. Data collection and analysis by courtesy of EtaMax. 36-08 and 71-10 were processed at process D and A, respectively.

To understand roles of point defects/dopants for dislocation visibility (dislocation decoration) changes, room temperature PL spectra was obtained as shown in Fig. 4. The highly decorated wafer shows a stronger band-edge emission (390 nm) than the un-decorated wafer. The peak around 500 nm could be the nitrogen donor-boron acceptor recombination-related emission [7]. The un-decorated wafer shows two peaks around 527 and 675 nm in the yellow region while the decorated wafer shows a single and dominant peak at 537 nm (PLATO data). The peak at 537 nm could be sum of the two separate peaks at 520 and 675 nm. Previously $N_C V_{Si}$ centers were characterized by the near infrared PL peak around 1300 nm in SiC [8] but origins of peaks from 500 to 700 nm in SiC are not clear at the moment. Wafers at different dislocation visibilities show different PL spectra in yellow region. Further work is needed to understand this observation.

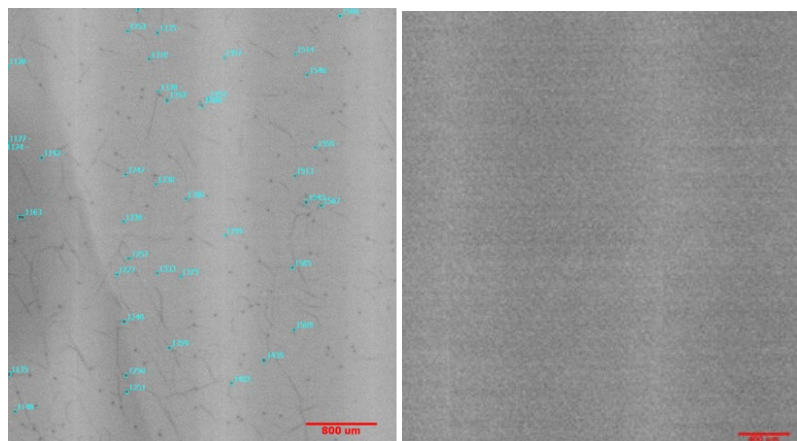
Figure 5. SICA 88 NIRW PL images. Decorated wafer (left) and un-decorated wafer (right). Dots in the left image are classified as PL black dots from the tool vendor defect count recipe. These two wafers are very comparable in both dislocation density and crystal quality. Markers and IDs in the image (left) are generated by the defect recipe.

Some of processed wafers in this study show dark lines and dots in PL images from SICA 88 (NIRW filter) tool as shown in Fig. 5. Those lines and dots correspond to BPDs and TDs, respectively and non-radiative recombination centers along the dislocations formed by decoration of point defects/dopants were proposed [7]. It is also observed that dislocation visibility changes in SICA PL image are significant (a few orders of magnitude in area density) even at very comparable dislocation densities.

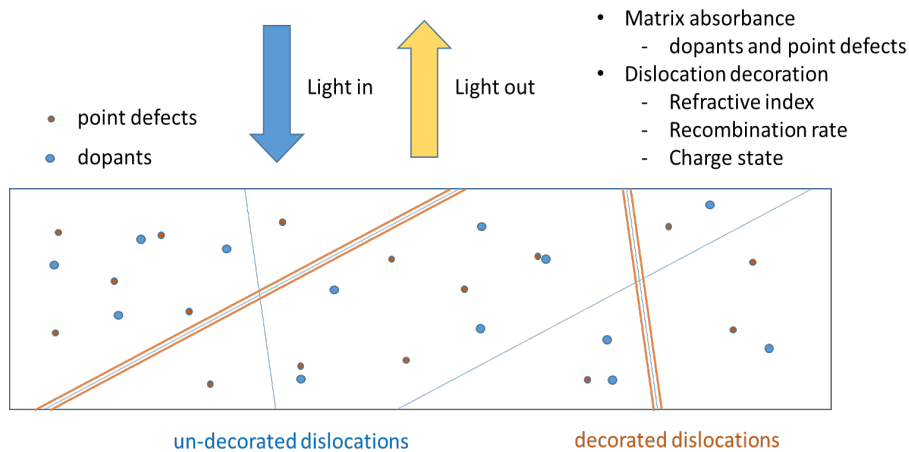
Figure 6. Schematic sketch to visualize dislocation decoration and SiC matrix light absorbance for dislocation visibility changes.

To explain dislocation visibility changes, a simple sketch as shown in Fig. 6 has been proposed as a working hypothesis. Two major factors play a role to determine dislocation visibility. First is matrix absorbance, which is light absorbance by SiC wafer itself. Nitrogen dopants or various point defects including complexes could be major variables to control light absorbance. Second could be dislocation decoration itself. Local refractive index, recombination rate or charge states along the dislocations lines could be changed significantly to alternate light scattering or PL generation.
