Evaluation of Defects in a SiC Substrate Using the Photoluminescence Measurement Method

Yoshitaka Nishihara^{1,a*}, Koji Kamei^{1,b}, Daisuke Shiomi^{1,c}
and Kenji Momose^{1,d}

¹SHOWA DENKO K.K., 1505 Shimokagemori, Chichibu, Saitama 369-1893, Japan

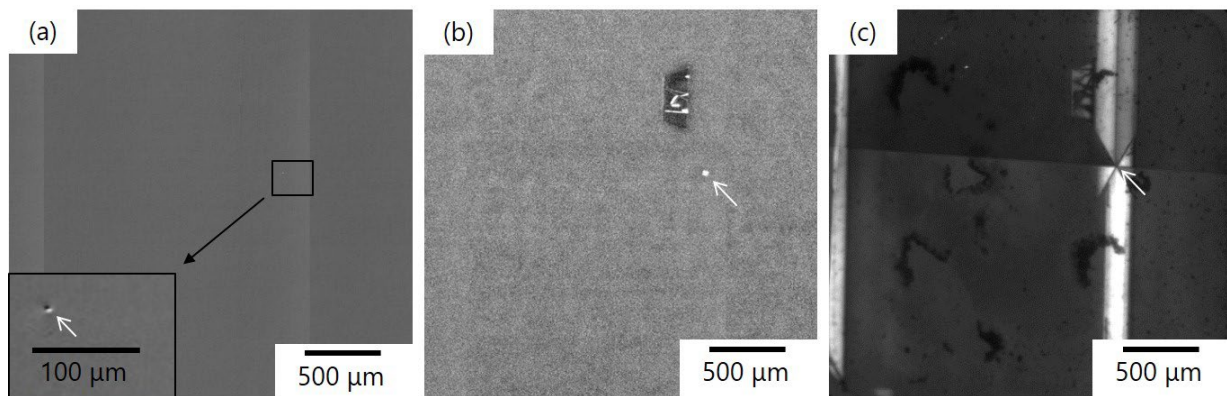
Large-pit Detection. Figures 1(a) and (b) show the CDIC and PL with LPF images of a large-pit detected in an epilayer. Both the pit structure and a bright spot at the same position were observed at the surface of the epilayer. This means that the pit was caused by a micropipe or a threading dislocation along with other dislocations formed in a direction parallel to the basal plane, which was introduced when the SiC substrate passed through the epilayer. Figure 1(c) shows a PL image observed at the same coordinates when using a 420 nm BPF with a PLIS-100 (PHOTON Design Corp.) after applying a direct current of 960 A/cm^2 for 1 hour to a PND fabricated on an epitaxial wafer. This image implies that extended SFs grown from the large-pit in the epilayer also contribute to bipolar degradation and need to be detected in an epitaxial wafer [5].

Fig. 1 (a)CDIC and (b)PL with LPF images on an epitaxial wafer. (c)PL in a 420 nm BPF image for the same region after applying DC stress to a PND fabricated using the wafer.

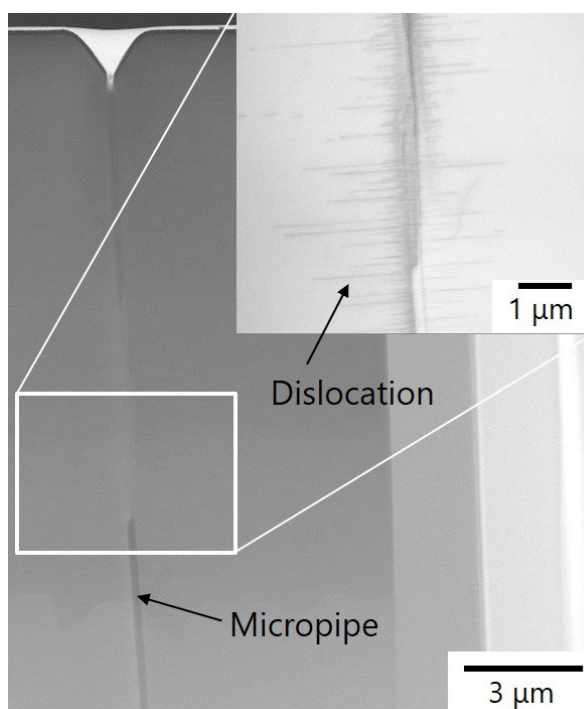
STEM image of a large-pit defect in an epitaxial wafer is shown in Fig. 2. A pit-shaped defect at the surface of the epitaxial wafer and a submicron size micropipe extending from the 4H-SiC substrate to the epilayer are observed; moreover, dislocations formed from the micropipe caused by spreading in the basal plane are also found. This means that the large-pit causes bipolar degradation due to the expanded SFs from the dislocations. Furthermore, BPDs in the epitaxial wafer extended to triangular SFs, however, dislocations with large-pits can form bar-shaped SFs, which cover larger area of the chip than in the former case. Thus, it is preferable that the large-pit is detected before the epilayer is grown.

Fig. 2 Cross sectional STEM image of large-pit in a 4H-SiC wafer.

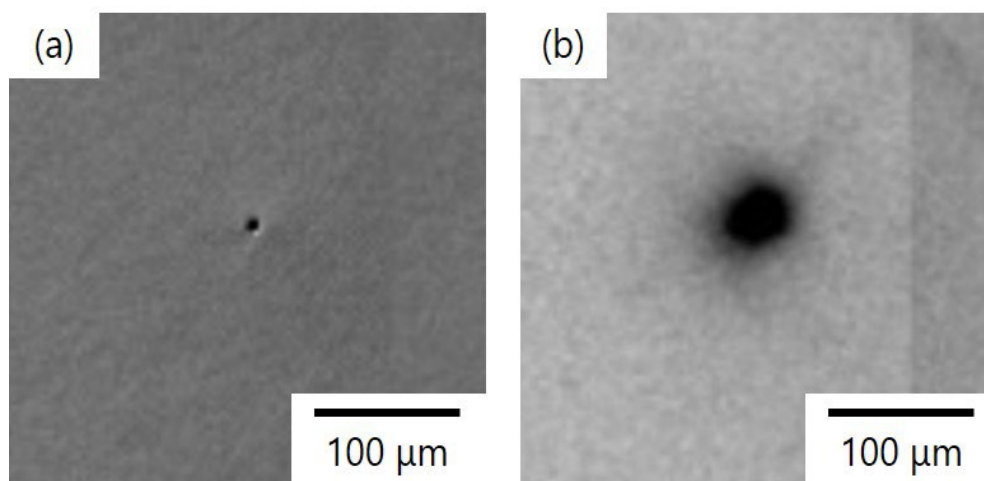
Figure 3 shows CDIC and PL with LPF images of a large-pit detected in a SiC substrate. The pit was found on the surface, which is the same as when it was measured in the epilayer, however, a dark spot was observed due to the different recombination paths in epilayers and substrates [2]. Thus, the large-pit on the substrate could be accurately examined by detecting pits on the surface with dark areas as nonradiative recombination centers in PL images.

Fig. 3 (a)CDIC and (b)PL images observed on a SiC substrate.

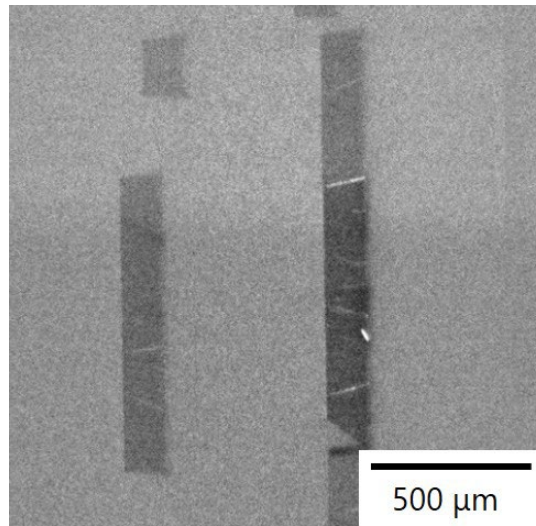
BSF Detection. With other epitaxial wafers, PL imaging was used to detect BSFs, when no structures were found on the surface using CDIC mapping. Figure 4 shows several dark rectangles indicating BSFs that extended into the epilayer from the SiC substrate that were observed by using PL imaging with an LPF. Owing to all the BSFs extending to the epilayer from the SiC substrate, they should be detected before the epilayer is grown in order to reduce the number of fabricated epitaxial wafers that include many BSFs.

Fig. 4 PL image observed on an epilayer.

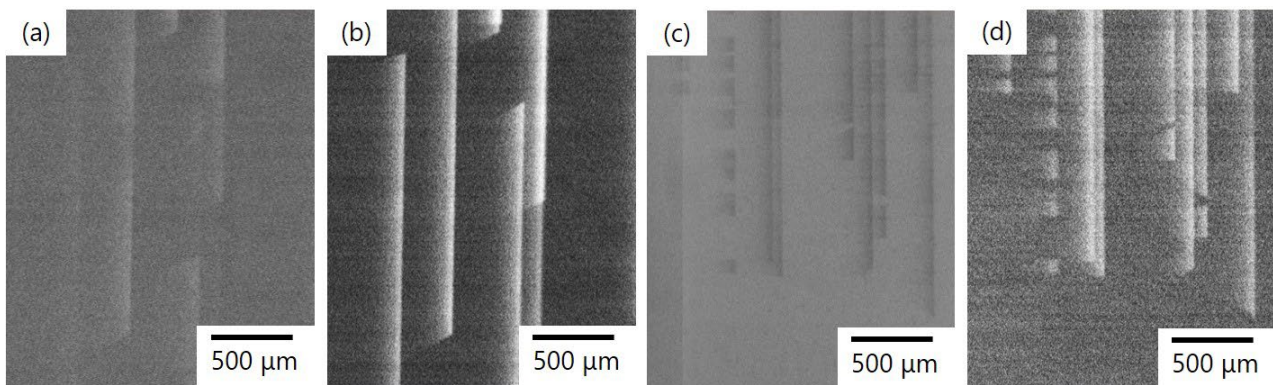
Figures 5(a) and (c) show PL images observed with the conventional PL measurement method. BSFs can be found in both images, however, there is a concern that some BSFs may be missed, because one exhibited a very weak contrast with the background and another exhibited a different degree of contrast. These BSFs found as bright contrast (Fig. 5(a)) and dark contrast (Fig. 5(c)) make difficult to detect automatically using various inspection tools. To make it possible to observe BSFs clearly, an improved PL measurement method with choosing suitable detection wavelength using the BPF was employed for the same region, and the results are shown in Figs. 5(b) and (d). The bright area of BSFs observed clearly in both PL images helped us calculate the BSF area or yield and determine whether an epilayer was grown on the substrate.

Fig.5 PL images observed same location (a)/(b) and (c)/(d) on a SiC substrate using (a), (c) the conventional measurement method, and (b), (d) the improved method.
