Electrical Scanning Probe Microscopy Investigation of Schottky and Metal-Oxide Junctions on Hetero-Epitaxial 3C-SiC on Silicon

Abstract. This paper presents a macro- and nanoscale electrical investigation of Schottky and metal-oxide junctions with hetero-epitaxial 3C-SiC layers grown on Si. Statistical current-density-voltage (J-V) characterization of Pt/3C-SiC Schottky diodes showed an increase of the reverse leakage current with increasing the devices diameters. Furthermore, C-V and J-V analyses of SiO₂/3C-SiC capacitors revealed non-idealities of the thermal oxide, such as a high trapped positive charge ($3 \times 10^{12} \text{ cm}^{-2}$) and a reduced breakdown field ($E_{BD}=6.5 \text{ MV/cm}$) compared to ideal SiO₂. Nanoscale electrical characterizations by conductive atomic force microscopy (CAFM) and scanning capacitance microscopy (SCM) allowed to shed light on the origin of non-ideal behavior of Schottky and thermal oxide junctions, by correlating the morphological features associated to 3C-SiC crystalline defects with local current transport and carrier density.

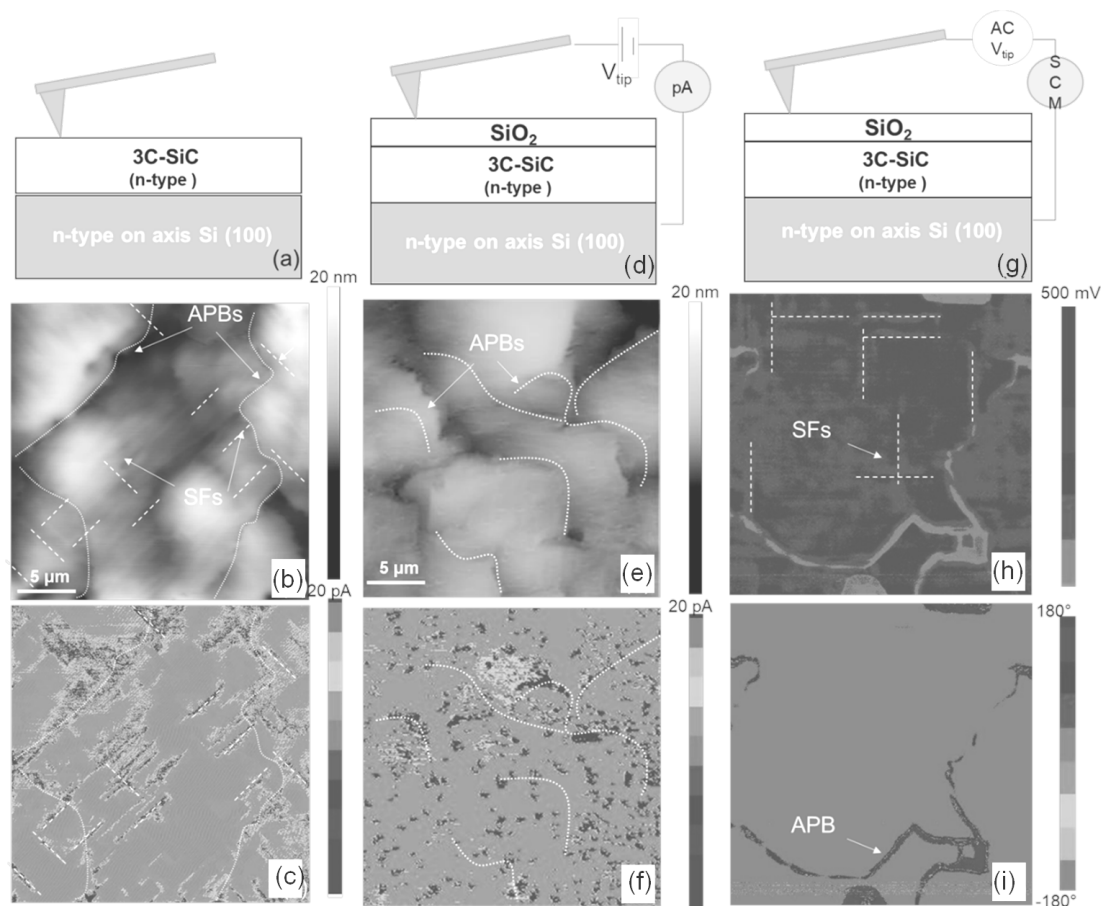
Fig.3 (a) C-AFM setup for current mapping of 3C-SiC/Si, (b) surface morphology and (c) current map. (d) CAFM setup for current mapping of SiO₂/3C-SiC, (e) surface morphology and (f) current map. (g) SCM setup for surface carrier profiling of SiO₂/3C-SiC, maps of SCM amplitude (h) and phase (i) signal.

In the following, the nanoscale electrical characterization of the bare 3C-SiC surface and after the growth of a thin (~ 10 nm) thermal oxide are reported. The CAFM metal tip (working as local Schottky contact) was preliminarily employed to probe the conduction on the 3C-SiC bare surface, as illustrated in Fig. 3(a). Fig. 3(b) and (c) show the surface morphology and the current map, collected simultaneously with a tip bias $V_{tip}=0.5$ V. Under this forward polarization, preferential conductive paths are visible on the 3C-SiC bare material, such as the anti-phase boundaries (APBs), indicated as dotted curved lines, and stacking faults (SFs), indicated as straight dashed lines [8]. Furthermore, current maps collected at negative tip bias (not shown) revealed that APBs are the main conductive defects under reverse polarization. Interestingly, their distance ($10\text{--}20\ \mu\text{m}$) is similar to the average value obtained from statistical analysis of macroscopic diodes.

Fig. 3(d) shows a schematic illustration of the CAFM setup on the SiO₂/3C-SiC system [9]. The morphology of the as-grown oxide (Fig. 3(e)) resembles the one of the bare 3C-SiC material, i.e., characterized by terraces separated by darker lines associated with the APBs. The SiO₂ surface roughness (RMS) was in the order of 5 nm, a value comparable to those measured directly on 3C-SiC layer before oxidation, demonstrating the conformal growth of the oxide onto the substrate, confirmed also by cross-section TEM analyses [9].

Fig. 3(f) reports the simultaneously collected current map by the positively biased conductive tip with $V_{tip}=8$ V. It can be considered as a breakdown map of an array of nano-MOS capacitors simultaneously stressed at 8 MV/cm. The BD events are not randomly distributed but there are some regions with a larger density, located in correspondence with some APBs. Noteworthy, the SFs were not visible in the case of 3C-SiC covered by thermal SiO₂. The SCM experimental setup is illustrated in Fig. 3(g), whereas Fig. 3(h) and (i) show two representative images of the SCM signal amplitude $|\Delta C|$ and of the phase signal. In particular, both straight line features resembling SFs (dashed lines) and curved line features resembling APBs can be distinguished in the SCM amplitude image in Fig. 3(h), whereas only APBs features can be observed in the phase map in Fig. 3(i). The spatial variations in the SCM amplitude are related to local changes in the carrier density in the 3C-SiC layer.

Interestingly, Fig. 3(i) shows a strong change of the SCM phase signal from 180° on APBs to -180° on the surrounding regions indicating a local increase of the minority carriers (holes) concentration in the 3C-SiC material. Thus, the APBs may act also as a preferential sites for positive charges trapping. On the other hand, the presence of positively charged APBs can cause an enhanced electron injection from the semiconductor into the insulator and the preferential dielectric breakdown close to these extended defects. This can explain the reduced E_{BD} observed in large area MOS capacitors.
