Solid State Phenomena
ISSN: 1662-9779, Vol. 375, pp 63-68
doi:10.4028/p-1N8gYx

Investigation on Bipolar Degradation Caused by Micropipe in 3.3 kV SiC-MOSFET

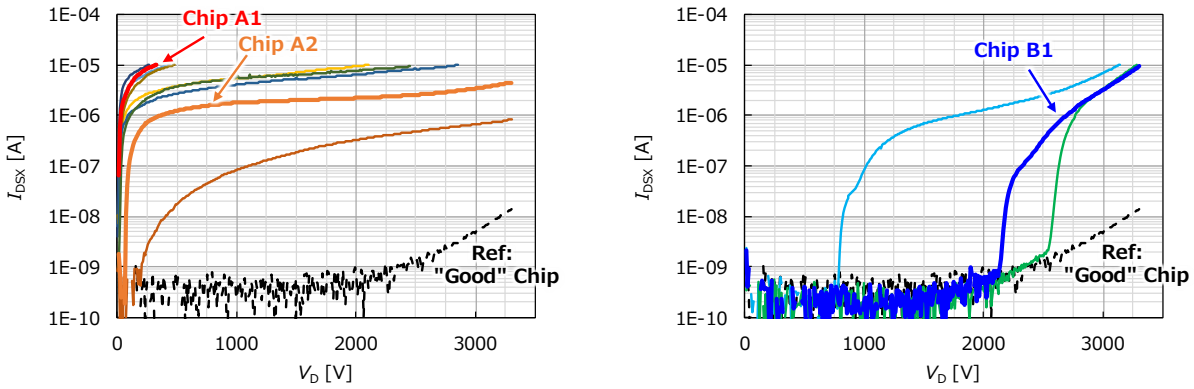
BD stress was applied to more than 1,500 chips, and out of the 159 degraded chips, 45 showed I_{DSX} degradation. Figure 2 shows the leakage current characteristics of the I_{DSX} degraded chips (n = 13) selected for failure analysis. Compared to the passing chip, a clearly abnormal leakage current was observed. Two types of leakage current characteristics were identified: chips with abnormal leakage starting at a relatively low drain voltage (V_D) are referred to as Type A (Fig. 2 (a)), while those with leakage starting at a high V_D are categorized as Type B (Fig. 2 (b)).

Fig. 2. Leakage current characteristics of I_{DSX} degraded chips. The compliance current in the measurement was set to 10μA. (a) Type A: Chips with abnormal leakage starting at low V_D. (b) Type B: Chips with abnormal leakage starting at high V_D.

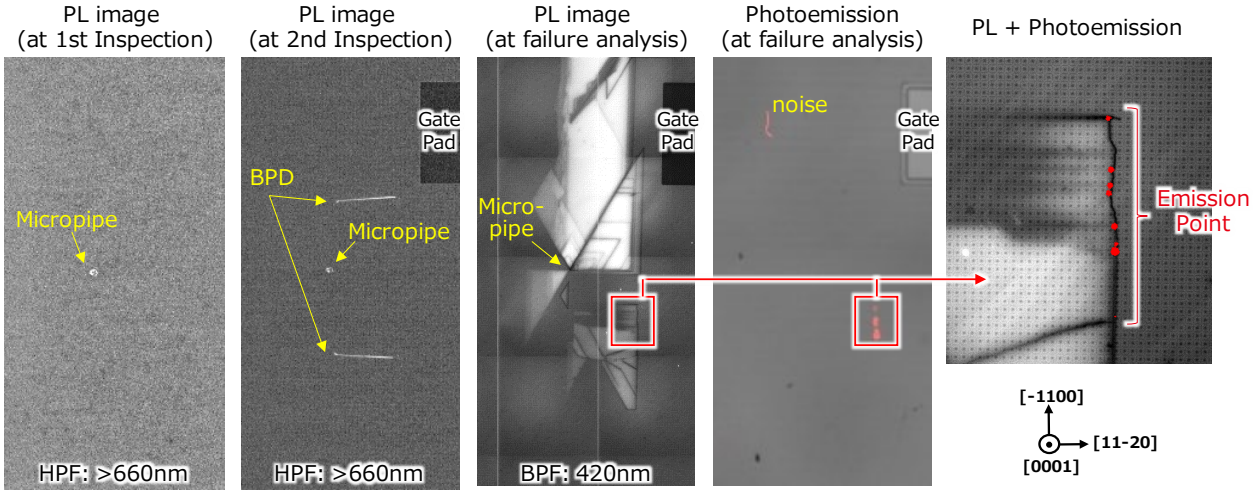
Type A. Figure 3 shows the PL image and the results of photoemission microscopy for Chip A1, as shown in Fig. 2 (a). In the initial PL image taken during defect inspection (after epitaxial growth), a white dot was detected, identified as a micropipe [12]. After activation annealing, basal plane dislocations (BPDs) propagated from the micropipe, and 1SSFs expanded from the propagated BPDs and micropipe itself (more precisely, from the BPDs surrounding it) after the high current stress. Notably, the strain associated with the micropipe generates a BPD cluster around the micropipe in the epitaxial layer [14]. Overlaying the photoemission and PL image revealed abnormal leakage near the periphery of the expanded 1SSF originating from the BPDs.

Fig. 3. PL images and photoemission microscopy results of Chip A1.

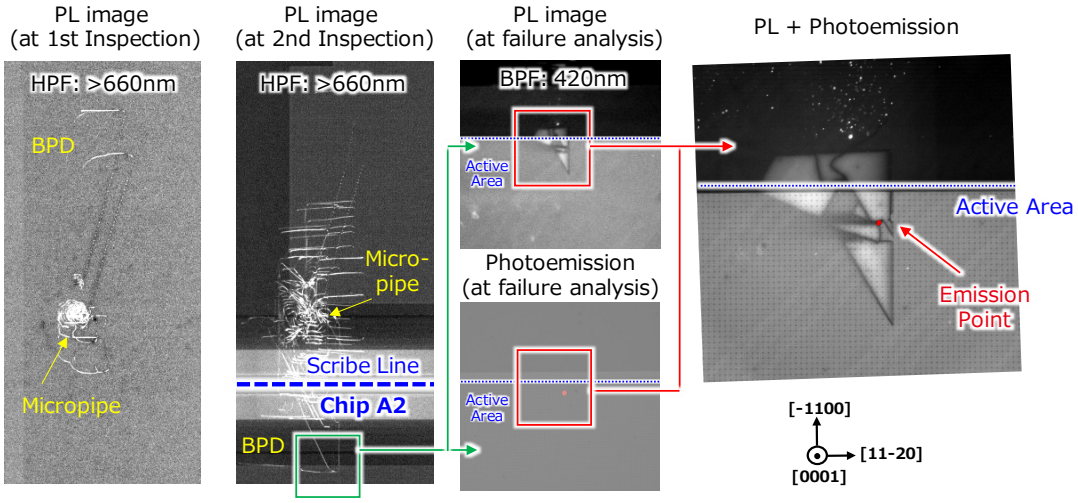
Figure 4 shows the analysis results for Chip A2 shown in Fig 2 (a). In this chip, BPDs also propagated after activation annealing, and photoemission was observed near the periphery of the expanded 1SSFs originating from these BPDs. Notably, the micropipe itself is in a neighboring chip, not within Chip A2. This indicates that the micropipe does not directly cause I_{DSX} degradation; rather, the propagated BPDs are responsible for the I_{DSX} degradation in Chip A2. Although failure analysis was not conducted on the neighboring chip containing the micropipe, it was categorized as an I_{DSX}-degraded chip after BD stress. This finding further supports the idea that BPDs propagate from the micropipe, leading to I_{DSX} degradation.

Fig. 4. PL images and photoemission microscopy results of Chip A2.

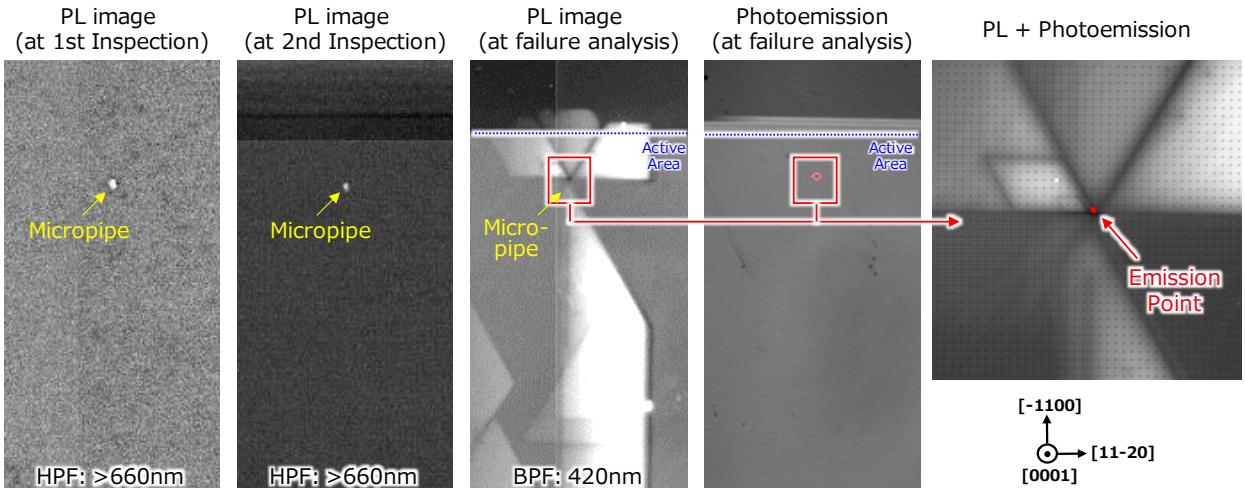
Type B. In Type B, abnormal leakage begins at a high V_D, unlike Type A. Figure 5 shows the analysis results for Chip B1 to determine if this type of degradation is also caused by the BPDs propagating from the micropipe, similar to Type A. The results in Fig. 5 show that 1SSF expanded from a micropipe, as observed in Type A; however, photoemission was detected near the micropipe itself. Unlike Type A, BPDs did not propagate from the micropipe after activation annealing in Chip B1, although BPDs are expected to be present around the micropipe since the 1SSF expanded following BD stress. This suggest that the specific BPDs causing I_{DSX} degradation in Type A may remain around the micropipe even after activation annealing, leading to degradation near the micropipe after BD stress. Similar results were observed for other Type B chips, as shown in Fig. 2 (b), where BPDs did not propagate from the micropipe after activation annealing. Thus, I_{DSX} degradation in both Types A and B is believed to be caused by similar BPDs around the micropipe.

Fig. 5. PL images and photoemission microscopy results of Chip B1.

The difference in *I-V* characteristics can be discussed by the photoemission point: the periphery of 1SSF in Type A and near the micropipe in Type B. In Type A, emission is observed near the periphery of 1SSF, especially at the surface side of the chip. This indicates that the defective area causing I_{DSX} degradation is near the surface of the chip, requiring a very low V_D to create a high electric field sufficient to initiate abnormal leakage. In contrast, for Type B, the defective area causing abnormal leakage is likely near the starting point of 1SSF around the micropipe. Since the starting point of 1SSF is deep within the drift layer, a high V_D is needed to achieve a sufficiently strong electric field to induce abnormal leakage at that depth. Thus, although the *I-V* characteristics of Types A and B are different, the underlying physical mechanisms of the leakage current may be similar, with the observed differences attributed to the varying depths of the defective areas.
