Failure Investigation & Analyses of AISI D3 Dies used in Tableting Machines for Pharmaceutical Application

¹STEER Engineering Pvt. Ltd, 4th Phase Peenya Industrial Estate, Bangalore, India

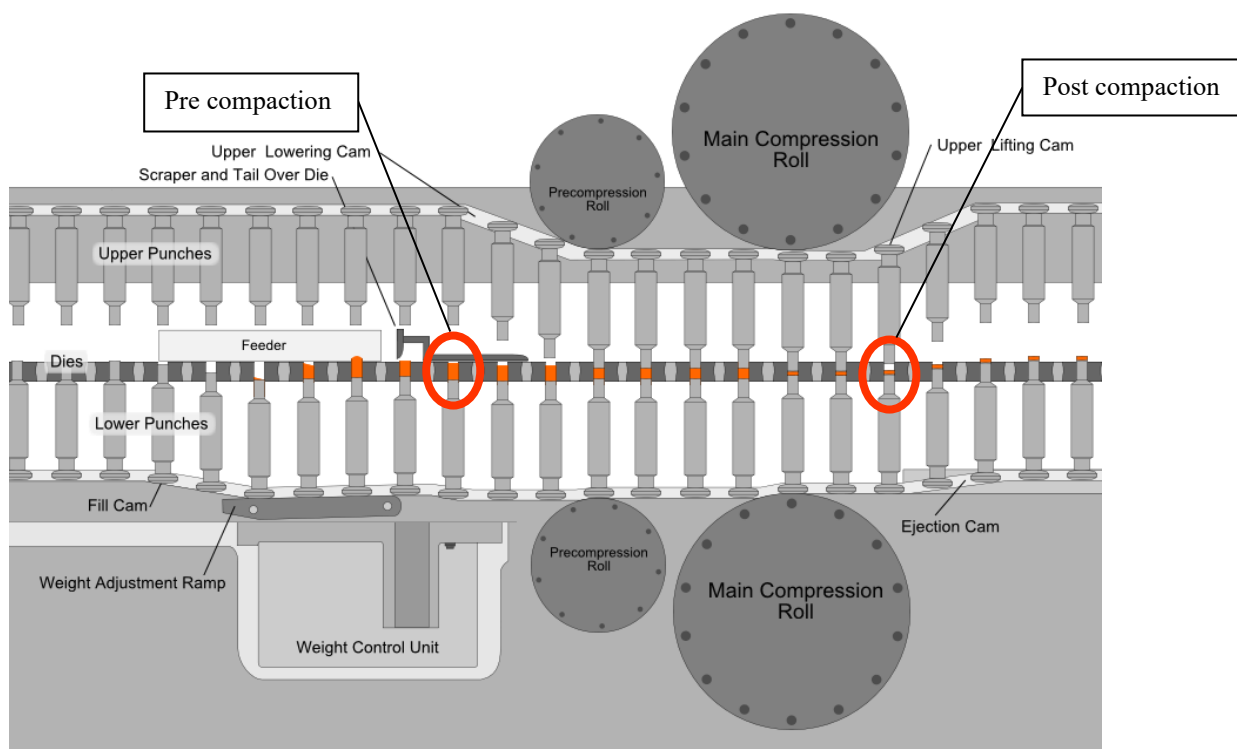
Fig. 1. Schematic of Tableting Process

The compression stage of the Tableting Process involves bringing together both the upper & lower punches under high hydraulic pressure through application of vertical load [75 – 80 kN] resulting in compaction of the formulation material by almost 80% to form the tablet [Fig.1]. This periodic application of load in the compression stage results in creating cyclic tensile hoop stress on the ID surface at the zone of compaction.

The tableting process, which involves high load compaction reduces the height of formulation product in the Dies by almost 80% [Fig 1], thereby squeezing out the ingredients [water + other] and smearing them at high tensile hoop stress on the ID surface causing the formation of several minute corrosion pits in the mid-section of the Dies as the material has had insufficient corrosion resistance.
