# Strengthening of a Damaged Concrete Structure - Case Study of an Eleven Stories Building in Dar es Salaam

Dr John K. Makunza

University of Dar es Salaam, Department of Structural and Construction Engineering,  
P.O. Box 35131, Dar es Salaam, Tanzania

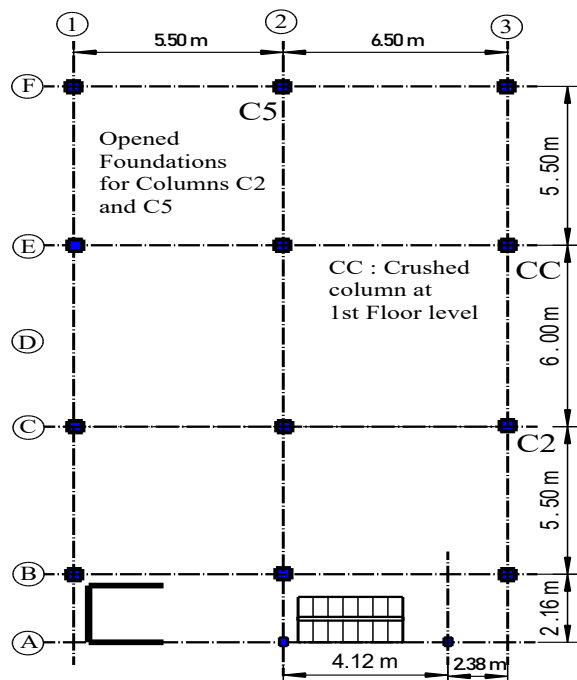
**Figure 2:** Layout of columns and slab of the building

The eleven stories building was observed to be a framed structure with three rows of columns longitudinally by four rows transversally as seen in Figure 2. The floors were of solid concrete slabs of an average thickness of 160 mm spanning two way. The ground floor was used for parking and had no infill walls except at the concrete staircase and lift shaft. From an interview of one person who was there when the crushing of the column took place, it was noted that it suddenly and abruptly crushed emitting a loud noise. However, from an observation on the beams, slabs, walls in upper floors, and columns feet, nothing detrimental could be seen. There were neither cracks nor settlement observed at all, except at the crushed point as depicted in Figure 1.

- (1) The structural members such as columns, walls, beams and slabs didn't show any form of deterioration, exception is for column CC at point E3 (Figure 2) which crushed and the beams meeting at the column moved downward by **42 mm**. The crushing of the column at bottom of 1<sup>st</sup> floor beams caused 40 mm downward movement, while settlement was 2 mm which is negligible.
