The Microstructure Changes in IN713LC during the Creep Exposure

Pospíšilová Simona^{1,a}, Kianicová Marta^{2,b}, Vlasák Tomáš^{3,c},
Hutař Pavel^{4,d}, Podrábský Tomáš^{1,e}, Hák Jan^{3,c}

¹Brno University of Technology, Faculty of Mechanical Engineering
Technická 2, 616 69 Brno, Czech Republic

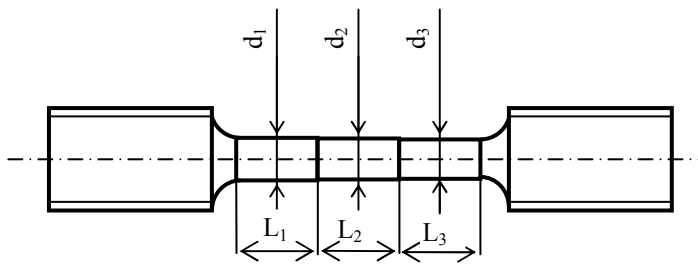
Creep testing. Creep tests were performed at 800 °C in air. The specimens with three different diameters were used for these tests. The scheme of testing specimen is shown in Fig. 1. It is obvious that each part of specimen ($L_1 - L_3$) was loaded by different stresses. The biggest constant load corresponds to stress 360 MPa in diameter d_3 . The dimensions and stresses are stated in table 2.

Fig. 1 The scheme of testing specimen.

Finite element modeling. The creep test specimen illustrated in Fig.1. was numerically modeled to find relation between geometry and stress distribution. Due to axisymmetry of the specimen geometry and loading, finite element model was built as two-dimensional with axisymmetrical boundary conditions. The mesh of the finite elements was nonhomogeneously distributed due to stress concentrations in the area where is change of the specimen diameter. Based on numerical results, it was found that the effect of these stress concentrators is small and can be neglected especially in the case of creep loading. Therefore, important question is influence of the creep cracks on the stress distribution in the specimen. For simplicity the model of the creep test specimen (see Fig.1) with potential damage in the centre was modeled. As approximate shape of damaged area was used penny shape crack.

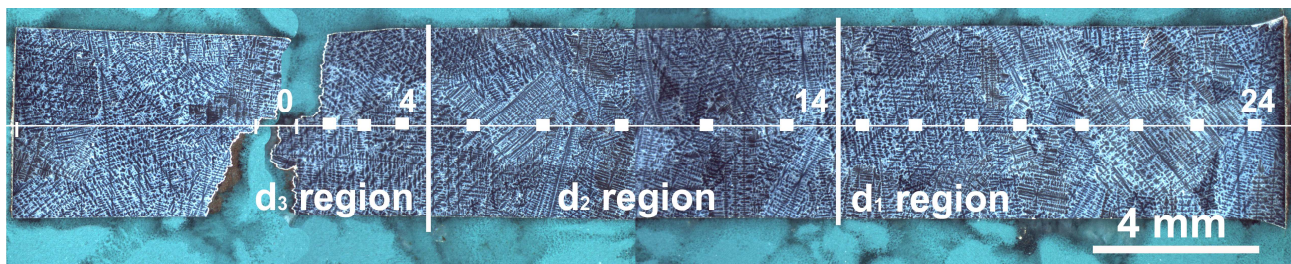
Microstructure analysis. The microstructures were studied by light microscopy (LM) and scanning electron microscopy (SEM) after rupture on the specimens sections longitudinal to the loading axis. The microstructure changes were analyzed by image analysis. The crystallographic orientations were studied by electron backscatter diffraction (EBSD). The observed areas were located directly in the loading axis and the distances between them were approximately 2 mm, see Fig. 2 (white squares). There the studied areas and the distances from the fracture are marked.

Fig. 2 The macrostructure of specimen 1, section longitudinal to the loading axis; the microstructure were studied by SEM and EBSD in areas marked by white squares, LM

Fig. 7 The stress distribution close to the crack tip, the specimen centre is on the left, shown area is about 4mm. Crack tip location corresponds to the experimental observations in Fig. 2.

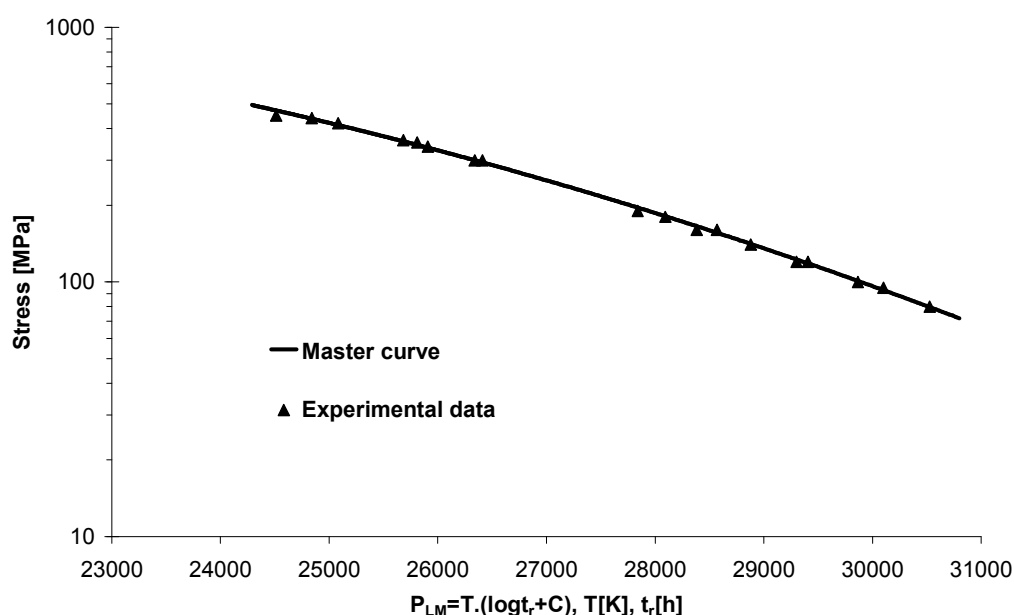
Creep testing. Mean values of time to rupture were obtained from evaluation of test results on the basis of previous work [7]. Evaluation details are in [7]. For illustration the graphical interpretation of creep strength dependence on Larson-Miller parameter $P_{LM}=T \cdot (\log t_r + C)$, where T is temperature and t_r time to rupture, is shown in Fig. 3.

Fig. 3 The dependence of stress to Larson Miller parameter according to [7].

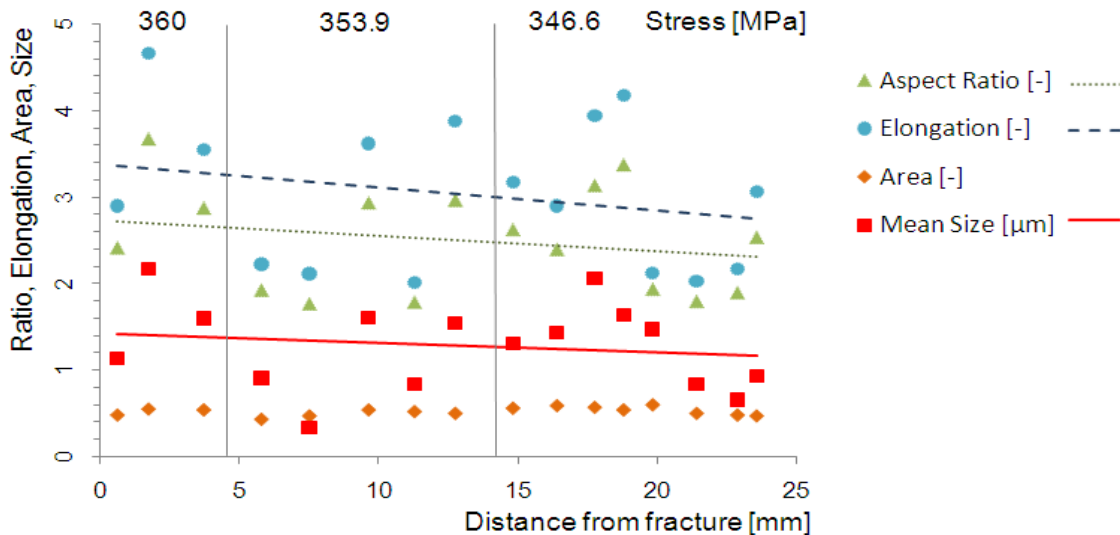
The results from image analysis were statistically evaluated. The dependence of the structural parameters and the distance from fracture or the stress from $d_1 - d_3$ region are shown in Fig. 5.

The γ' fraction with stress value and distance from the surface were almost unchanged and respond to 52 % approximately. But the morphology of precipitates γ' and mean size increase with stress value and with decreasing distance from fracture.

Fig. 5 The dependence of structural parameters and the distance from fracture or the stresses from d_1 - d_3 regions in specimen 1.

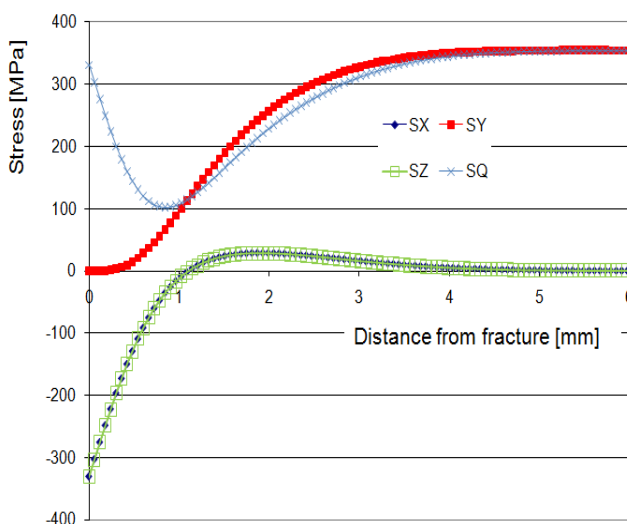
Finite element modeling. The results of the finite elements are shown in Fig.6 and 7. It is visible that there is high triaxiality of the stresses in the area close to the creep crack. Size of this region depends on the actual damage zone size and probably is smaller than 2 mm. Then, part of the specimen is influenced by stress redistribution, due to the creep crack existence. The stresses SX and SZ have similar dependence, which is given by axisymetry of the model, see Fig. 6 (center of the creep specimen). There is area of the strong stress decrease in the center of the specimen and strong increase on the free surface, see Fig.7. Cross hatched area near the free surface is area of the stresses which are higher than 400 MPa. Shift of the stress scale to smaller values was used due to better visibility of the stress distribution in the center of the specimen, where microstructure observations were done. Redistribution of the stress state in the center of the specimen can lead in the case of high creep loading levels to the nonhomogenous change of the microstructure. However these changes will be important in d_3 region only.

Fig. 6 The stress distribution in the area close to the crack tip (center of the specimen); SQ is von Mises stress; SX, SY, SZ are the stress components; SY is stress in the loading direction.
