Cast Iron Components with Intelligence

Abstract. The paper describes a project with the aim to develop communicating and functional cast iron components in smart systems. The concept is based on sensors integrated into cast iron components; this will influence not only the component but also the casting process. Among the technical challenges is how to choose a sensor solution that cost-efficiently and with minimal environmental impact can be integrated into the component during the casting process, and especially without being damaged during mold filling and the high pouring temperature. Another challenge is how the iron will interact and interfere with sensor signals and whether an insulating intermediate material is needed or not. Integrating the sensors into the casting makes sensors a natural part of the component, which in turn can lead to more resource efficient designs, increased value added for the casting sector, and a general access to different possibilities of digitalization. The integrated sensors can be used for effective control and monitoring of components when in service and give information about for example how the component is used and what conditions it is ex

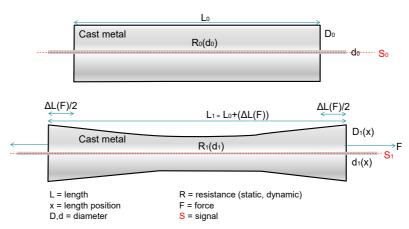
Figure 2 presents the generic approach used in this work; a wire of deviating material acting as a sensor embedded in the cast metal. Changes in the cast metal will also affect the wire. Changes in the signal through the wire will reflect changes in the cast metal. The wire may be a metal or any other material that can carry a signal. If necessary, the wire will also have to be encapsulated in an insulating material.

Figure 2. The generic approach used in this work [1].

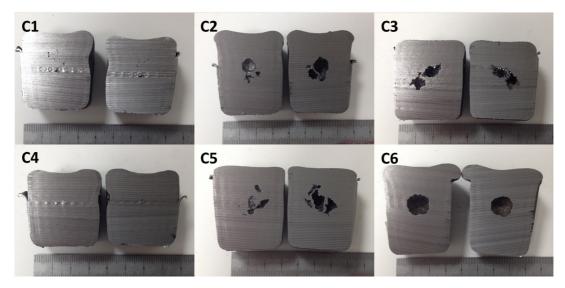
Figure 5. Cross-sections of the SGI samples.

The first observation is that all SGI samples have defects to different extents, see Fig 5. These are of various kinds; some are related to shrinkage while others are gas defects. However, these defects are not necessarily formed due to the sensor/insulator material. Due to these cavities it was difficult to find all sensor/insulator materials on the cross-section. In some cases the materials that should have been located inside the cavity can be expected to have been detached during the cutting. It is also interesting to notice that defects were found on C1 which actually is an ordinary cup for thermal analysis. The question one can ask is how that influences the result during thermal analysis. Another interesting observation is the depressions found on the surfaces, see Fig. 4. These are present on the samples also having interior defects.

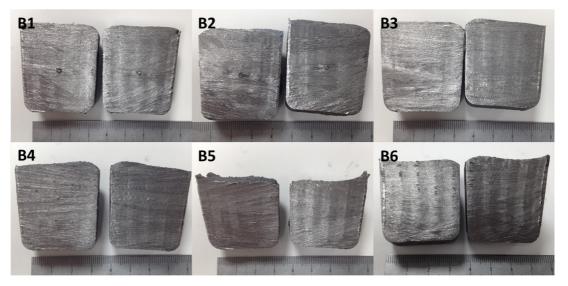
Figure 6. Cross-sections of the LGI samples.

Surprisingly, in the case of lamellar iron there were no defects observed and thus easier to find the sensor/insulator materials, Fig 6. It must however not be forgotten that the investigation on this stage only is done on the center cross-section. This means that minor defects still can be present. Another problem was that some of the wires were not located in the center where expected, and could not even be found on the cross-section examined. In these cases the second cut closer to the surface was made, where the sensor/insulator material was fixed and therefore should be found. The only sensor wire still not found when examining this second cross-section was the stainless steel wire. However, the wire is observed on the outside of B5 so the question is whether it has been dissolved. In the other cases the most probable explanation is that the wires has been attached too loose, and therefore located outside the region investigated on the first cross-section. Once again, it is interesting to notice the differences in outer sunks, or depressions. In general, there is much more tendency for depressions on the SGI samples.

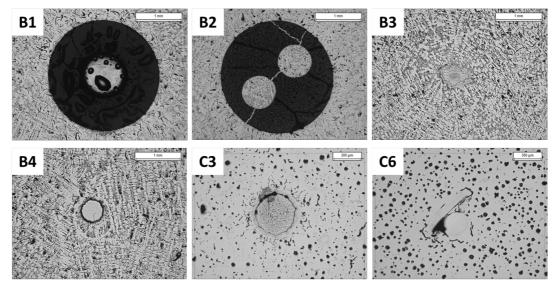
Figure 7. Interaction between iron and sensor/insulator materials for some of the samples.

Some interesting observations in the microstructure have been summarized in Fig. 7. On sample B1 some minor cracks were found growing from the quartz tube into the iron until they reached a graphite flake. These cracks have also been seen away from the tube. These cracks can also be a result of the cutting. There is some undercooled graphite in the structure but that can of course be a consequence of no inoculation. Close to the tube A-type graphite is formed. In Sample B2, Al₂O₃ tube, cracks has formed in the alumina that filled the ordinary holes with iron. Graphite is found in the structure and therefore it can be concluded that these cracks were formed before the cutting. On all samples with insulating material a small air gap is found at the interface. In both B3 and C3 carbides are found. Sample C3 also has interfacial problems with large gaps between the wire and the iron. Another observation is that the wire in C3 still is circular but in B3 it has changed shape. Besides, in C3 it is very clear that degenerated graphite has formed.

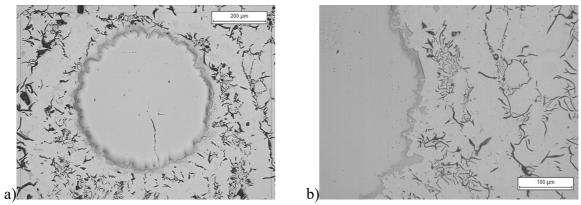
Figure 8. a) Close up of sample B4 reveals both a crack in the sensor material and carbides in the structure, b) carbides and intermediate phases close to the tungsten wire.

One strange observation on sample B4 is that the wire should be 0.7 mm in diameter but on the cross-section it is only about 0.5 mm. This wire also has a crack, see Fig. 8a, and both carbides and an intermediate layer of deviating structure has formed between the wire and the iron, see Fig 8b. There are different carbides and inclusions formed; some of them have a very characteristic sharp appearance. Other inclusions are distributed not only around the wire and have a characteristic gold/copper color. The strange shape of the wire in C6 depends on the wire that is a twisted flat ribbon and clearly not a good solution for complete bonding with the iron as voids very easily are formed. The matrix structures in both LGI and SGI were mostly pearlitic with some ferrite.
