What to do with Alvar Aalto?

Keywords: Alvar Aalto, renovation

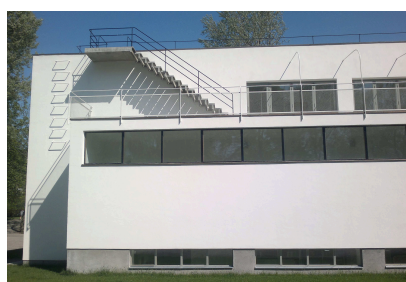
Fig. 2. The exterior stairs of the lending hall terrace [Paajanen, 2014].

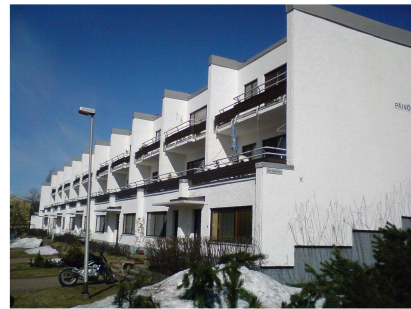
Fig. 5. Karhu and Päivölä, stepped apartment blocks [Paajanen, 2010].

Sunila area in the near of the town Kotka was built by the wood company Sunila Pulp Mill in the middle of the 20th century. The company wanted to build one kind of a new factory area for a new age: the factory with a residential area for the employees. In Aalto's plan an open woodland area stretches between the buildings (see figure 4). There is a villa for the manager of the mill, row houses and apartment blocks for different kind of categories of employee. The plan is rather democratic, the open gardens between the buildings are open for everybody. The flats of the workers are small, in the flats there are toilets but not showers, originally there were some common sauna buildings. The architecture of the buildings is modern, for example the stepped apartment blocks Karhu and Päivölä are famous (see figure 5). [7.]

protect also the architectural details. Before that the owners of the stepped apartment blocks Karhu and Päivölä have chanced the parapet capping during the renovation (see figure 5).

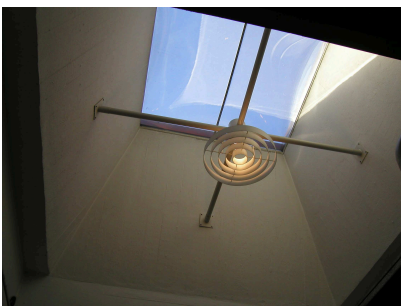
Fig. 8. Skylight in one laboratory room [Paajanen, 2004].

Nano laboratory building was built in 60es as wood laboratory. There are many very fine architectural rooms and details in the building, for example skylights, also in the laboratory rooms (see figure 8), the beautiful main lobby (see figure 9) and inner courtyard, so called “secret garden” (see figure 10).

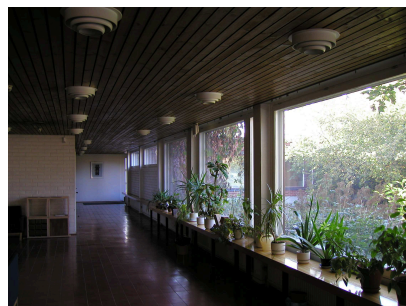
Fig. 9. Main lobby [Paajanen, 2004].

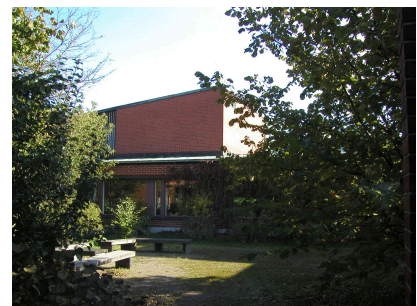
Fig. 10. “The secret garden”, the inner courtyard [Paajanen, 2004].
