# Applicability of a Flat-Bed Birefringence Setup for the Determination of Threading Dislocations of Silicon Carbide Wafers

**Keywords:** silicon carbide, physical vapor transport, birefringence, KOH etching

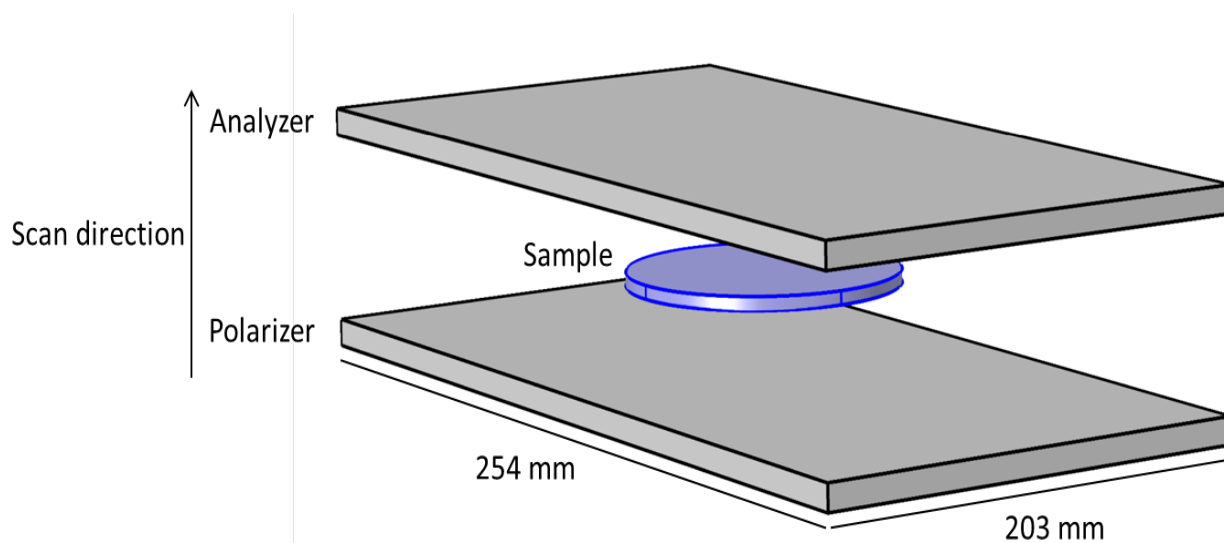
Figure 1: Schematic of the flat-bed scanner setup.

A commercially available flat-bed scanner (Epson perfection v800) with a maximum resolution of 6400 dpi and a scanning area of up to 254x203 mm was utilized. The SiC-wafer is placed between two linearly polarizing foils, placed in a 90 degree configuration in respect to each other so that passing light is fully extinguished. One scan of a 100 mm diameter sample takes approximately 7 minutes.

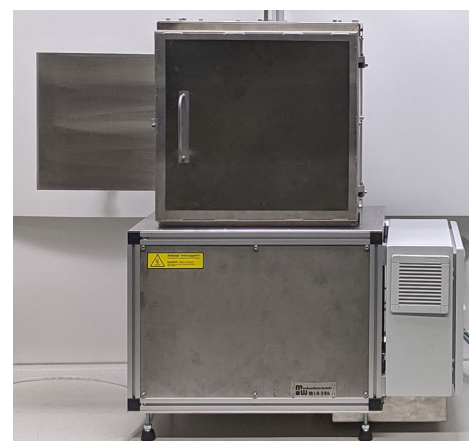
Figure 2: FAU KOH-etching setup

**KOH Etching.** The KOH etching was carried out using the fully automated FAU KOH-etching setup, which is able to perform etchings of multiple 150 mm to 200 mm SiC wafers.

The samples were placed into a KOH melt of 520°C for 6 minutes until the dislocations are etched sufficiently.

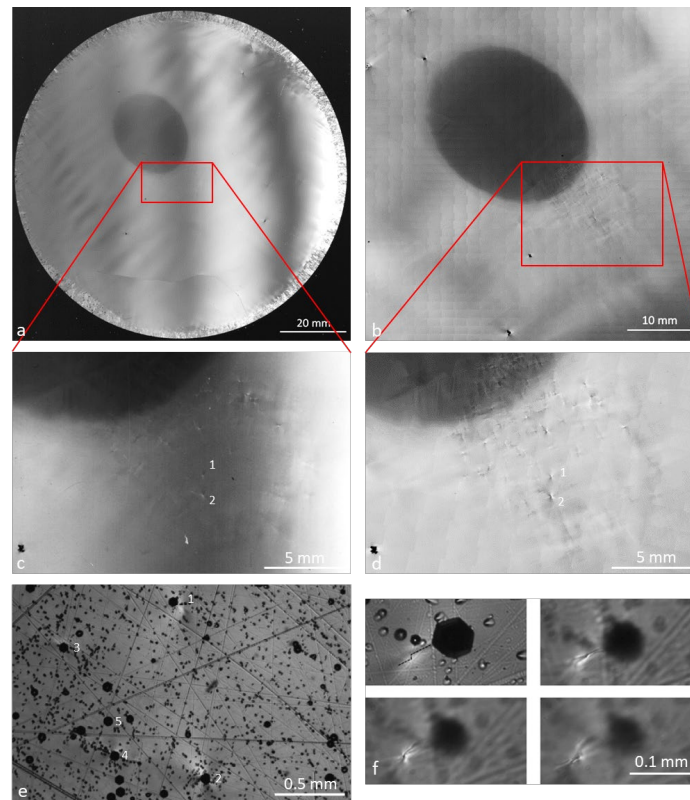
Figure 3: Birefringence mapping of the sample done with a) the flat-bed scanner setup and b) the Imager.Z1m microscope. c) and d) depict magnifications of the area marked with a rectangle in a) and b), respectively. e) pictures the region of the sample after KOH etching, marking MPs with birefringence signal as 1-4 and a TSD without any signal as 5. MPs 1 and 2 are the same as in the images c) and d). f) illustrates the path of MP 1 through the crystal. The path is marked with a dashed line.

**Comparison between flat-bed scanner image and stitched microscopic image.** Fig. 3a) depicts the result of the birefringence measurement done with the flat-bed scanner setup while Fig. 3b) shows the image taken by birefringence microscopy with the Imager.Z1m. In the latter case, a magnification of 200x was employed. The faint repetitive rectangular pattern is an artefact of the stitching process. Both setups are able to show a MP cluster in the center of the wafer. This cluster was caused by a polytype switch during the start of the crystal growth and is not visible in an optical scan. In addition, small angle grain boundaries (SAGB) can be observed at the edge of the wafer. These SAGBs also extend into the center of the wafer, which are apparent in the scan as well. In Fig. 4a) a repeating pattern is visible in our scanner setup. This pattern was verified in Fig. b) and c) as TED arrays by KOH etching.

Apart from that, the sample depicts a homogeneous intensity distribution in both images 3a) and 3b). The black dots visible are carbon inclusions caused by a process irregularity. In general, there are no apparent features missing in the birefringence image taken by the flat-bed scanner setup compared with the one taken by the Imager.Z1m microscope. The MP cluster in the center of the sample is magnified in Fig. 3c) and 3d), where 3c) belongs to the scanner setup and 3d) to the microscopic setup. For an easier comparison, two MPs are marked as 1 and 2. The MPs are clearly visible in both images, as well as a faint hexagonal pattern in the facet region. However, this pattern was not detected after the KOH-etching was completed. Since it is also apparent in the optical scan without birefringence, it is most likely a variation in nitrogen doping concentration in the facet, which was already reported in literature [10]. Overall, the result of the flat-bed scanner setup proves to be comparable with the one taken by birefringence microscopy.

**Limitations of the flat-bed scanner setup.** The limitations of this setup also have to be considered. Figure 3e) shows another magnified image of the MP cluster, concentrating on the MPs marked as 1 to 4. An additional etch pit is marked as 5. This defect is identified as a TSD via microscopy. The image was taken after the sample has been etched with molten KOH. While these four MPs are visible in the birefringent images, the TSD marked with 5 doesn't show any intensity variation in neither the images taken by the flat-bed scanner setup nor taken by the microscope. The defect count of TSDs and MPs in Fig. 3e) was approximated as 33 in total by means of image analysis using an algorithm developed by the Research Center Jülich Institute for Advanced Simulation. From these 33 threading dislocations, nine were identified as MPs. As a conclusion, the defect cluster can be detected in general while a calculation of the total defect density is not feasible with only birefringence imaging, since from nine MPs only four showed a contrast in the birefringence measurements. The defect cluster depicted in Fig. 3c) and d) exhibits 427 etch pits belonging to

TSDs and MPs. 68 of these defects show a contrast in the images taken with the flat-bed scanner setup, while the remaining 359 defects cannot be observed by the setup.

MP 1 was further investigated in Fig. 3f), where the focus of the microscope was shifted to highlight the path of the MP. As discussed in [7], the MP doesn't progress exclusively along the c-axis but also has an edge component. This behavior was observed for all MPs exhibiting an intensity shift in the birefringence measurements. Other MPs didn't show any influence on the detected strain in the crystal. It is calculated by Steeds and further covered by Ouisse et al. that screw dislocations without any edge component in the burgers vector are invisible in birefringence measurements, since they are photoelastically isotropic in the basal plane [8, 11]. Moreover, similar to the TSD marked with 5, we could not detect any TSDs featuring an intensity variation. While possible, it is highly unlikely that there are no mixed-type screw dislocations present in this sample. Therefore, the conclusion has to be that our flat-bed scanner setup doesn't feature the required dynamical range necessary for the detection of TSDs. It has to be noted that the Imager.Z1m microscope was not able to detect TSDs as well despite the fact that birefringence microscopy was able to be utilized for investigating TSDs in previous works.

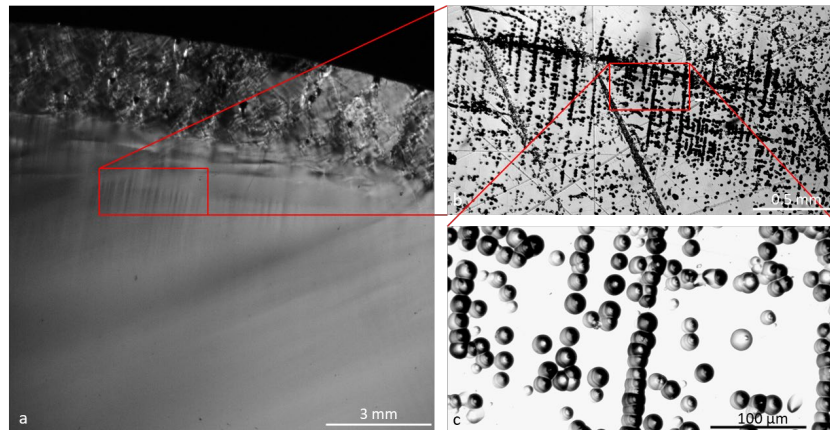
Figure 4a): Birefringence image of the sample before etching, taken with the flat-bed scanning setup, showing a TED array. b): Magnified image of the etched sample. c): Further magnification showing the single TEDs.
