Pulsed Forward Bias Body Diode Stress of 1700 V SiC Mosfets with Individual Mapping of Basal Plane Dislocations

Abstract. In this work, body diode stress has been carried out for 1700 V 25 mΩ planar SiC MOSFETs. The epitaxial wafers were mapped with Infra-Red photoluminescence (IR-PL) to determine and localize the exact number of basal plane dislocations present in the drift layers of each die. The SiC MOSFETs were then packaged in groups with individual BPD counts in different bins ranging from 0 up to more than 30 per device. Pulsed body diode measurements with high currents of 250-400 A (about 1000-1600 A/cm²) were then performed with electrical characterization before and after to check for drift in key electrical parameters. Significantly increased R_{DSon} was found after high current stress from about 300 A for devices with BPDs. A physical analysis of the degraded devices by backside electroluminescence show the presence of several trapezoid-shaped patterns indicating the occurrence of bipolar degradation.

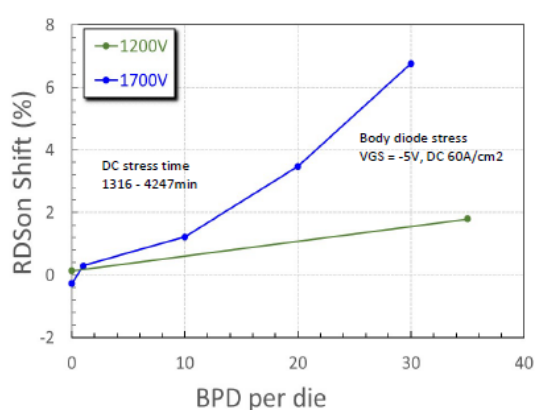
Fig. 1. R_{DSon} drift in percentage after body diode stress for MOSFETs in dependance of voltage class and BPDs per die. [4]

Bipolar degradation by body diode stress [1] has mainly been studied in SiC MOSFETs for high voltages such as 3.3 kV where it has been found to cause significant R_{DSon} increase for some devices [2-3]. For lower voltage classes like 1200 V, bipolar degradation is expected to have less influence because smaller chip areas will be affected by each stacking fault expansion event. Fig 1. shows drift on R_{DSon} vs. average BPD per die for 1200 V 20 mΩ and 1700 V 25 mΩ SiC MOSFETs after body diode stress with a DC current of 15 A corresponding to a quite low current density of 60 A/cm² [4]. Here, devices without BPDs show no R_{DSon} drift and the shift clearly increases with BPD count. Inspired by these results, a further analysis has been done in this work by stressing the body diode in pulsed mode with very high current densities of 1000-1600 A/cm². Finally, devices with different percentage of R_{DSon} drifts after high current stress were examined by backside electroluminescence to check for bipolar degradation.

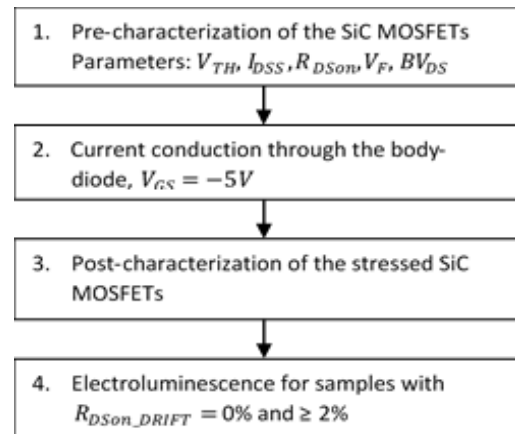
Fig. 2. Test procedure for bipolar degradation

Fig. 2 shows the approach of testing the SiC MOSFETs. The samples were electrically characterized before and after stressing by using the Keysight's B1505A Power Device Analyzer. The measured parameters are V_{TH} , I_{DSS} , R_{DSon} , V_F , BV_{DS} . The pulsed body diode stress was performed using a special surge current tester, which can provide currents well above 1kA and is limited only by the system voltage and the DUT voltage drop. The measurements were all performed at ambient temperature. Fig. 3 shows transient measured forward voltage drop V_F and current I_D during a typical almost square-shaped 50 μ s I_D pulse using a measurement frequency of 100 Hz. The tester uses an arbitrary voltage signal, which enables to create the desired current pulse shape. There is a moderate V_F overshoot due to parasitic inductance, and V_F thereafter shows a small gradual decrease that may be the result of an increasing carrier plasma level due to a temperature increase by self-heating. After the post-characterization of the samples, some of them were sent for a package lead-frame removal to enable back-sided electroluminescence analysis.

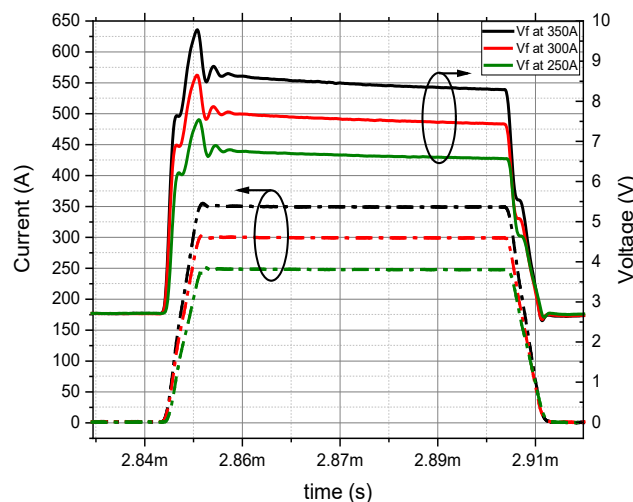
Fig. 3. Transient measured body diode forward voltage drop V_F and current I_D during pulsed current measurements with 250, 300 and 350 A and $V_{GS} = -5$ V V.

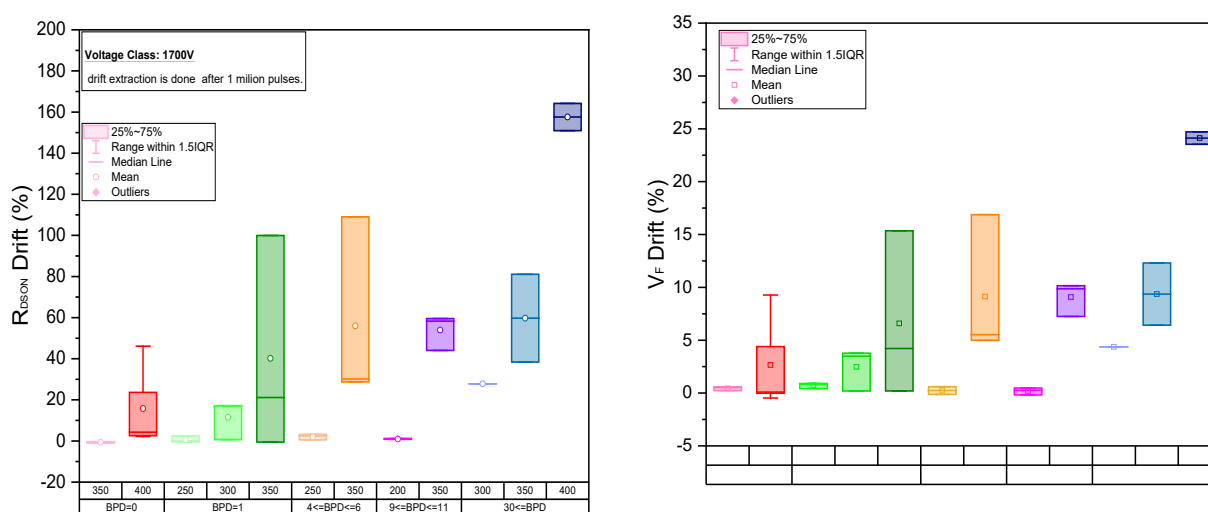
Fig. 4. Drift in $R_{DS(on)}$ and V_F vs. BPD count after body diode stress of 1700 V 25 m Ω SiC MOSFETs with 1 million 50 μ s long pulses vs. stress current.

In the following analysis, results are presented for 1700V 25 m Ω SiC MOSFETs. There are six groups with different numbers of BPDs per device. Fig. 4 shows the drift in $R_{DS(on)}$ and V_F vs. BPD count after 1 million pulses of body diode stress for different stress currents. The drift in $R_{DS(on)}$ and V_F follow a similar trend with typical drift after body diode stress increasing with the BPD count, but also a significant sample to sample variation for each BPD count group. The large sample to sample variation and the significant $R_{DS(on)}$ shift that can occur for a sample with 1 BPD suggests that the observed $R_{DS(on)}$ shifts are not connected only to the individual BPD count in the epi-layer but may also be influenced by BPDs in the border region between substrate and epi (BPDs in this region cannot be detected in the UVPL analysis). The shifts in $R_{DS(on)}$ are most significant with the largest increase being close to 170 %.

The $R_{DS(on)}$ shift vs. stress current for the devices with 1 BPD or more BPDs, illustrates the strong current acceleration of the $R_{DS(on)}$ shift, an effect which is expected since the carrier plasma level will depend on the current density. No significant shifts were found for other parameters such as threshold voltage and breakdown voltage. Fig. 5 shows the $R_{DS(on)}$ drift vs. amount of pulses for a device with 0 BPD, 1 BPD and more than 30 BPDs, where $R_{DS(on)}$ drift does not show any saturation for the devices with BPDs. The results illustrate the usefulness of BPD mapping for predicting the risk for $R_{DS(on)}$ drift after body diode stress and show the stability of zero BPD die at the high stress current of 350 A ($J \approx 1450$ A/cm²).

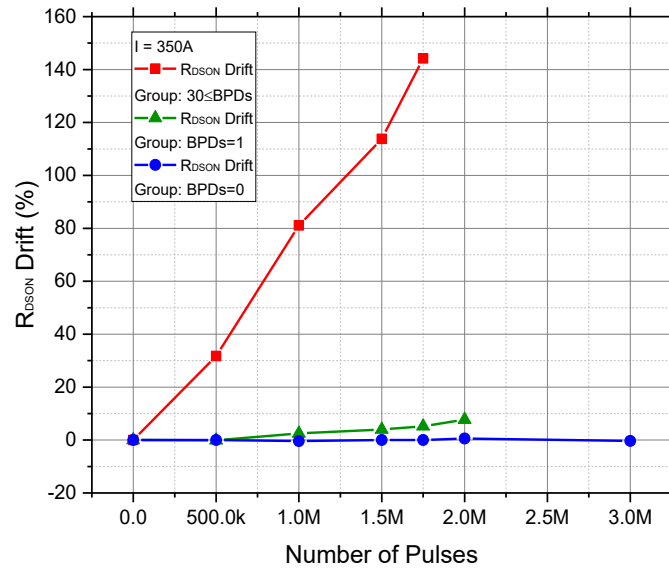
Fig. 5. $R_{DS(on)}$ drift vs. amount of pulses for a device with 0 BPD, 1 BPD and more than 30 BPDs.

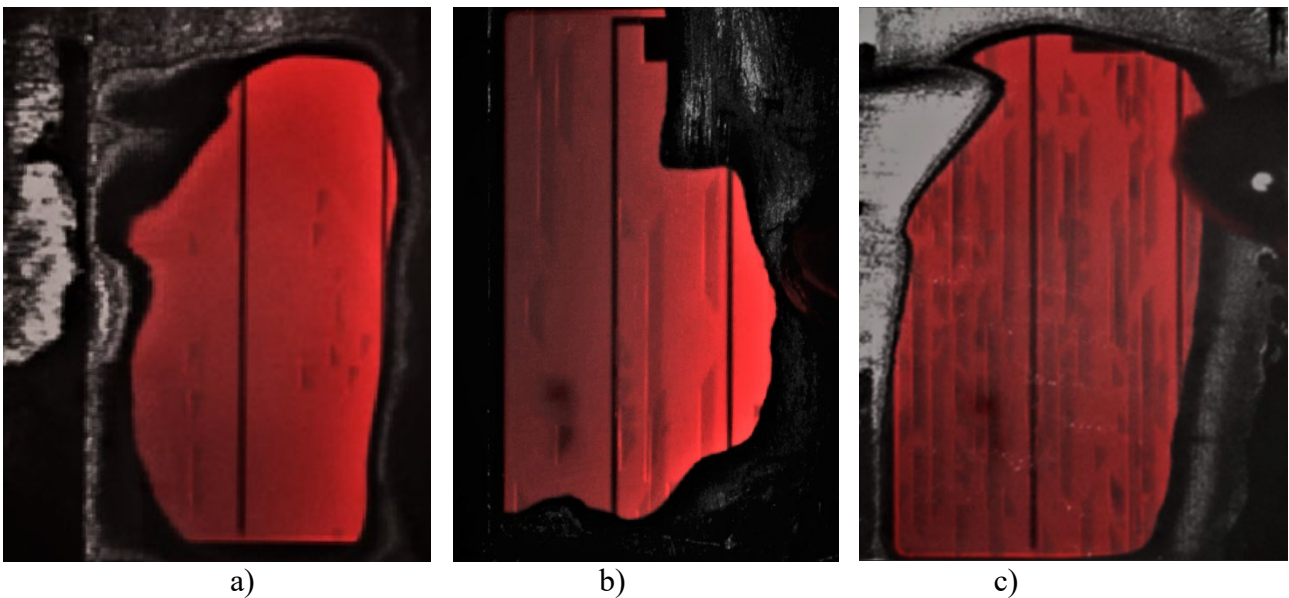
Fig. 6. Electroluminescence analysis on 1700 V SiC MOSFETs after body diode stress at very high current density $\sim 1600 \text{ A/cm}^2$ with $R_{DS(on)}$ drift of: a) $\sim 4 \%$, b) $\sim 46 \%$ and c) above 100% .

Fig. 6 shows Electroluminescence (EL) images captured from the backside for previously body diode stressed SiC MOSFETs during body diode forward bias with $I_{SD}=1 \text{ A}$ and $V_{GS}=-4.5 \text{ V}$. EL patterns can be seen in parts of the chip area where lead frame and solder was removed by mechanical polishing. Triangularly shaped and trapezoidal shaped stacking faults can be observed and there is a clear trend between observed increase in $R_{DS(on)}$ of 4% , 46% and $>100 \%$ after body diode stress and total size of dark areas in EL. The same trend was observed also for the other body diode stressed samples in agreement with bipolar degradation causing creation and expansion of SSF (triangles and SSF bars). No specific features were seen in EL for samples with zero $R_{DS(on)}$ drift.

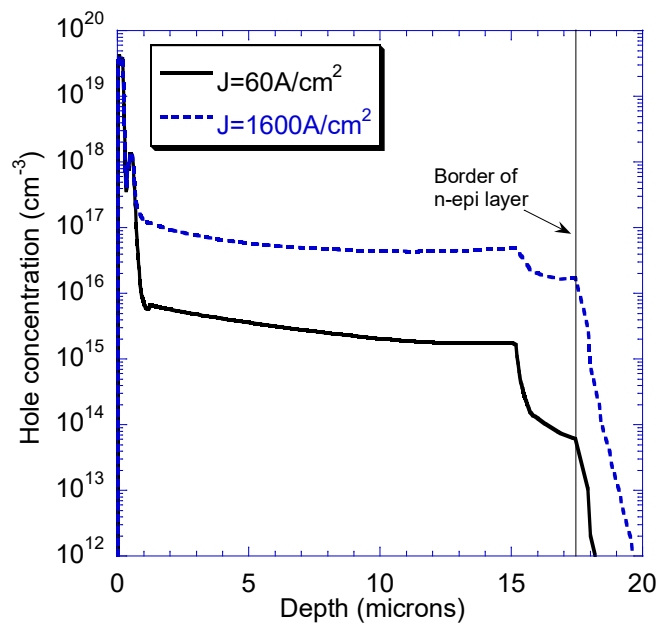
Fig. 7. Simulated hole density in vertical cross-section with 60 A/cm^2 and 1600 A/cm^2 using $V_{GS}=-5 \text{ V}$.

Forward conduction of the 1700 V SiC MOSFET body diode was simulated in Sentaurus using doping dependent carrier lifetime with $\tau_{\max}=100$ ns in the n-epi and $\tau_{\max}=1$ ns in the p-implanted and the n^+ substrate regions to match the measured and simulated forward voltage drop. The cross-section plot in Fig. 7 shows that the hole density in the n-epi region with 60 A/cm^2 ($I_{SD}=15 \text{ A}$) looks sufficiently large to cause propagation of a triangularly shaped Shockley-type stacking fault from a BPD in the n-epi, a result in line with the correlation between small R_{DSon} increase and epi BPD count in Fig. 1. In case of the high current density of 1600 A/cm^2 ($I_{SD}=400 \text{ A}$) the hole density has increased more than 10x in the n-epi and has reached a level in the 10^{16} cm^{-3} range in the border region between epi and substrate. The finding of large trapezoidal features in EL after body diode stress at this high current density is likely caused by bar-shaped Shockley-type stacking faults caused by carrier recombination in the epi-substrate border region where most BPDs are converted to threading edge dislocations [5].
