# Reliability of SiC MOSFET Power Modules under Consecutive H3TRB and Power Cycling Stress

**Keywords:** SiC MOSFET, Reliability, High Humidity High Temperature Reverse Bias, H3TRB, Power Cycling, PC, Combined Testing, Multimodal Reliability Testing

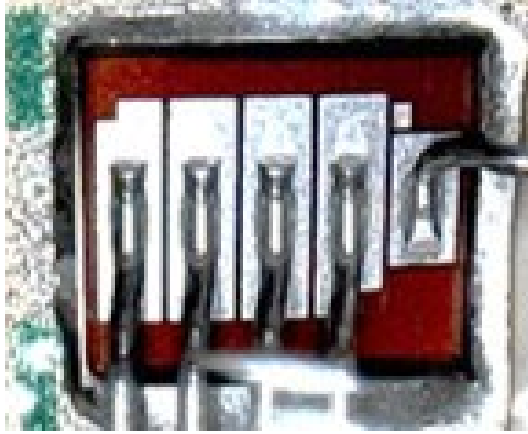
(a) Image of the chip under test, a 1200 V/25 A SiC MOSFET chip with a chip area of approximately  $12 \text{ mm}^2$

As devices under test (DUTs), SiC MOSFET chips with a nominal blocking capability of 1200 V and a current rating of 25 A were used. An image of the chip under test is shown in Fig. 1a. The chips were packaged in a base plate less module package with spring terminals (MiniSKiiP), depicted in Fig. 1b. The module consists of a DCB substrate with solder die-attach and silicone gel as filler material. For this investigation, a total of 24 SiC MOSFET modules of the same production lot were used.

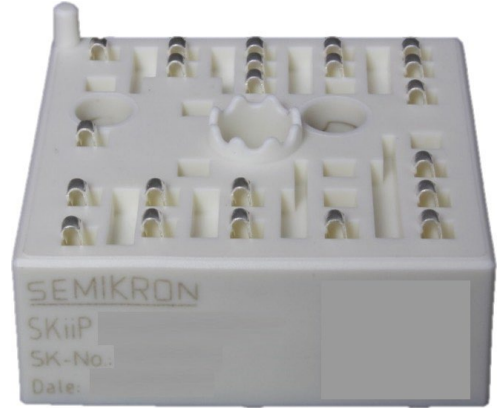
(b) Image of the package under test, a base plate less module package with spring terminals (MiniSKiiP)

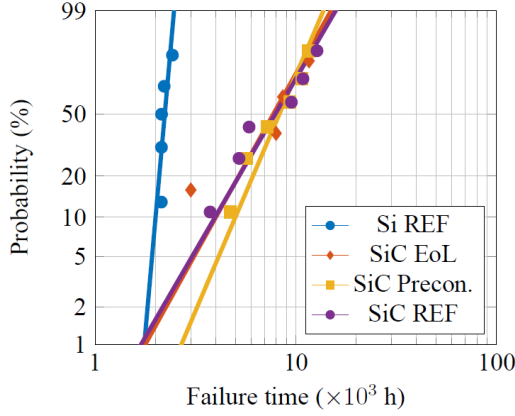
Fig. 5: Weibull plots of the H<sup>3</sup>TRB test results for all three test splits and data for silicon devices as a reference [4]

**Statistical Analysis** The Weibull plots of the H<sup>3</sup>TRB test results are shown in Fig. 5, and the associated Weibull parameters are summarised in table 2. In comparison to the reference data for silicon [4], the Weibull scale factors are significantly higher for all test splits. While this indicates a much higher ruggedness of the SiC devices under electro-chemical stress, as previously reported in [4], this is not necessarily material related, since the considered silicon counterparts are not state-of-the-art designs anymore, because novel silicon devices feature an improved H<sup>3</sup>TRB performance, too [12]. On the other hand, the Weibull shape factor is much smaller for the SiC devices, which represents the wider failure distribution of the SiC devices. Considering the Weibull scale factors of the three test

splits of the H<sup>3</sup>TRB after PCT test, the reference split with the pristine devices features a slightly higher scale factor. However, the difference between the preconditioned devices and the reference split is only marginal, i.e. less than 3 % between the REF split and the one with the lowest scale factor (Precon. split). Considering the error margins, no significant difference between the test splits can be derived from the test results. Hence, the results suggest that the previous thermo-mechanical stress induced by the preceding power cycling test did not affect the lifetime under H<sup>3</sup>TRB stress for the investigated devices.

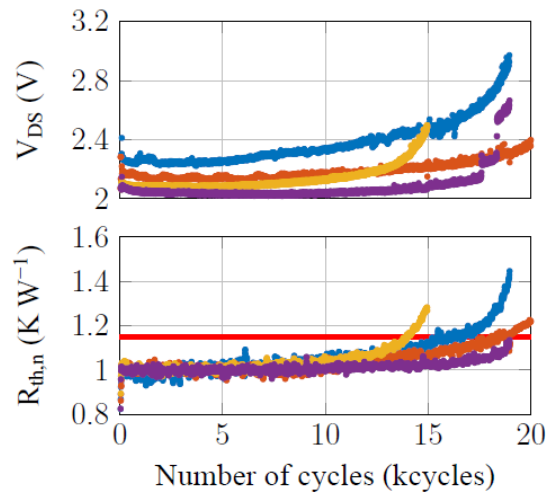
Fig. 6: Characteristics of  $V_{DS}$  and  $R_{th}$  of the four DUTs of test split 3 during the PCT test, performed after the DUTs parametric end of life during H<sup>3</sup>TRB

**Failure Mechanism** The characteristics of  $V_{DS}$  and  $R_{th}$  of all 4 DUTs are shown in Fig. 6. All DUTs exhibited an increase in  $V_{DS}$  and  $R_{th}$  towards their parametric end of life. Three of the four devices showed only a gradual increase of  $V_{DS}$  and  $R_{th}$  and surpassed the CSD failure criterion of 15 % increase in  $R_{th}$  without any indication of bond wire failure. One DUT exhibited multiple step increases in  $V_{DS}$ , indicating bond wire failure, shortly before the  $R_{th}$  failure criterion was met. Previously published power cycling test results for modules of the same production lot [6] showed that the dominating failure mode for the applied test conditions is CSD, but some bond wire failures can be expected as well. Therefore, the results of this test do not indicate a shift in failure mode due to the preceding H<sup>3</sup>TRB test. Since the  $R_{th}$  only indicates degradation of the thermal path without further information about the location, the thermal impedance characteristics  $Z_{th}$  was also monitored frequently during the test. The  $Z_{th}$  characteristics of one DUT during the PCT run 3 is shown in Fig. 7.

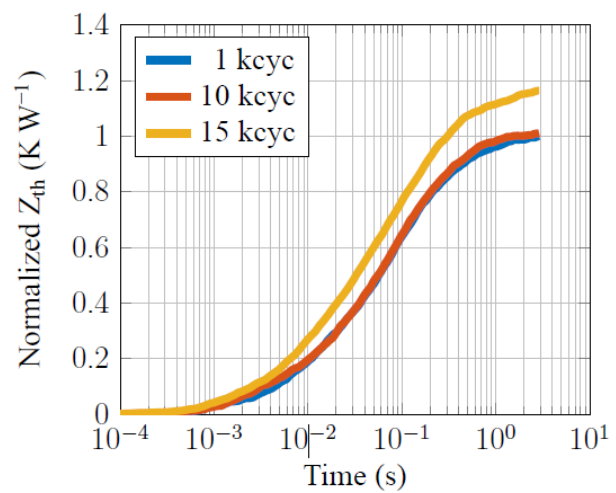
Fig. 7:  $Z_{th}$  characteristics of DUT 3 split 3 (yellow line in Fig. 6), failed due to chip solder degradation during the PCT performed after the H<sup>3</sup>TRB test (PCT run 3)

The  $Z_{th}$  characteristics exhibit a change in the time domain of 1 ms to 10 ms in the measurement taken at 17 kcycles. Degradation in this time domain is typical for chip solder degradation of this package type [10], which confirms that the underlying failure mechanism of the DUTs was indeed CSD.

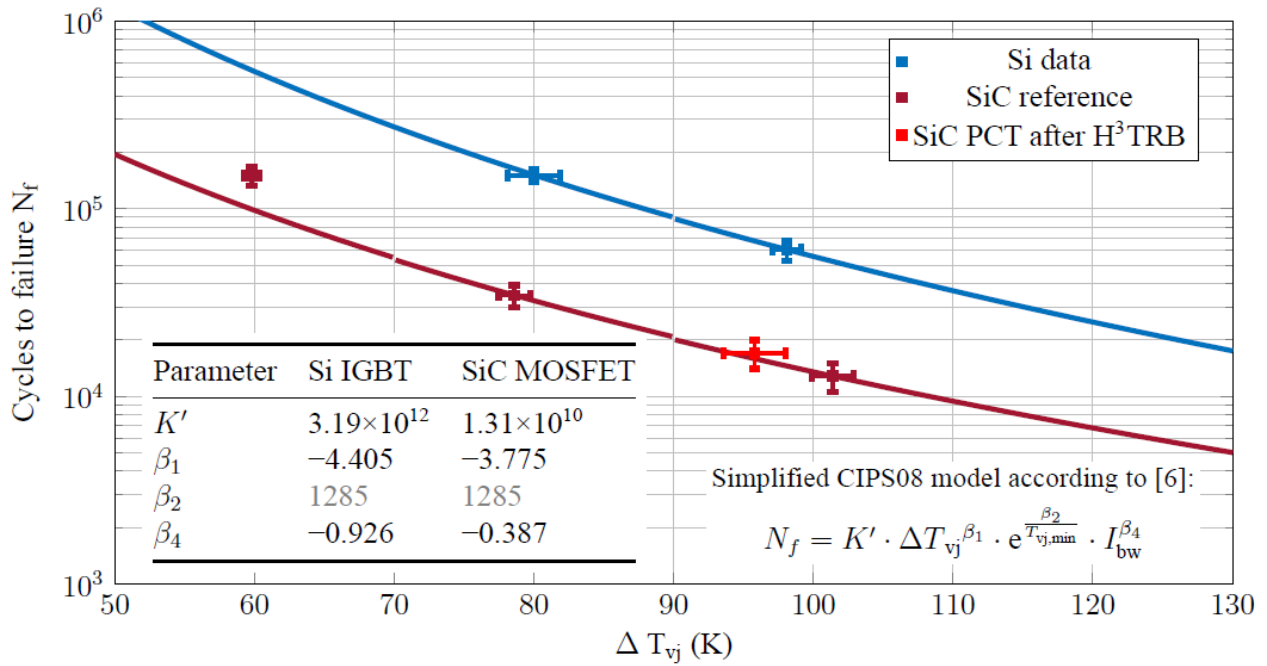
Fig. 8: Lifetime plot of the power cycling test results (Weibull scale factors considered as  $N_f$ ), with reference data for comparable silicon devices for comparison [6]. All 4 DUTs (including the DUT with bond wire failure shortly before the  $R_{th}$  failure criterion was reached) were used for the statistical analysis. The error bars indicate the standard deviation of  $N_f$  and  $\Delta T_{vj}$ . The lifetime curves are obtained using a fit on the simplified CIPS08 model according to [6]. The parameter for the impact of  $T_{min}$  ( $\beta_2$ ) was not fitted but taken from the original model.

**Lifetime Analysis** The test results are shown in the lifetime plot in Fig. 8, with the cycles to failure corresponding to the Weibull scale factor and the error bars indicating the standard deviation of  $\Delta T_{vj}$  for the x-axis and  $N_f$  for the y-axis, respectively. As a reference, a lifetime model obtained for identical devices of the same production lot, is also shown [6]. The lifetime model is obtained by a parameter fit on the simplified CIPS08 model according to the inset equation in Fig. 8. The corresponding parameters for the devices under test as well as for comparable silicon devices in the same package are given in the inset table in Fig. 8. As published before [6], the number of cycles to failure of the SiC MOSFETs is only approximately 25 % of the number of cycles to failure of their silicon counterparts, which is consistent with other studies [13, 14]. Considering the respective error bars, the data point for the results of the PCT after H<sup>3</sup>TRB is in good agreement with the lifetime model for the module under test. This indicates that the preceding H<sup>3</sup>TRB stress of several thousand hours did not affect the power cycling capability of the modules.
